# Shire Of Esperance

## Esperance Tanker Jetty Remediation Options Review

### Independent Peer Review

November 2016

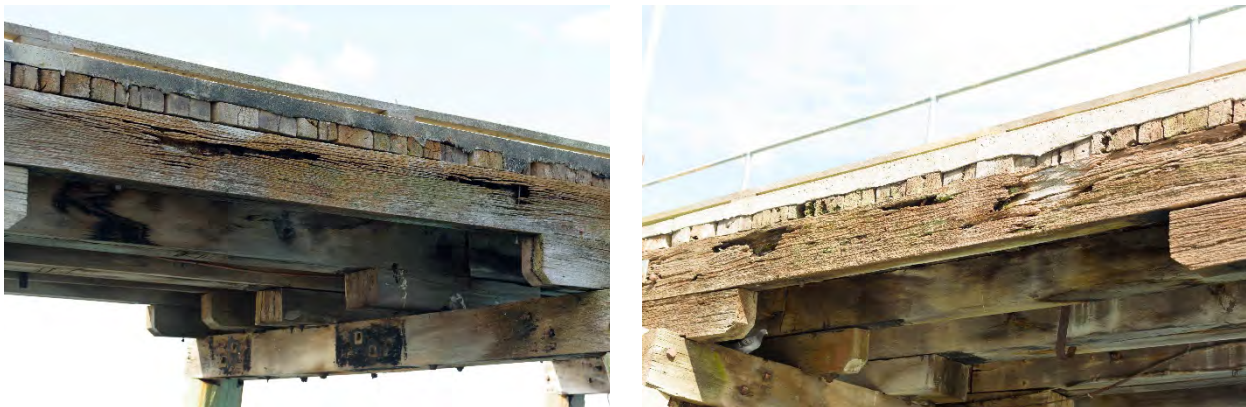
**Examples of typical external stringers that require replacement or structural augmentation**

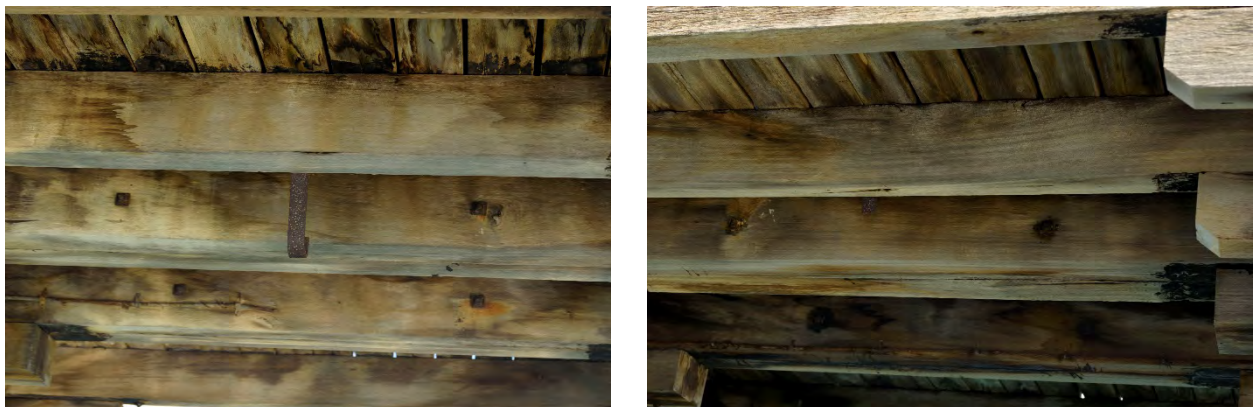
**Examples of typical internal stringers is relatively sound condition**

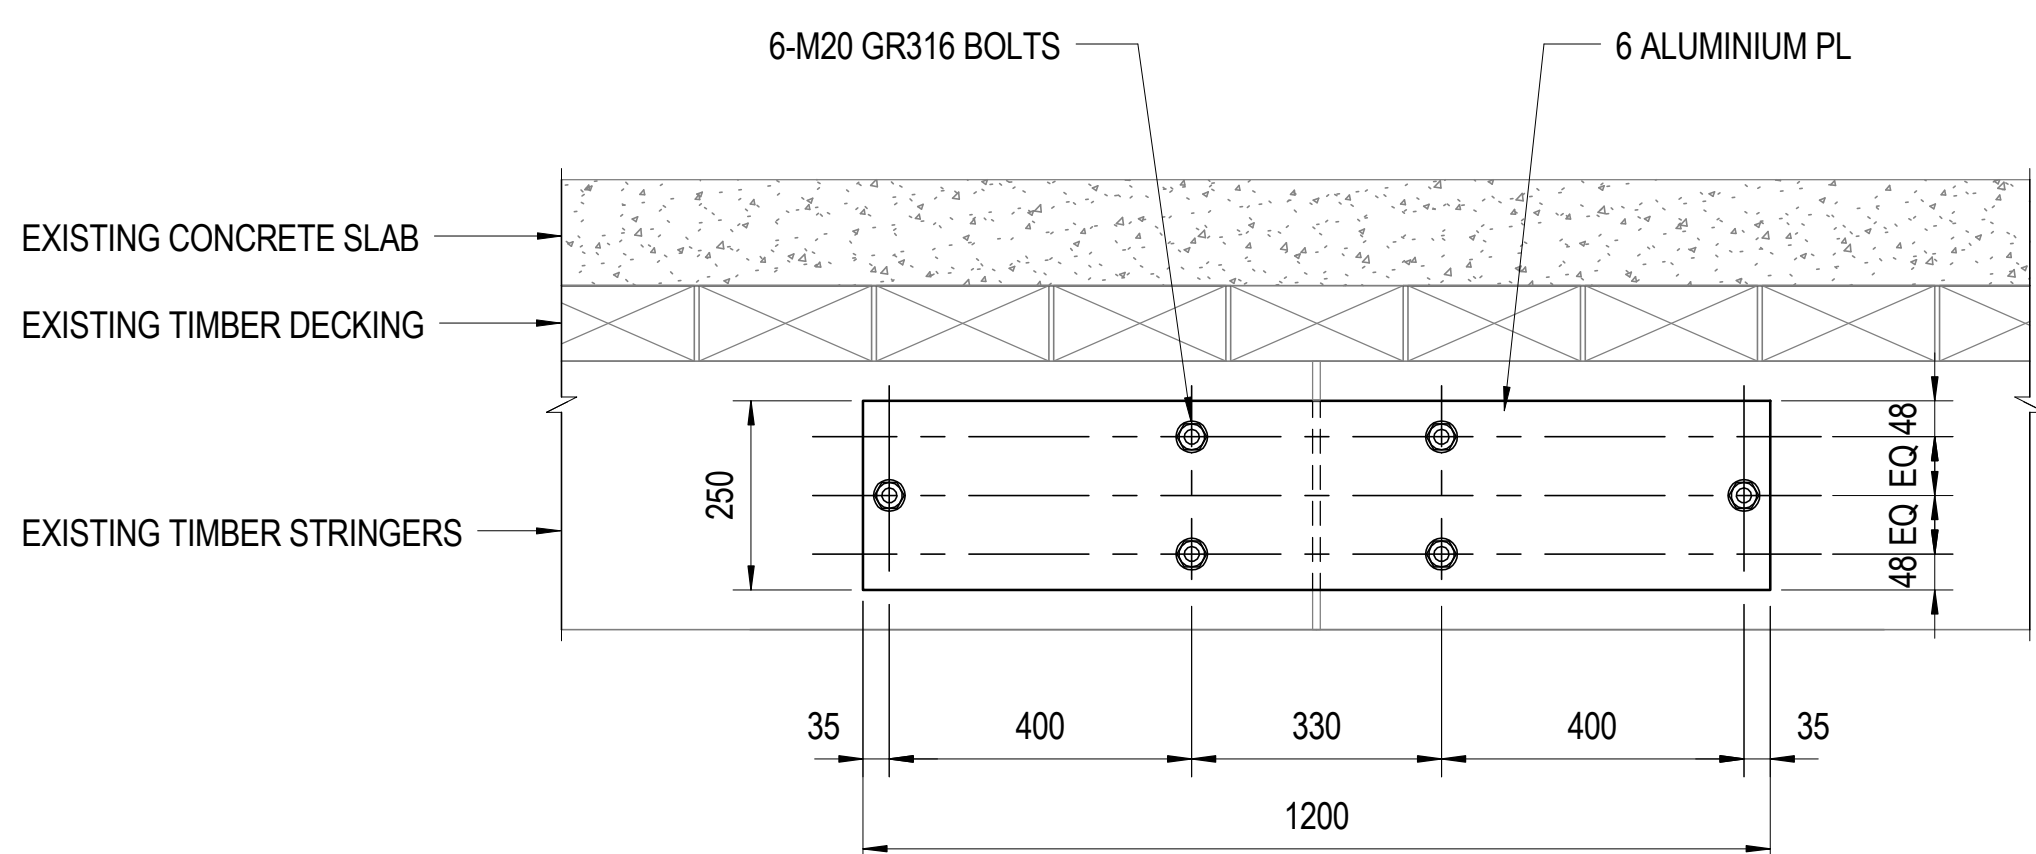
TYPICAL STRINGER SPLICE DETAIL - OPTION 1

4. In addition to the structural comments outlined in item 3.ii), the splice detail for the stringers is noted as a 6mm aluminium plate with M20 stainless steel bolts. From a durability perspective, aluminium plate may not be ideal for a marine environment and the plate itself is quite thin – confirmation should be provided that all steelwork (including aluminium) will comply with corrosion protection requirements for a 50-year service life. For example, in this case, with 3mm corrosion, there would be no plate section remaining. In addition, the dissimilar metals of the plate and bolts will need to be managed;

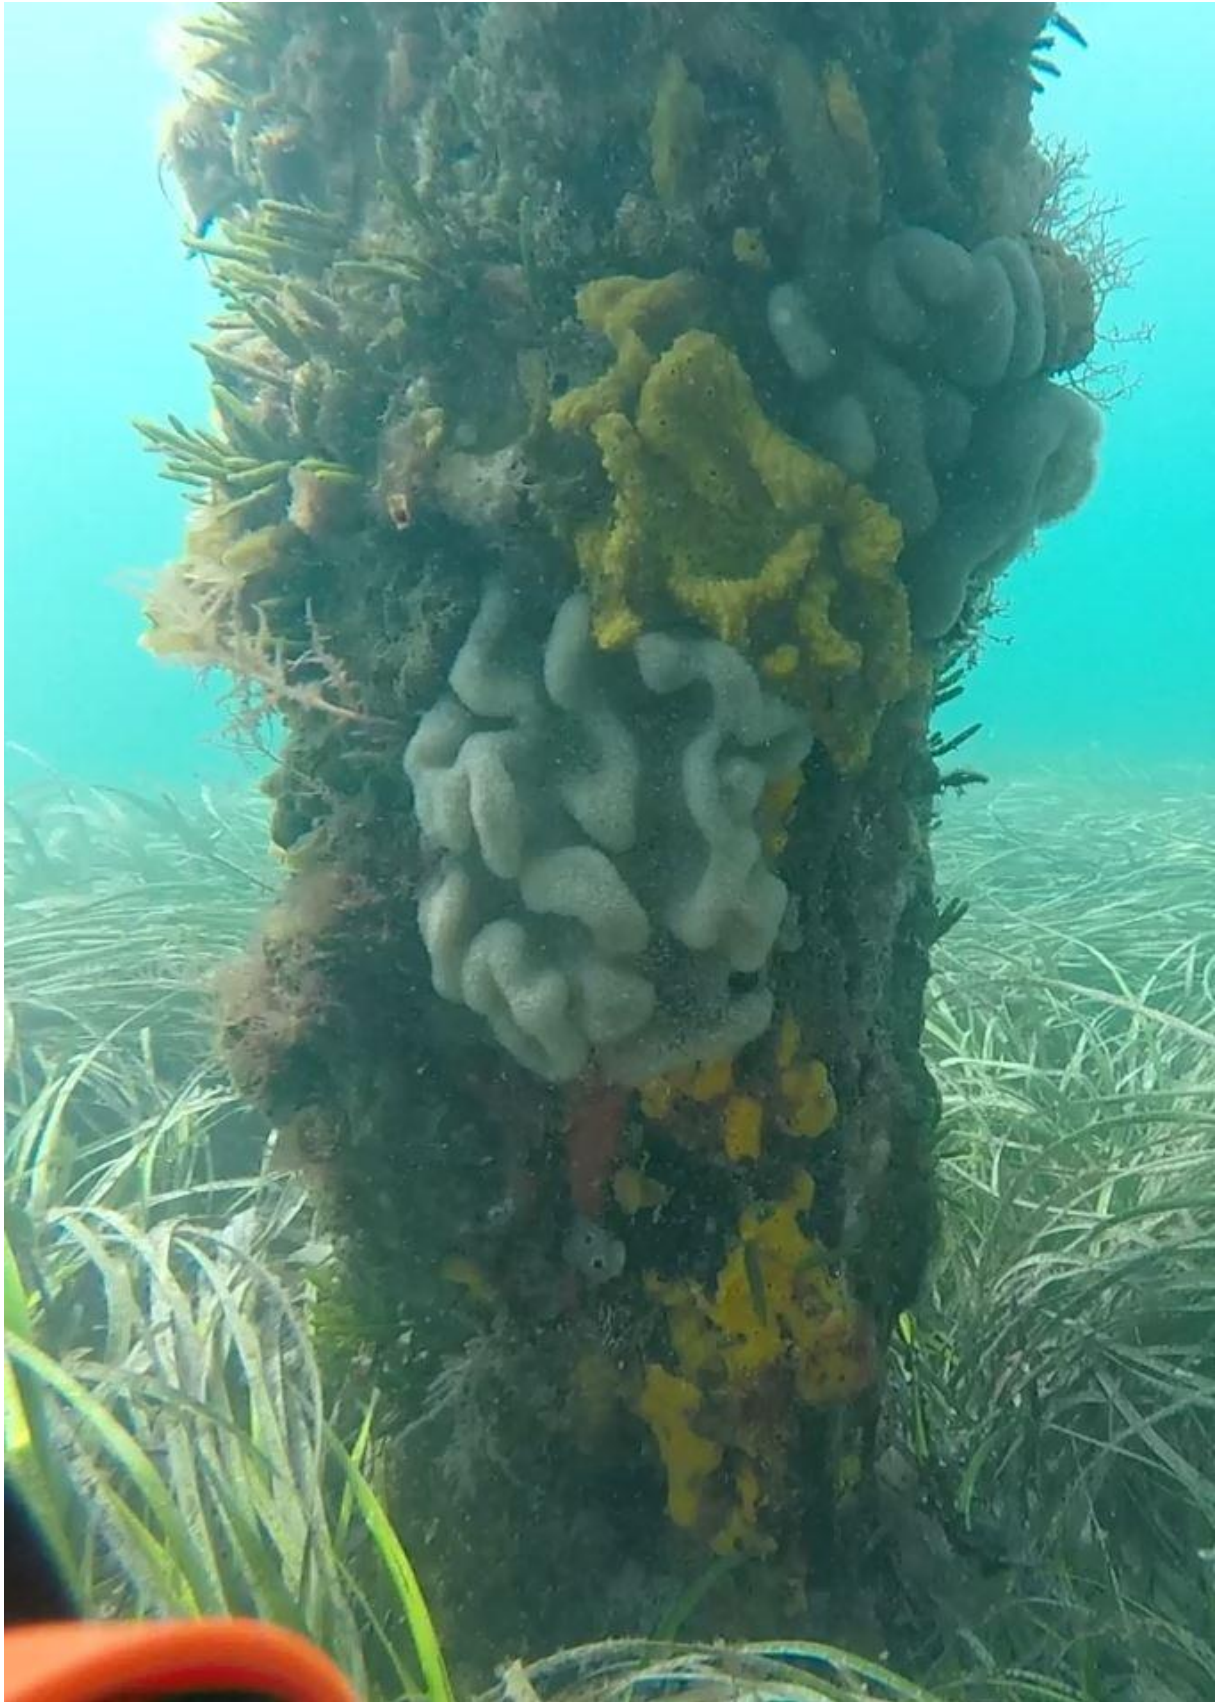
- 54 North – Appears to have failed between surface and sea bed

**Figure 3-1: 54 North 11/11/15 – Severe necking at base (prior to failure identified 17/11/15)**

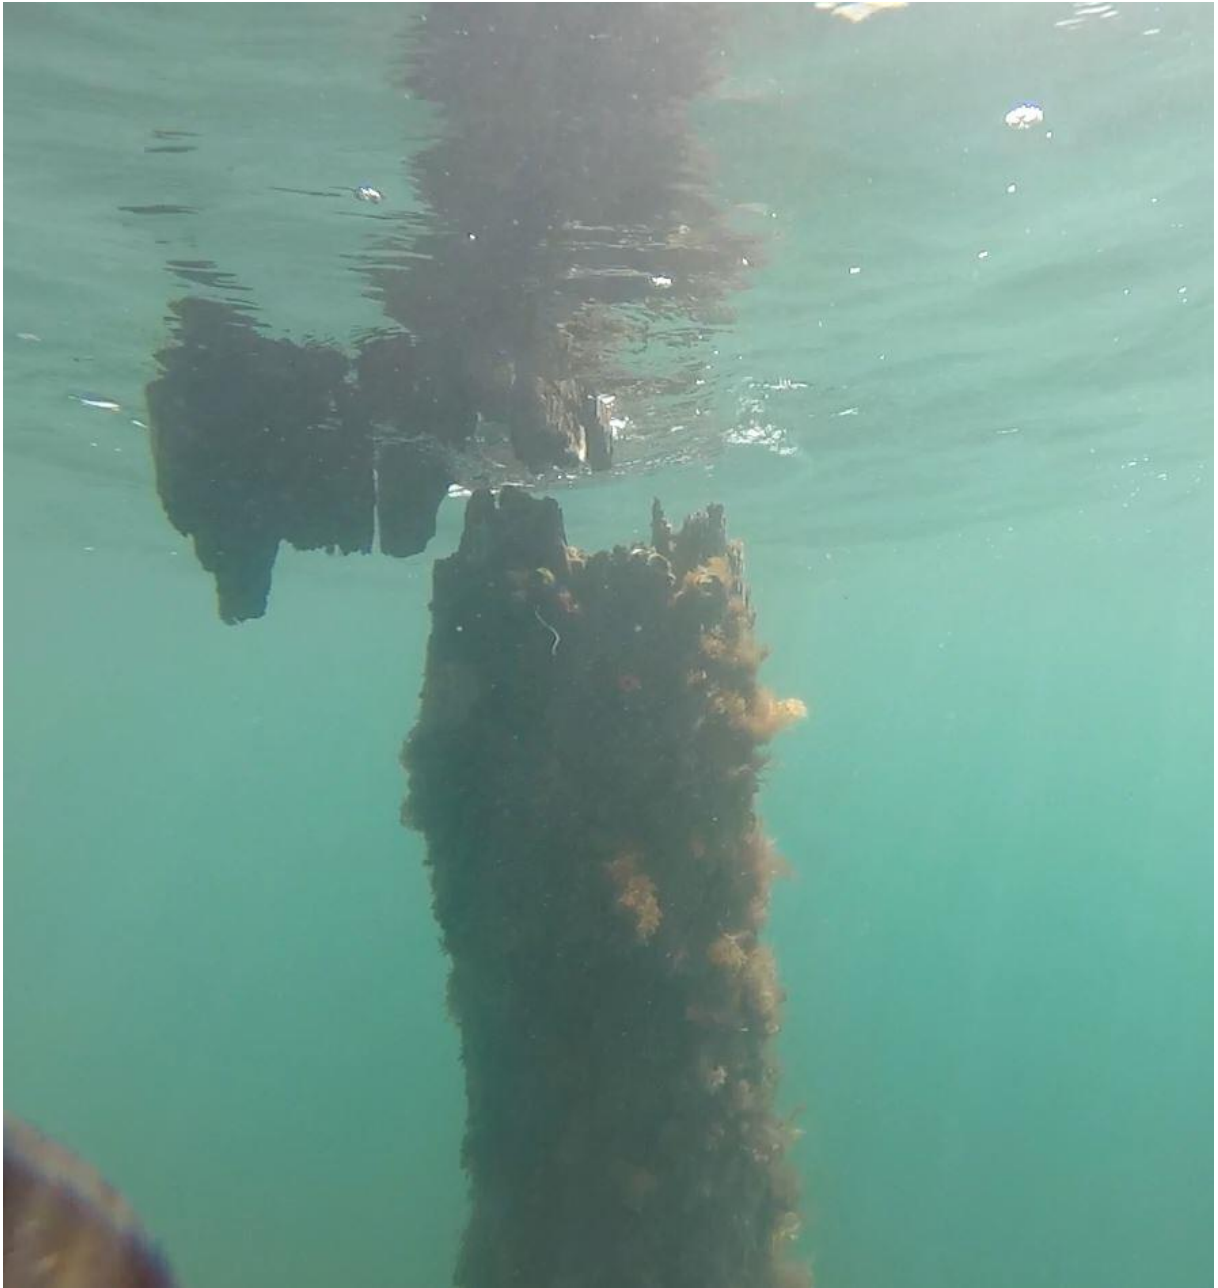
- 93 North - Failed at water surface

**Figure 3-2: 93 North 11/11/15 – Failure at surface**

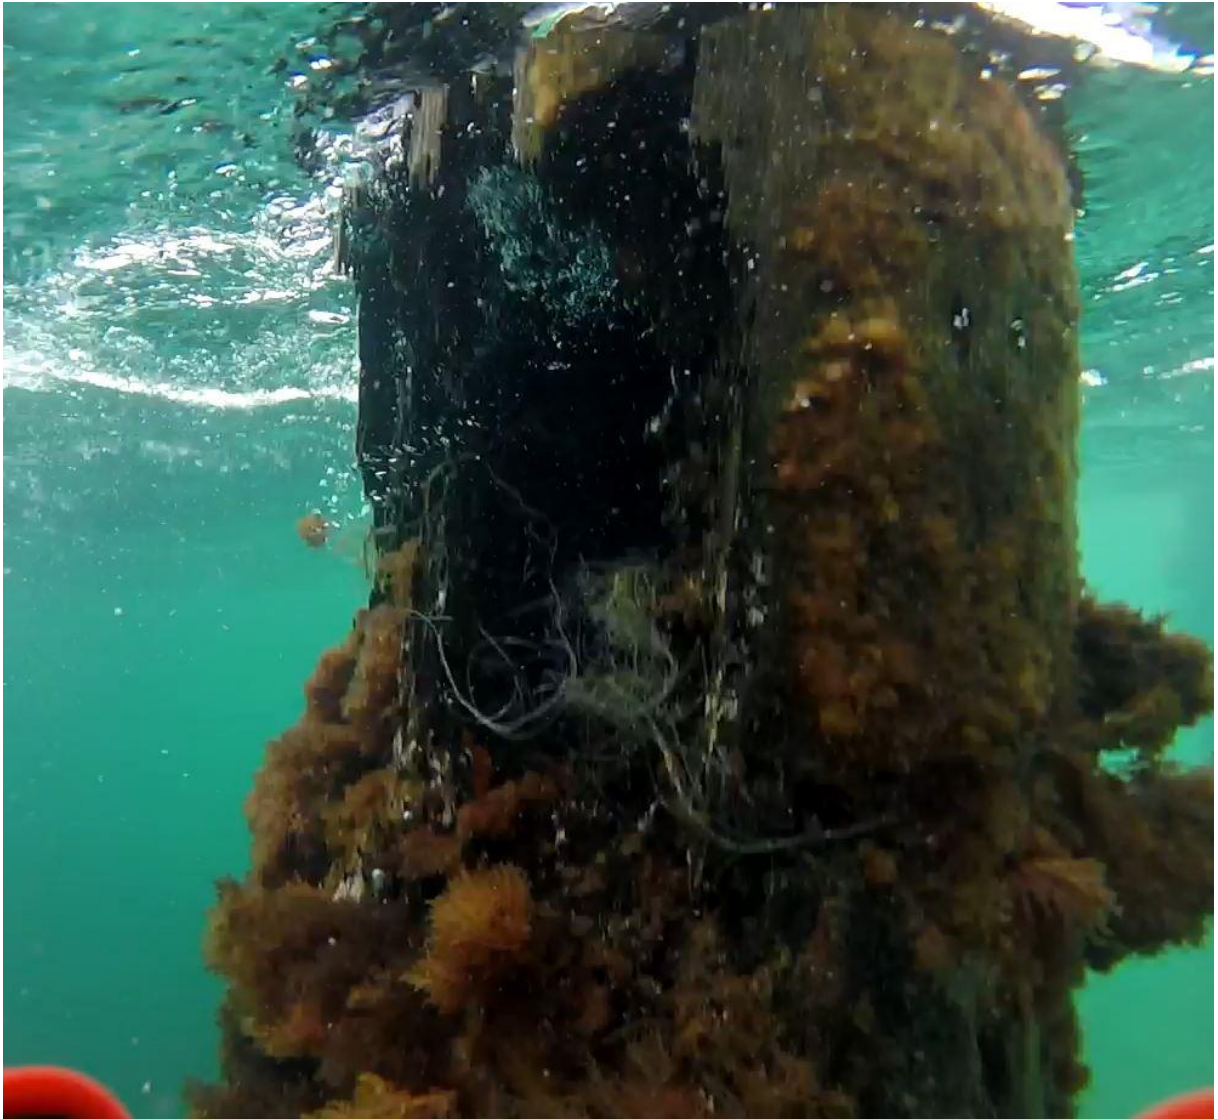
- 53 South

**Figure 3-3: 53 South 11/11/15 – Severe section loss at surface**

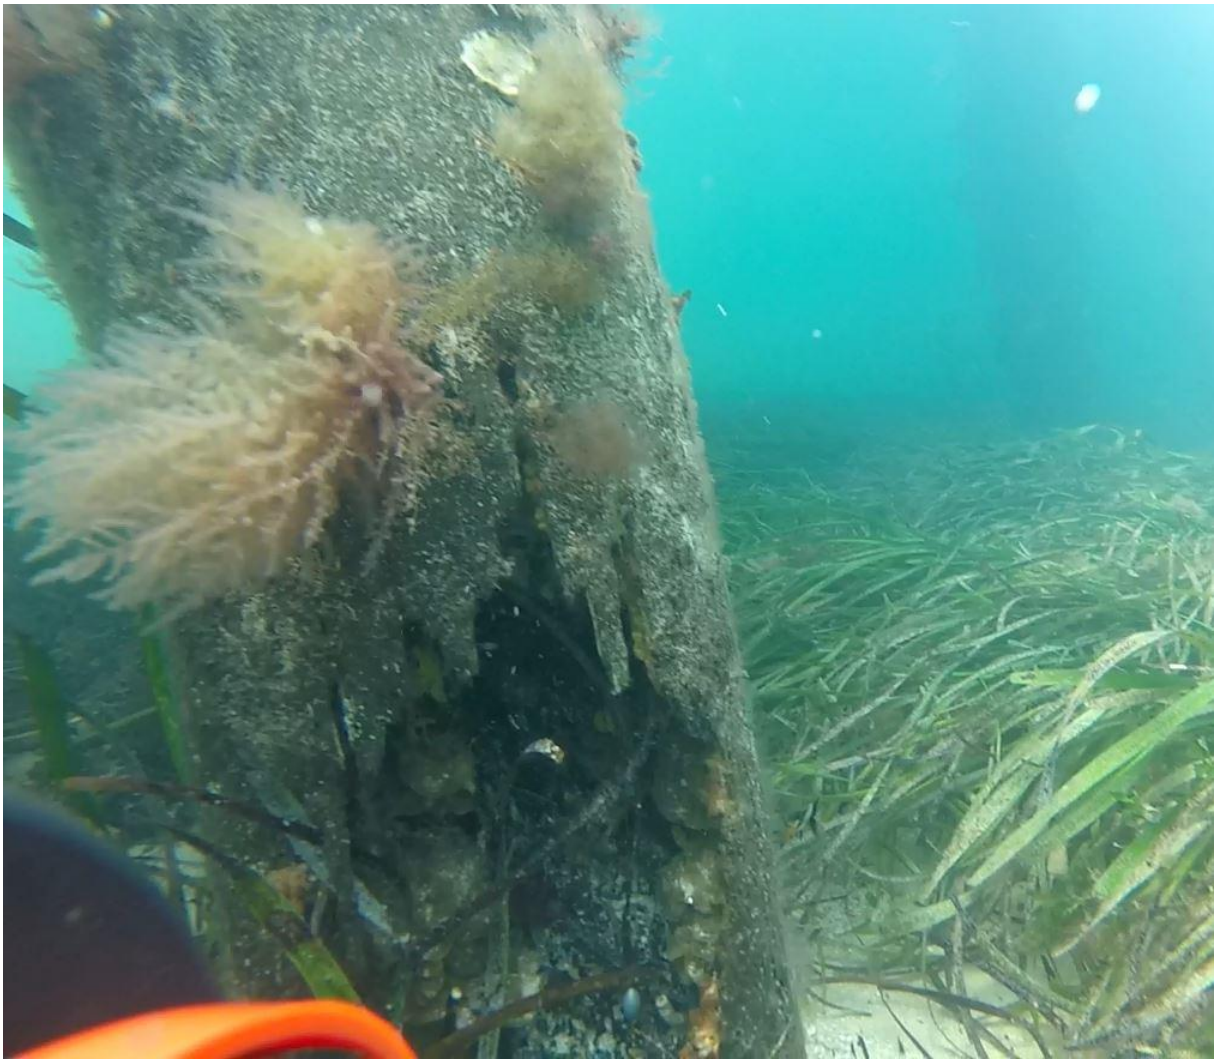
- 58 South

**Figure 3-4: 58 South 11/11/15 – Severe section loss at base**

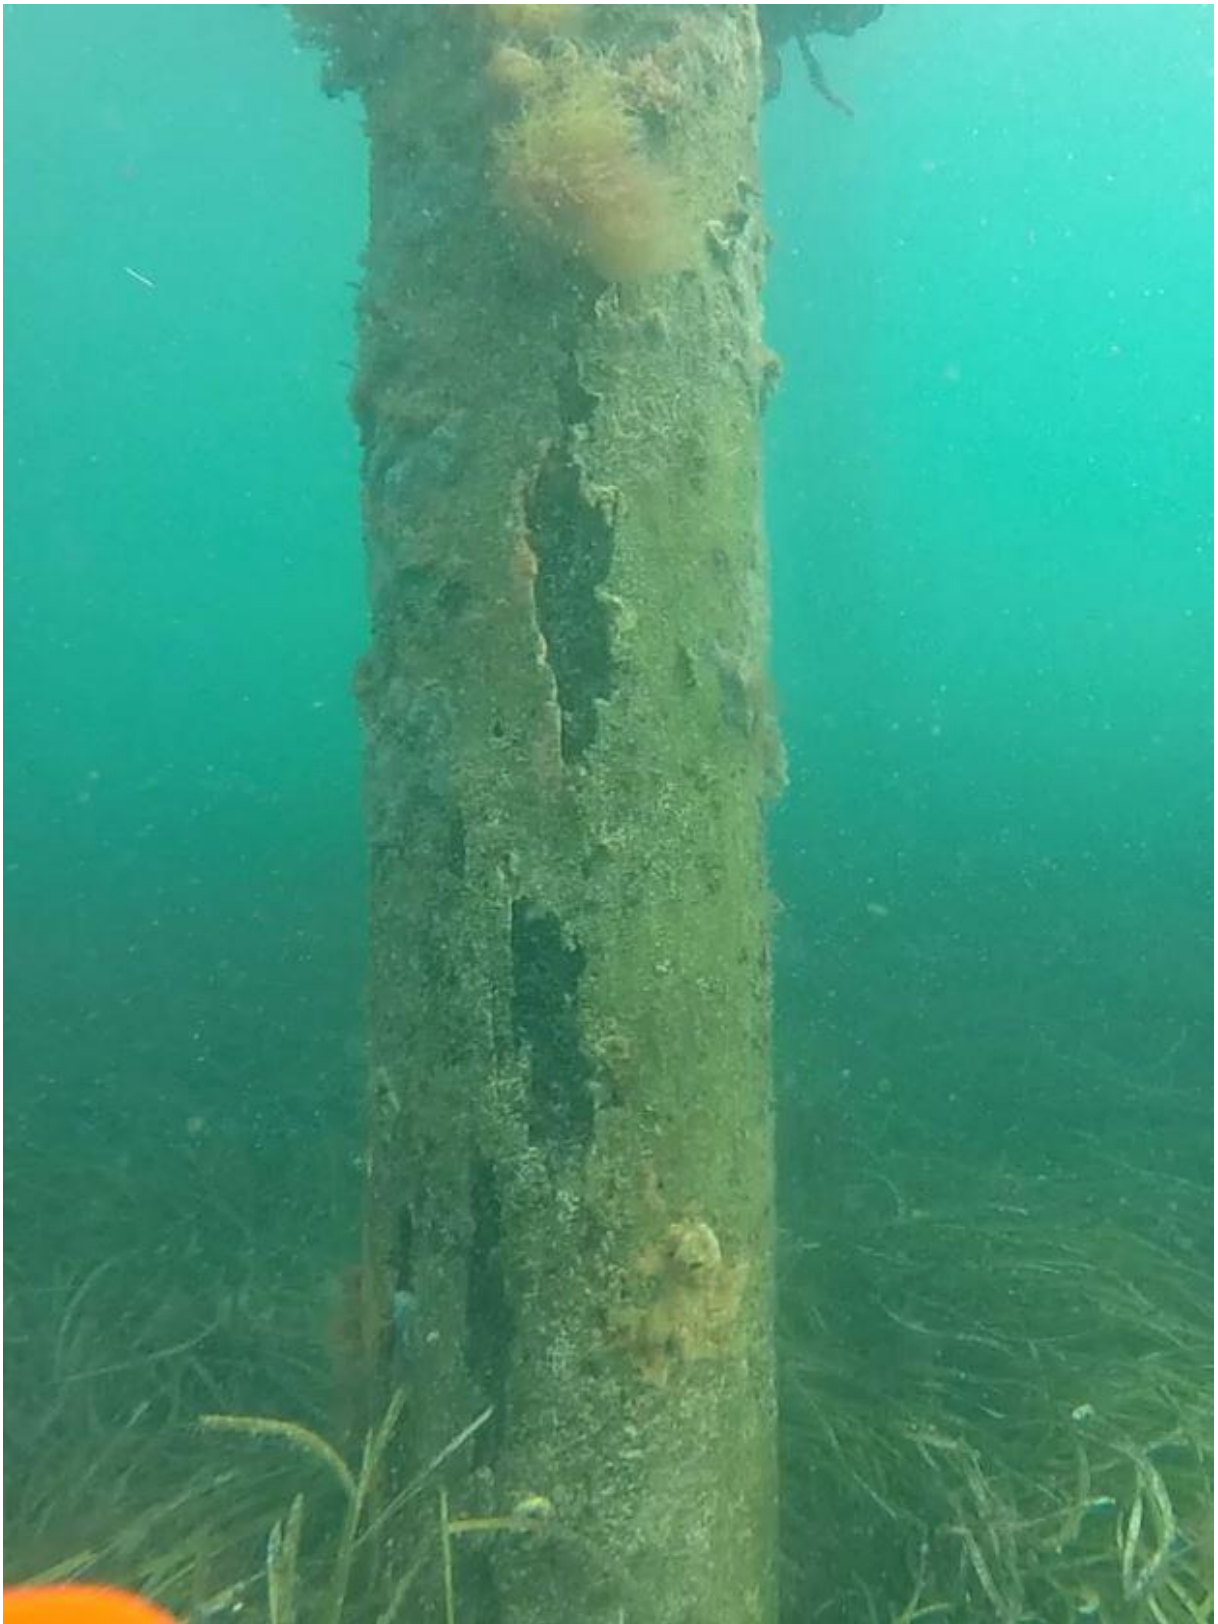
• 74 North

**Figure 3-8: 74 North 11/11/15 – Section loss and splitting at many locations through water column**

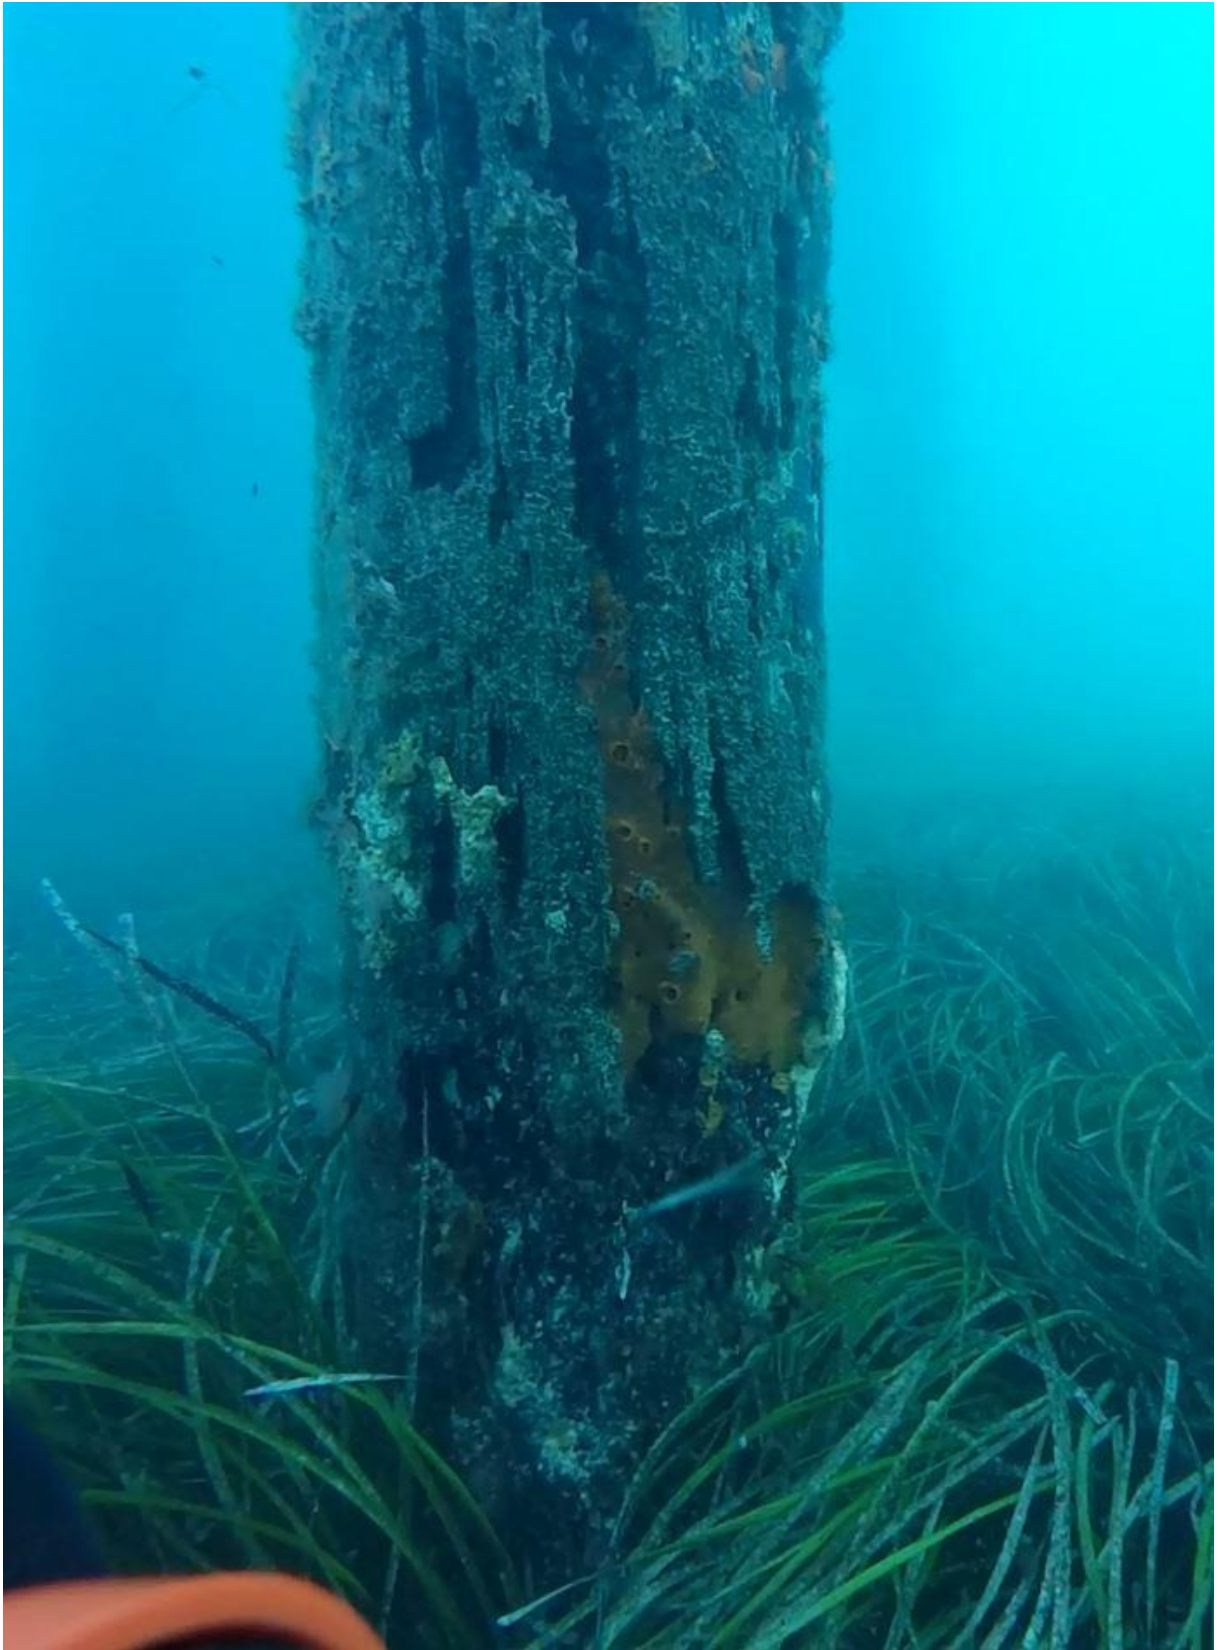
• 112 North

**Figure 3-11: 112 North 11/11/15 – Severe section loss at base**

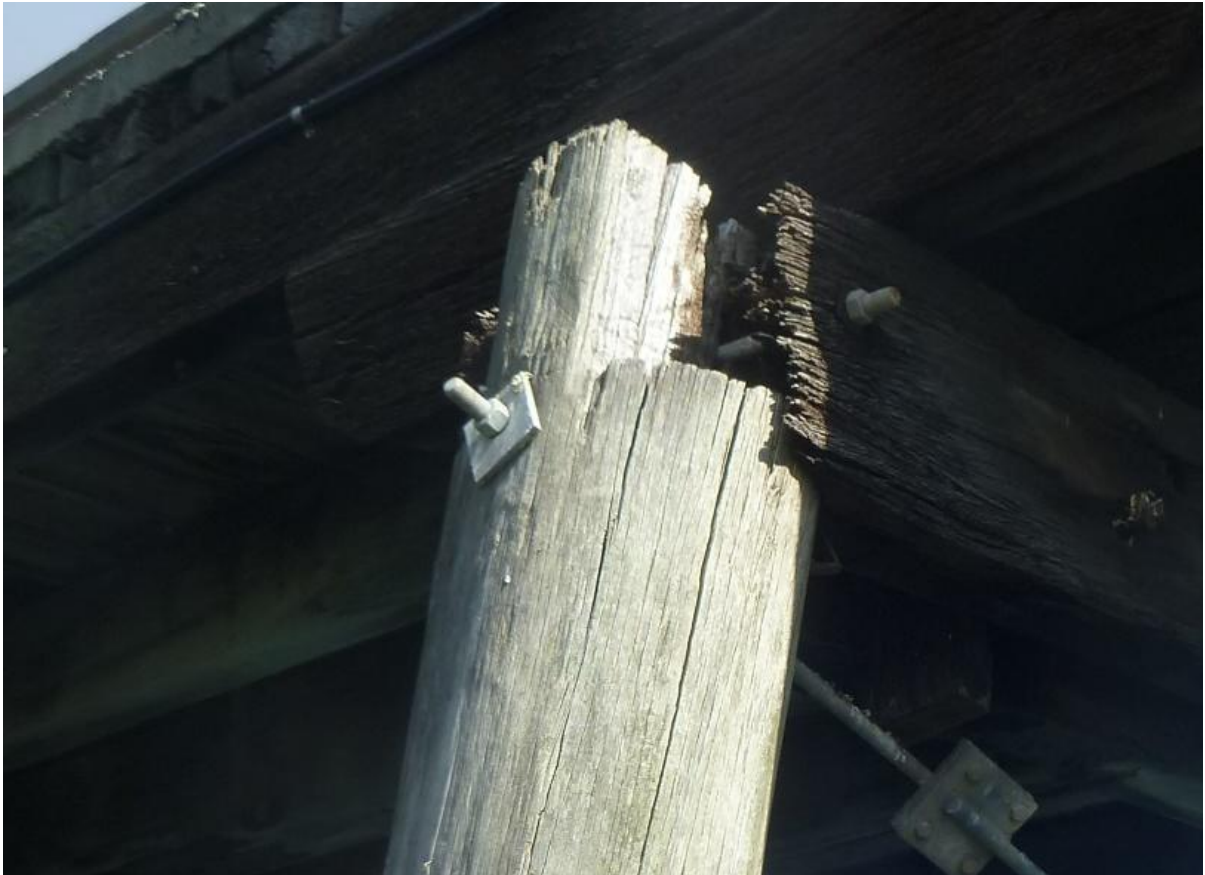
- 35 North

**Figure 3-14: 35 North West 17/11/15 – Crushing of both half caps**

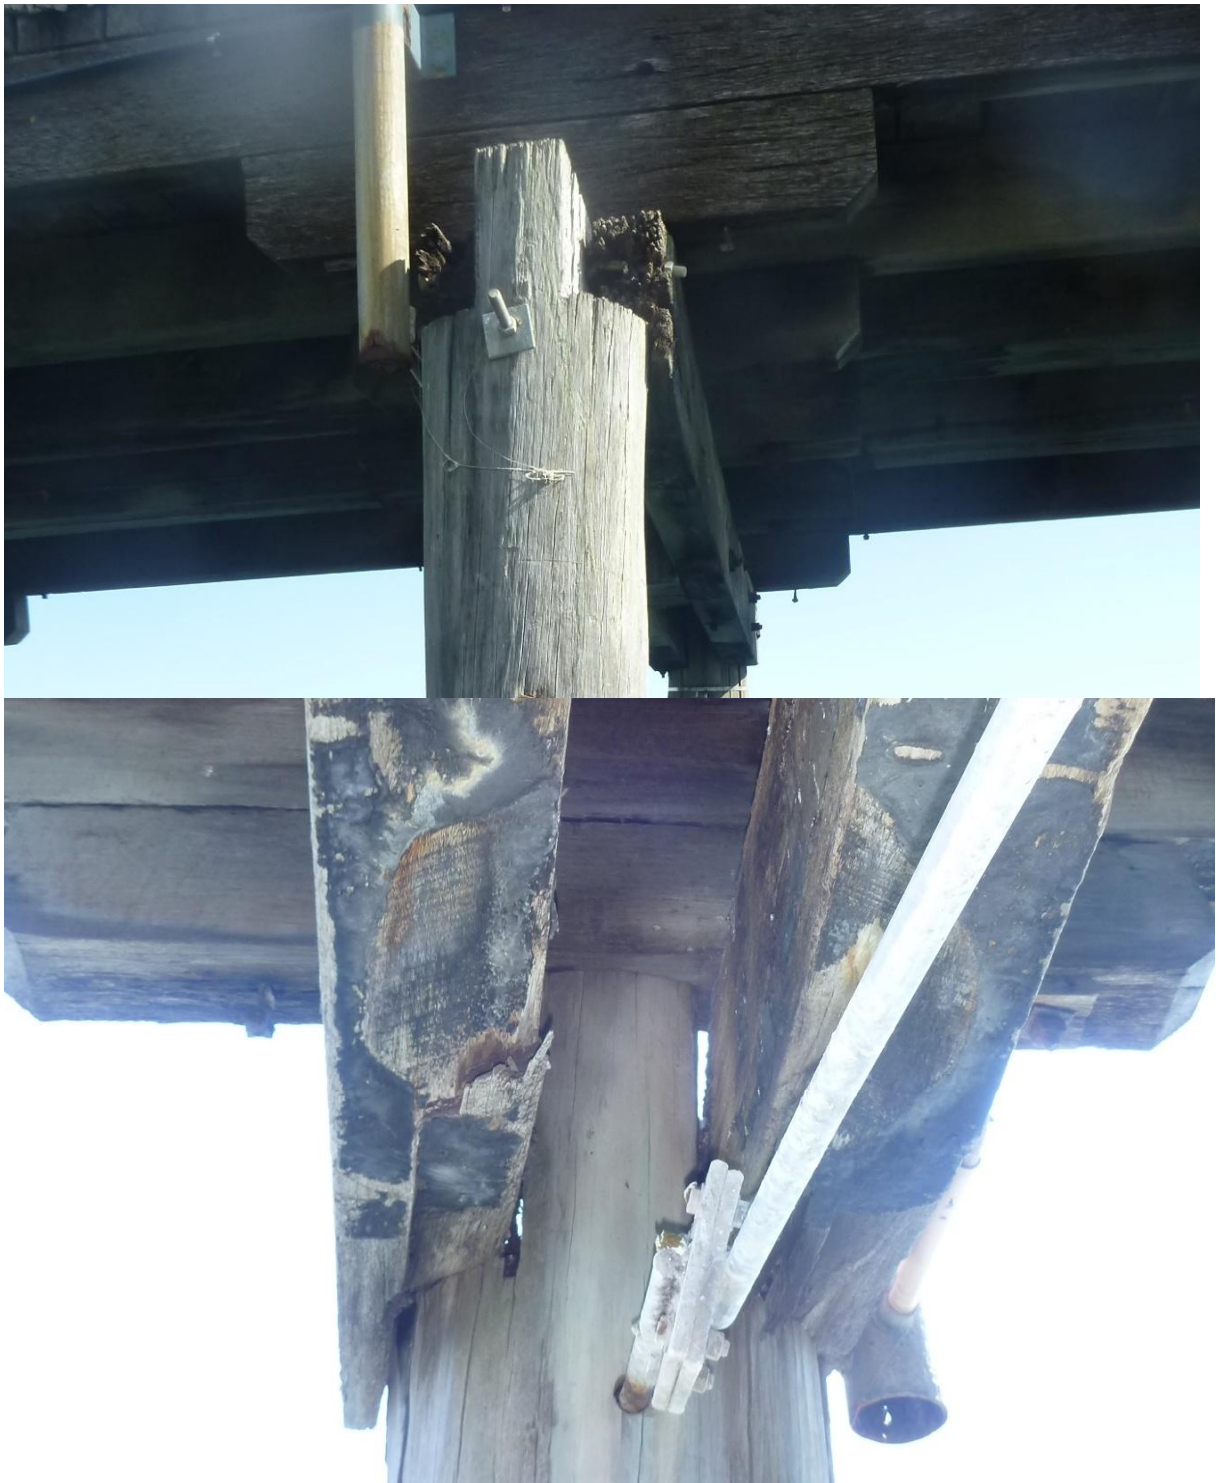
• 36 North

**Figure 3-15: 36 North 17/11/15 – Crushing of both half caps**

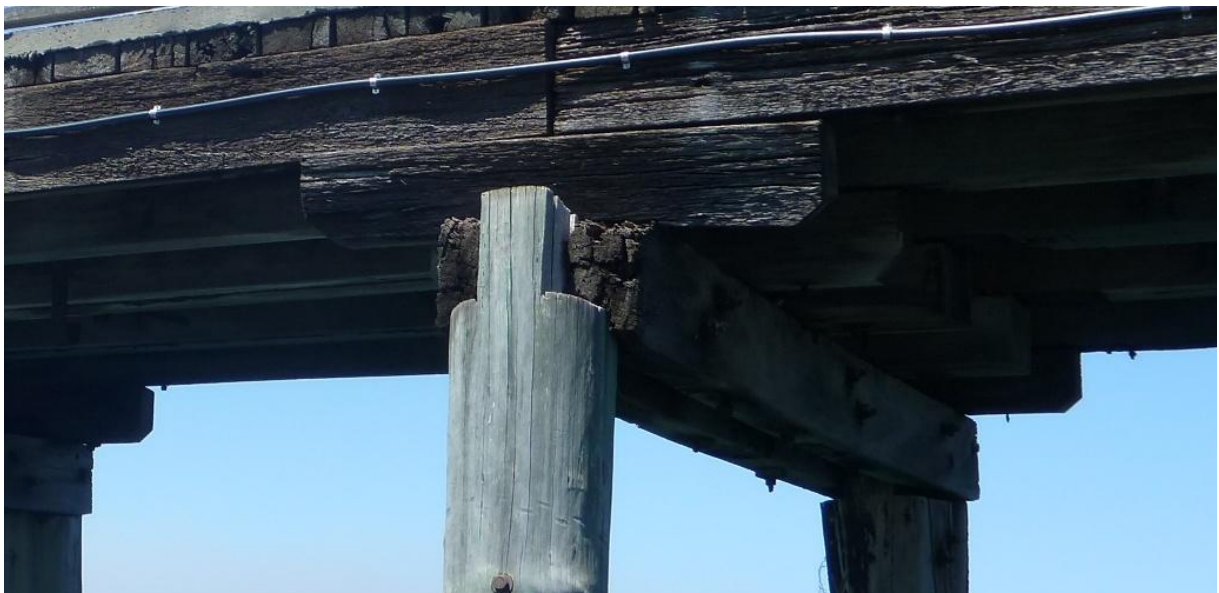
- 43 North

**Figure 3-19: 43 North 17/11/15 – Crushing of both half caps**

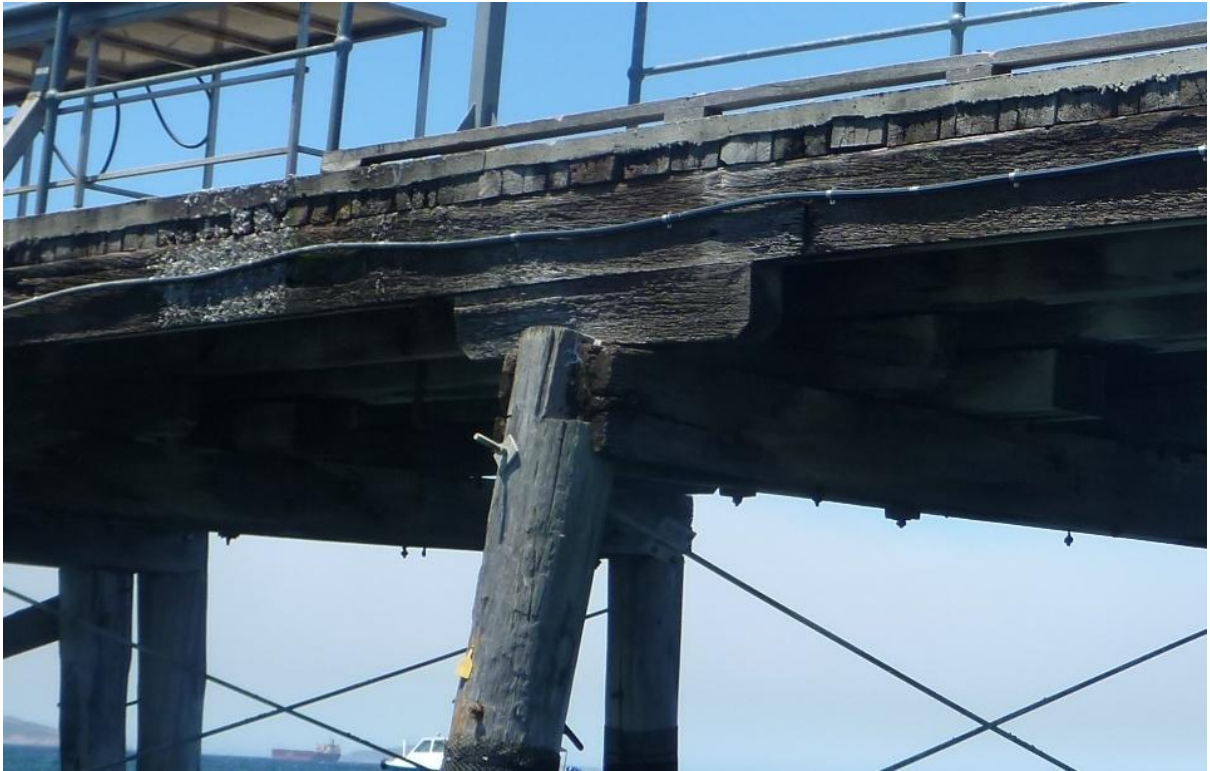
- 44 North

**Figure 3-20: 43 North 17/11/15 – Crushing of both half caps**

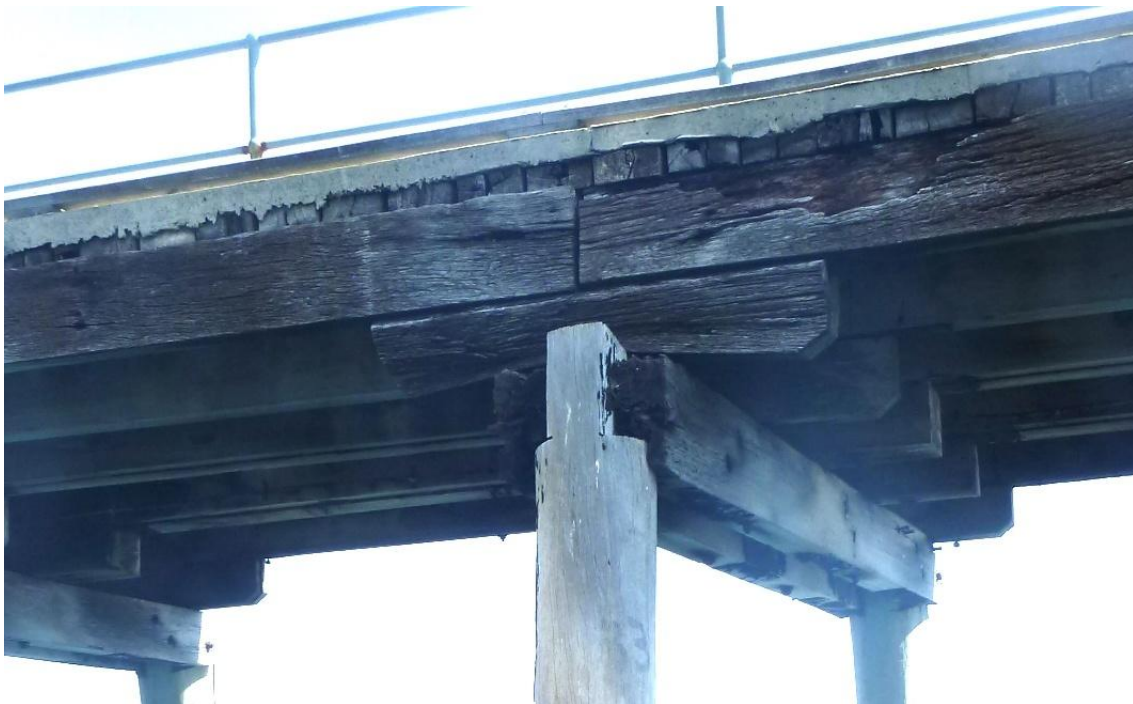
- 133 North

**Figure 3-23: 133 North 17/11/15 – Crushing of both half caps**
