ESPERANCE TANKER JETTY CONDITION

Jetty Condition Assessment Update

Reference: R-224.07-1

Date: September 2013

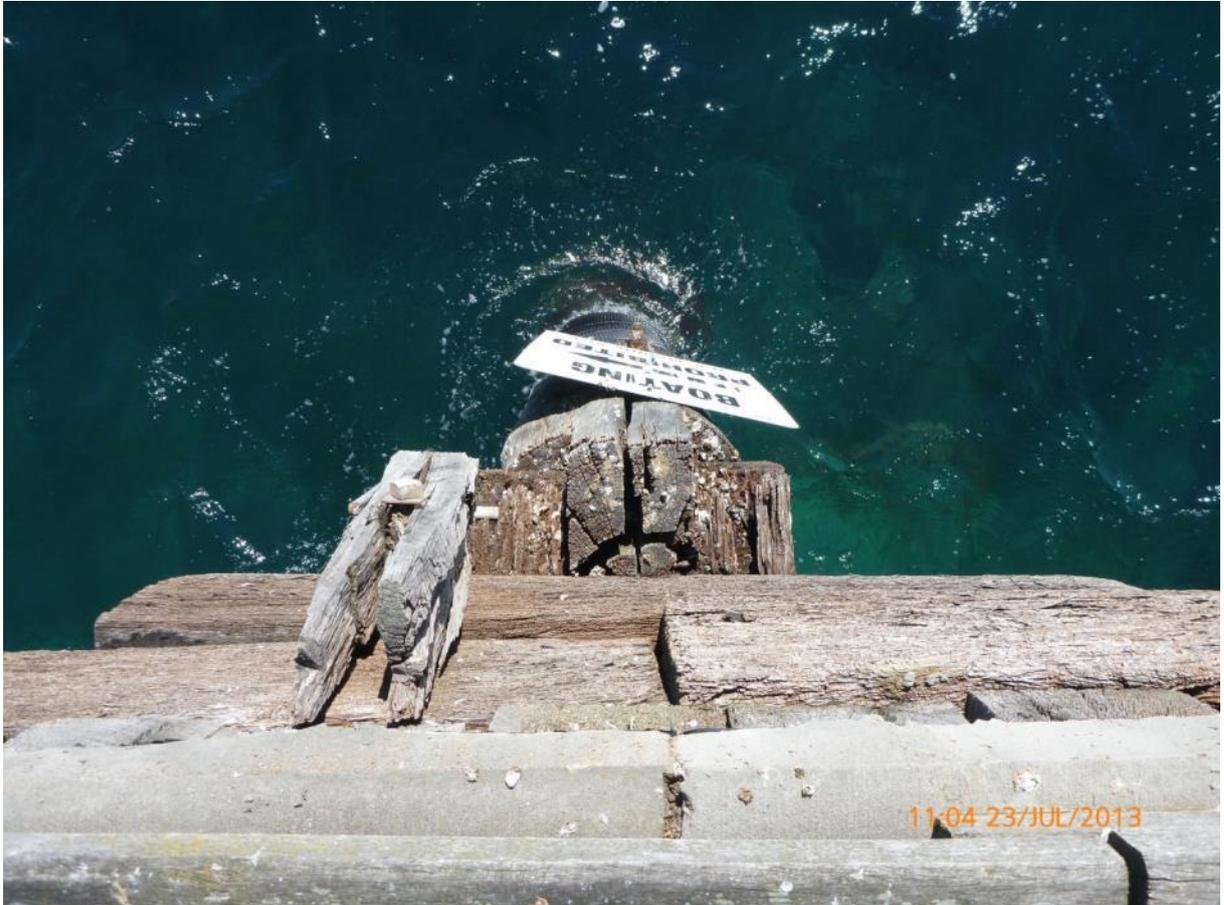
Figure 3-1: Pile 37 North

The top of the pile is split longitudinally. The remedial should be in order of preference where possible;

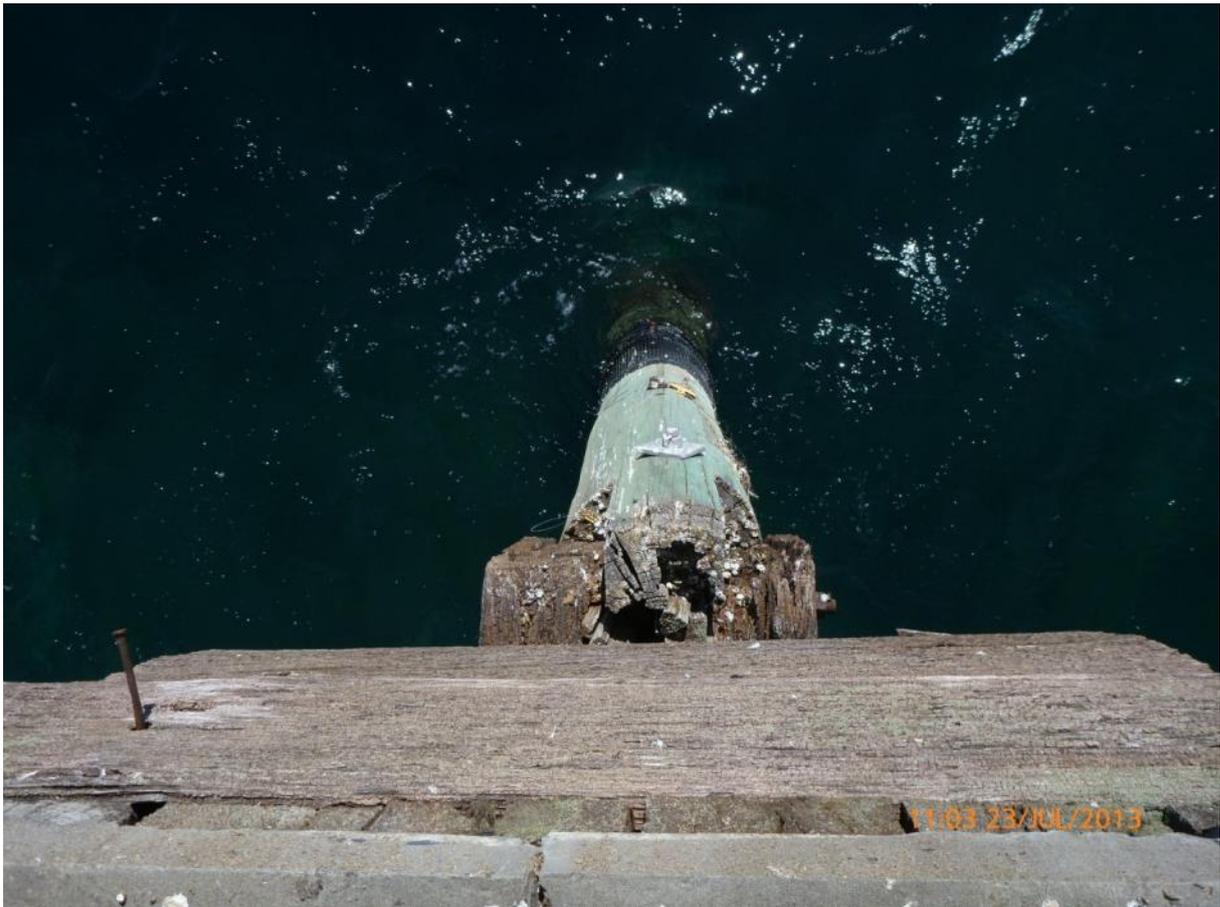
Figure 3-3: Pile 40 North

The top of the pile has lost section at the bolted interface with the half caps. The remedial should be in order of preference where possible;

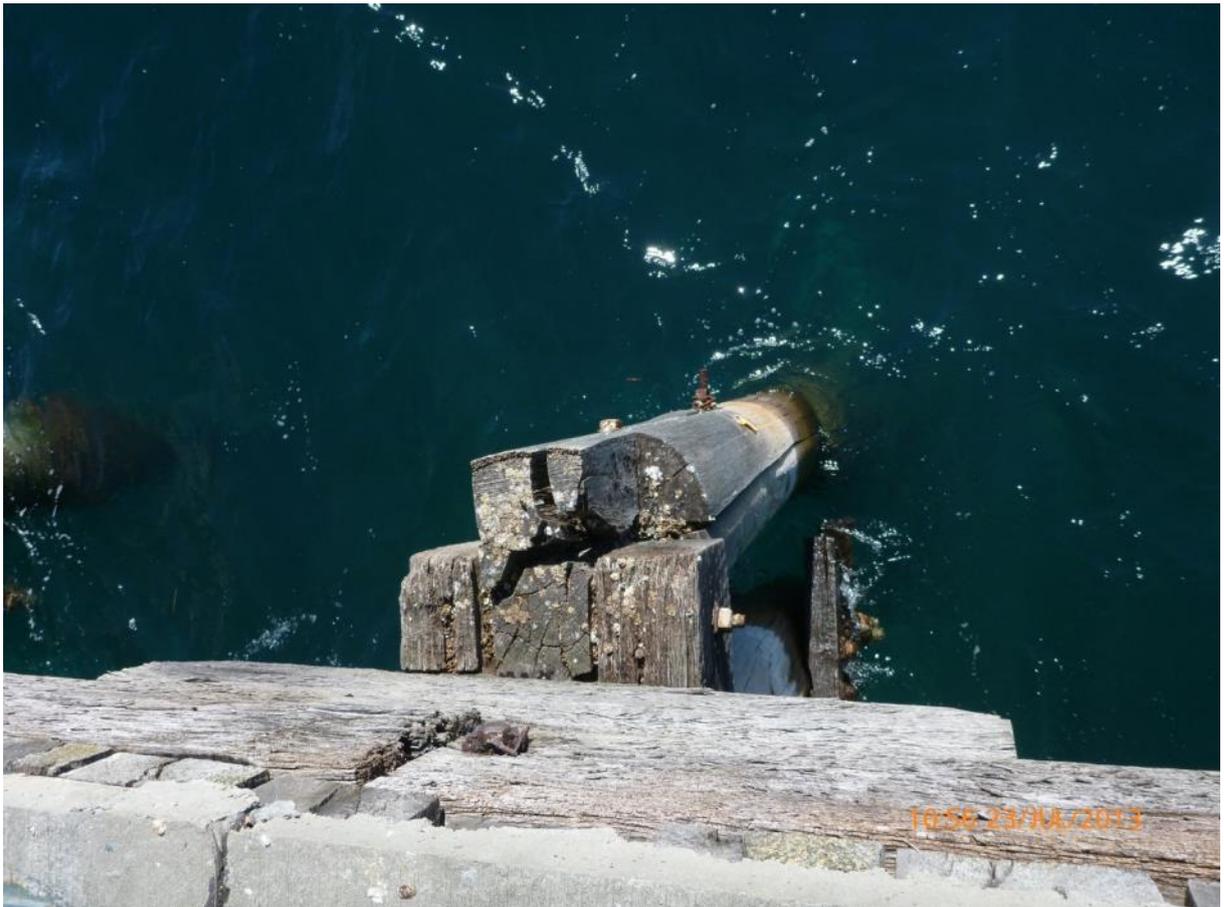
Figure 3-4: Pile 87 North

The top of the pile has split. The remedial should be in order of preference where possible;

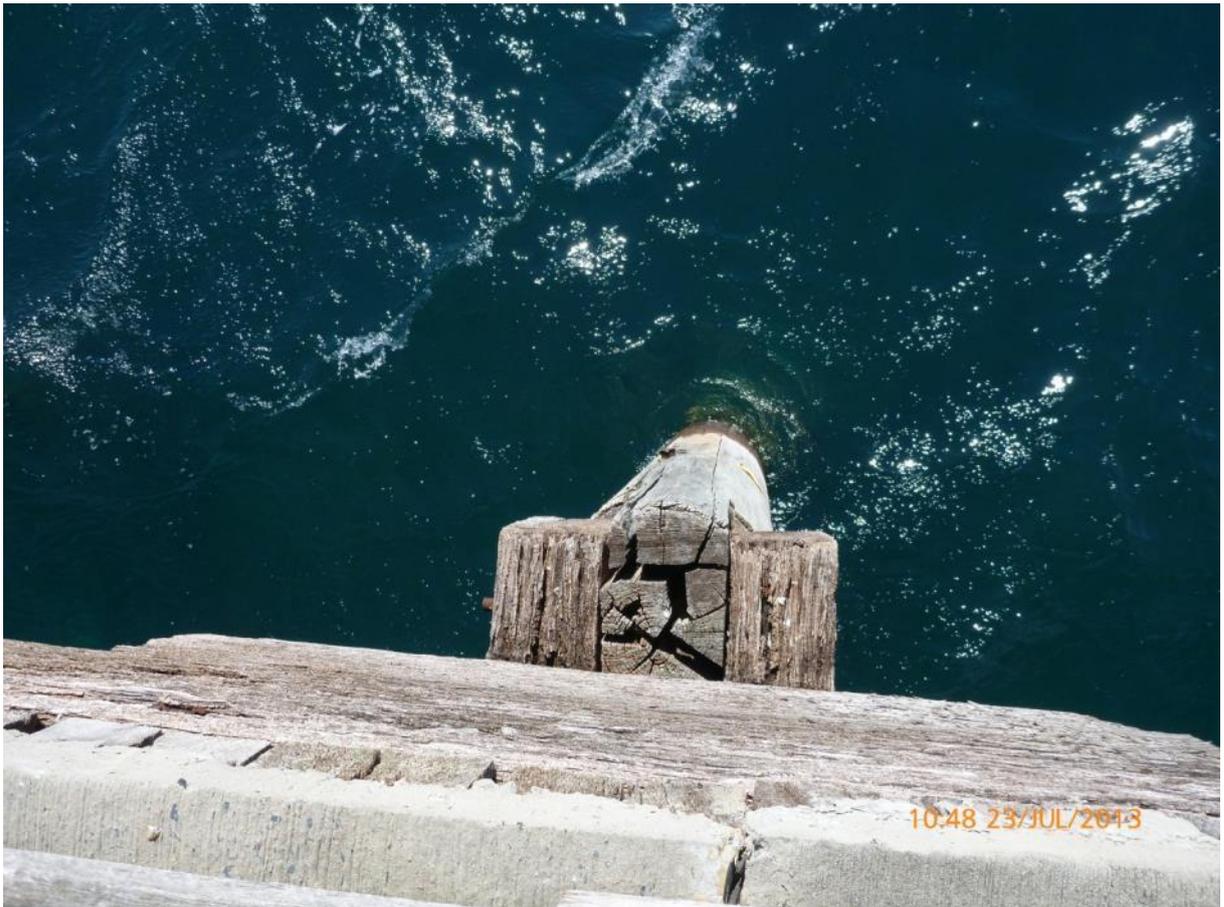
Figure 3-5: Pile 100 North

The top of the pile has split at the bolted interface with the half caps. The remedial should be in order of preference where possible;

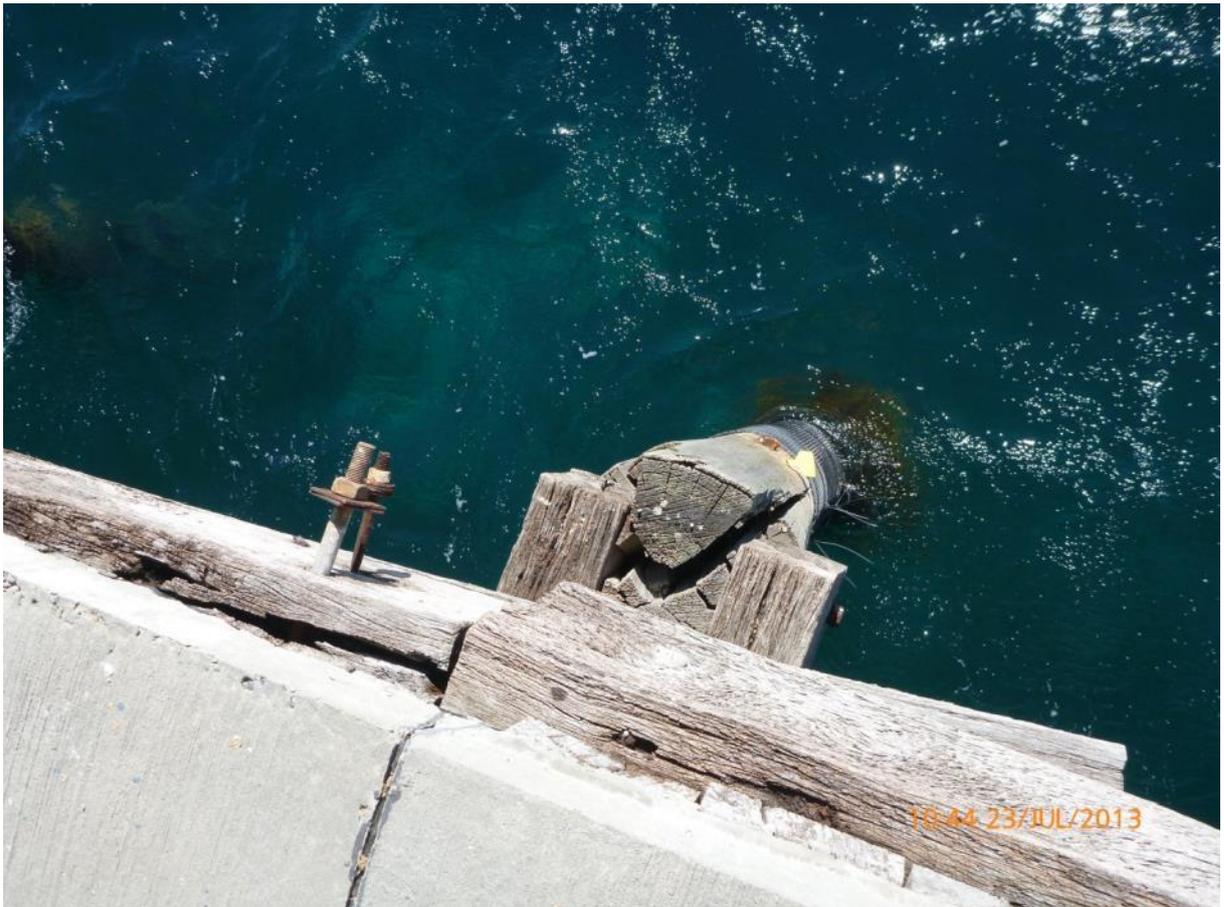
Figure 3-6: Pile 111 North

The top of the pile has split. The remedial should be in order of preference where possible;

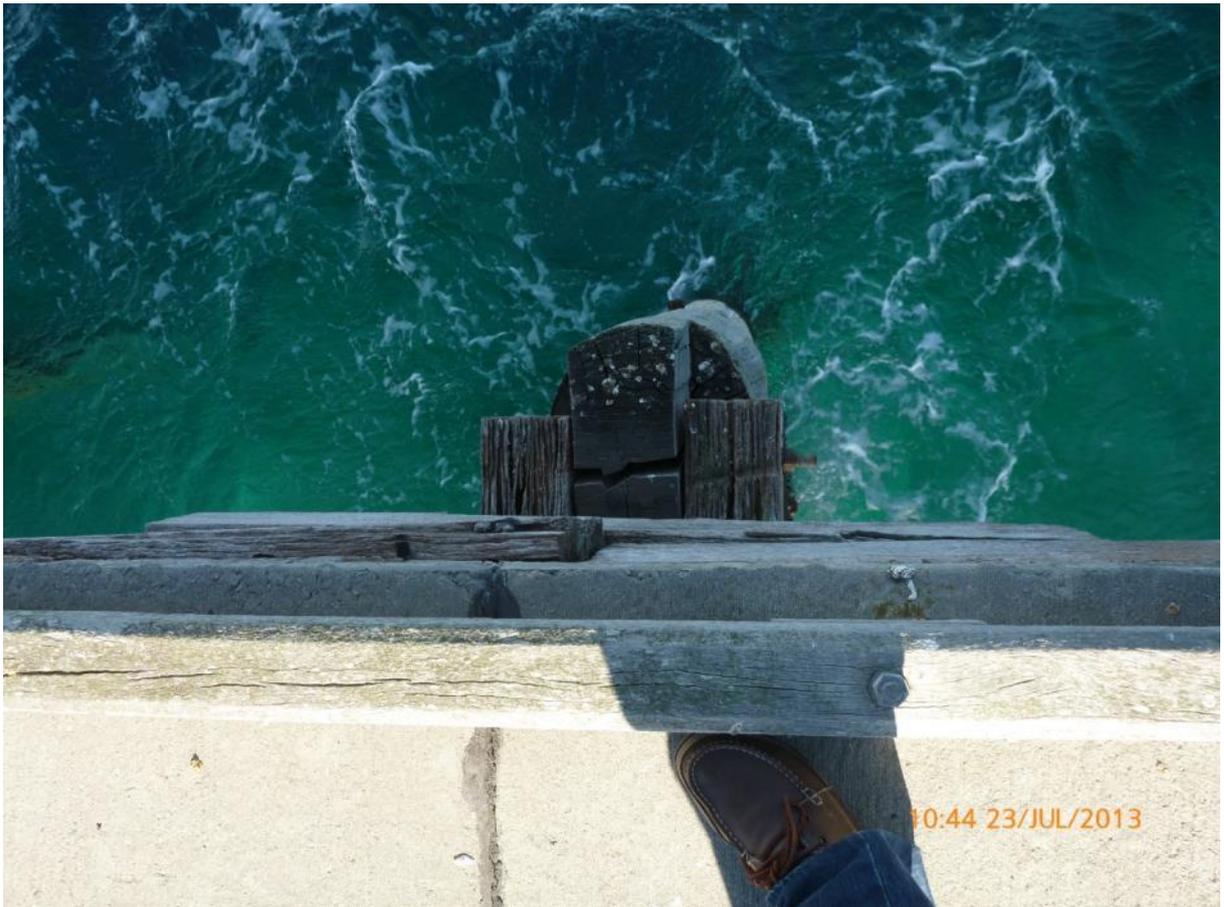
Figure 3-7: Pile 113 South

The top of the pile has split. The remedial should be in order of preference where possible;

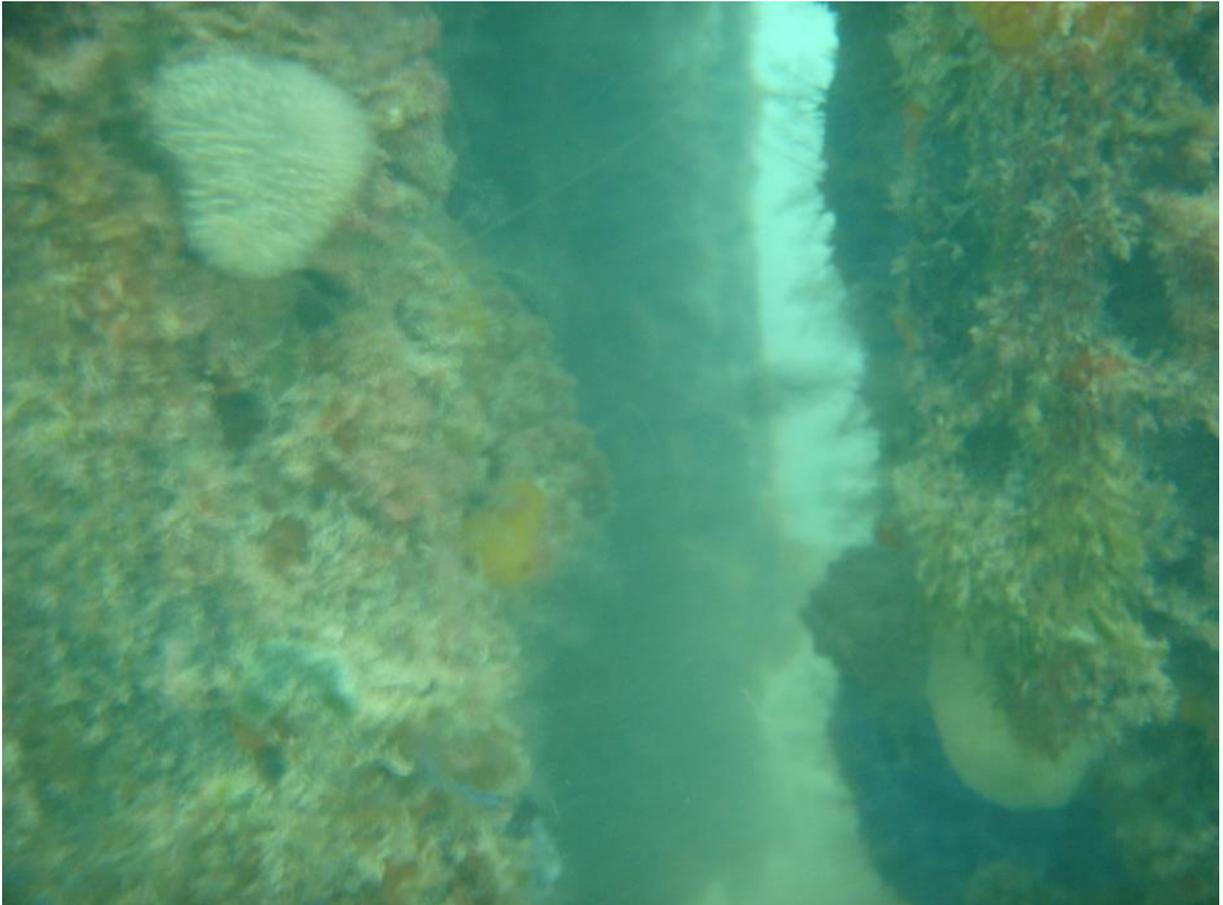
Figure 3-8: Pile 39 South

Pile 39 South has a hole through the centre of the pile (This was first encountered on the previous dive inspection – BG&E report 2010). The size of hole appears similar in size. Diver's reported that pieces of rotten timber could be broken away with fingers on one side, other side firm.

The repair at this pile is to wrap the affected length of pile in a zipped jacket. The jacket and internal voids are to be filled with grout. The location of deterioration is close to the seabed, therefore, some excavation using an air lift may be required.

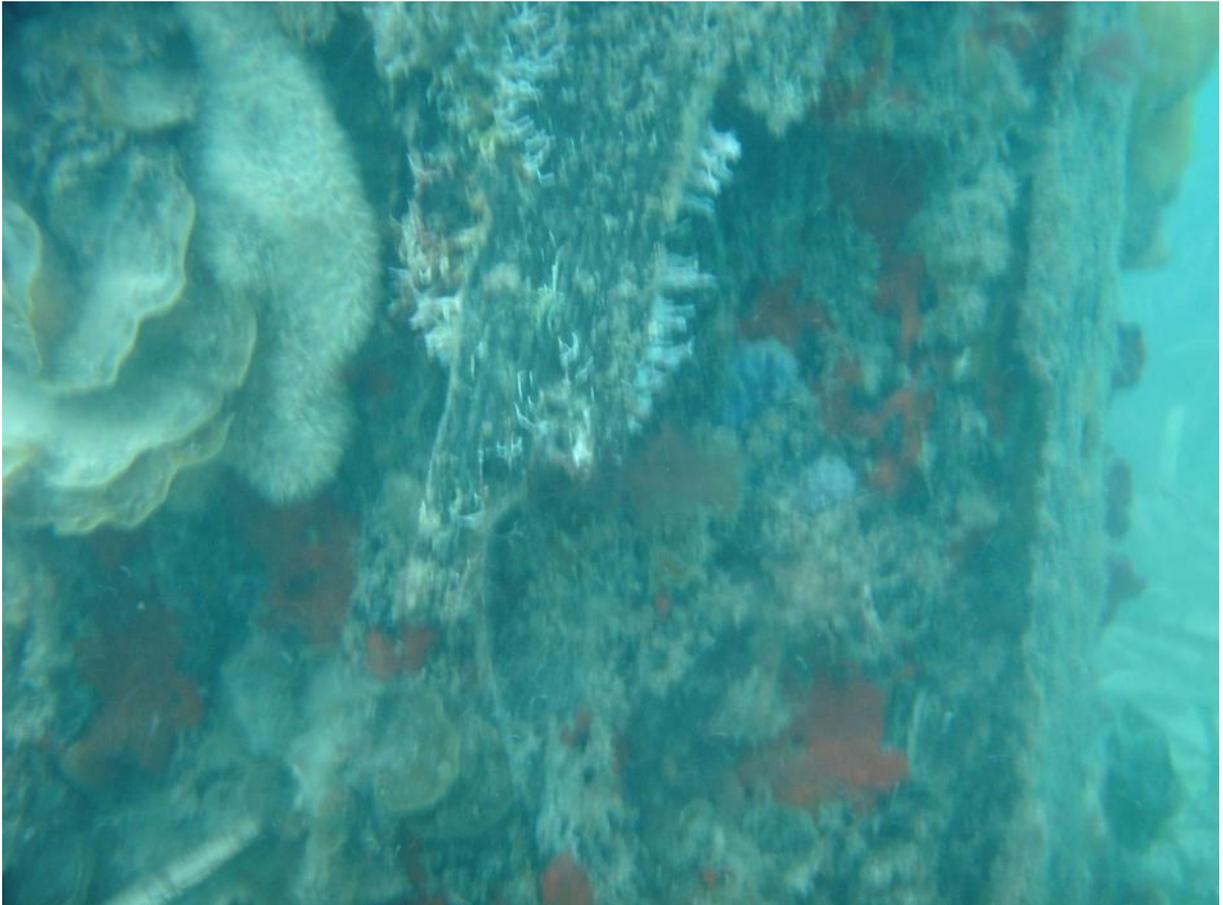
Figure 3-9: Pile 49 North

Pile 49 North has suffered some visible section loss. There is likely to be further section loss due to Teredo worm that is not visible.

The repair at this pile is to wrap the affected length of pile in a zipped jacket. The jacket and internal voids are to be filled with grout.

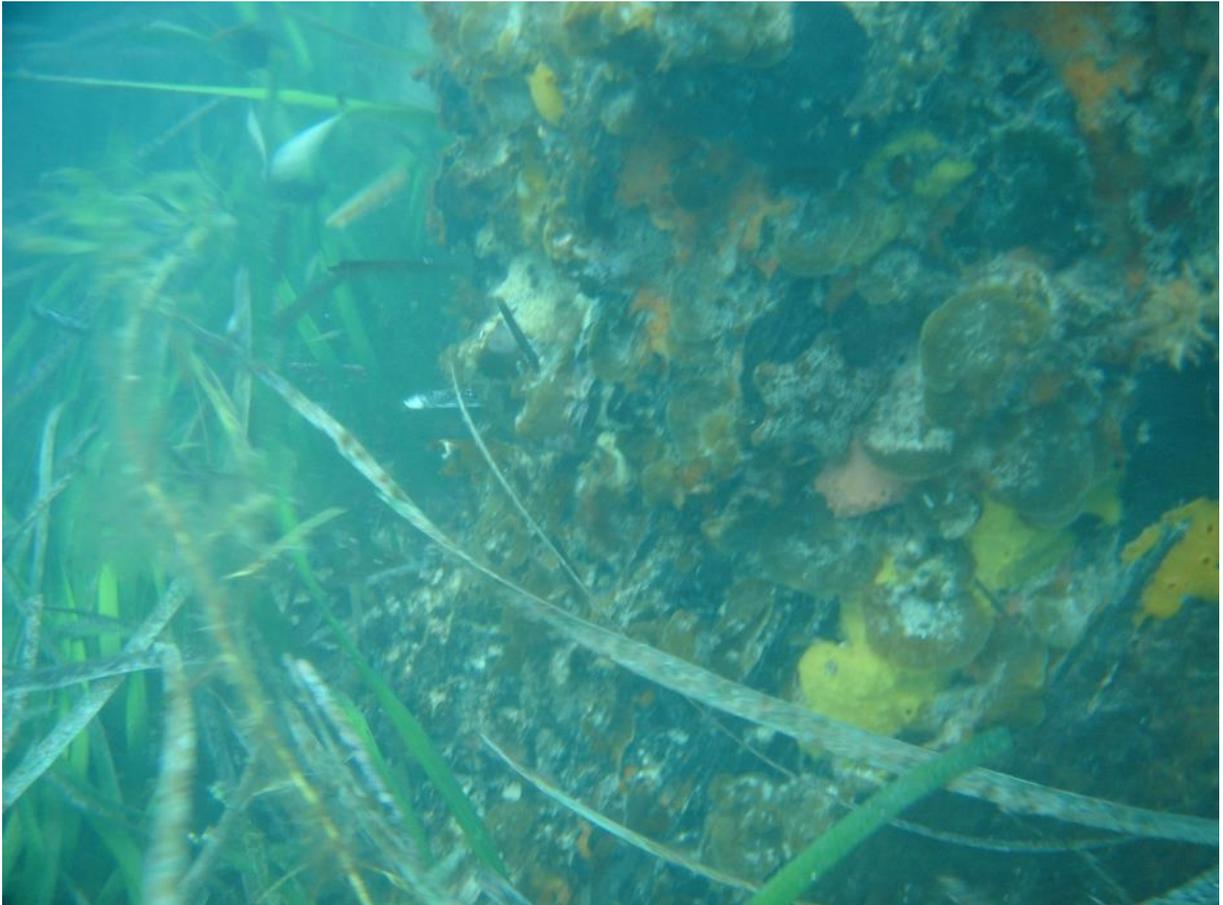
Figure 3-10: Pile 49 South

Pile 49 South has suffered some visible section loss. There is likely to be further section loss due to Teredo worm that is not visible.

The repair at this pile is to wrap the affected length of pile in a zipped jacket. The jacket and internal voids are to be filled with grout.

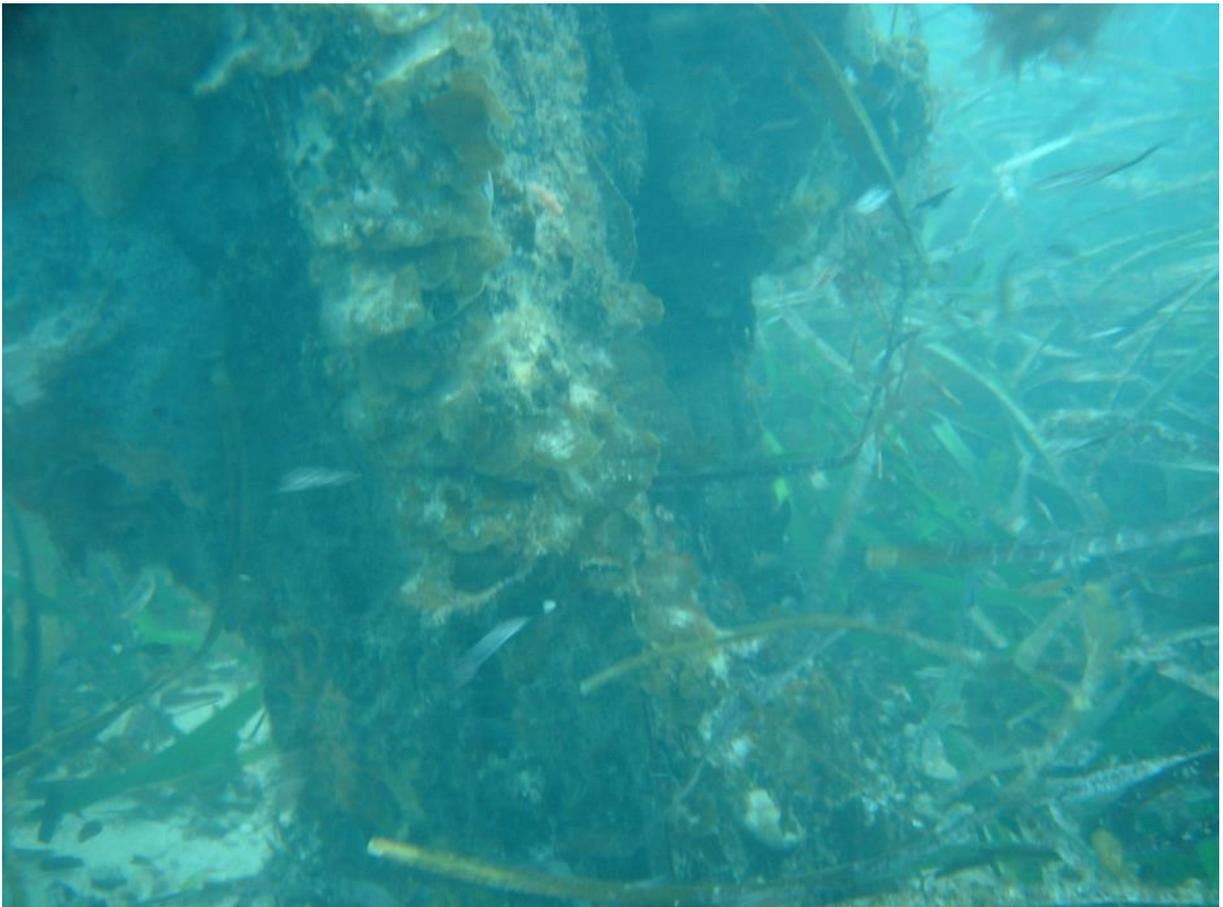
Figure 3-11: Pile 61 South

Piles 61 South and 62 South have not suffered such severe damage, but their proximity warrants immediate attention. This is because spanning two missing piles would very difficult to achieve.

Pile 61 South has suffered visible section loss. There is likely to be further section loss due to Teredo worm that is not visible.

The repair at this pile is to wrap the affected length of pile in a zipped jacket. The jacket and internal voids are to be filled with grout. The location of deterioration is close to the seabed, therefore, some excavation using an air lift may be required.

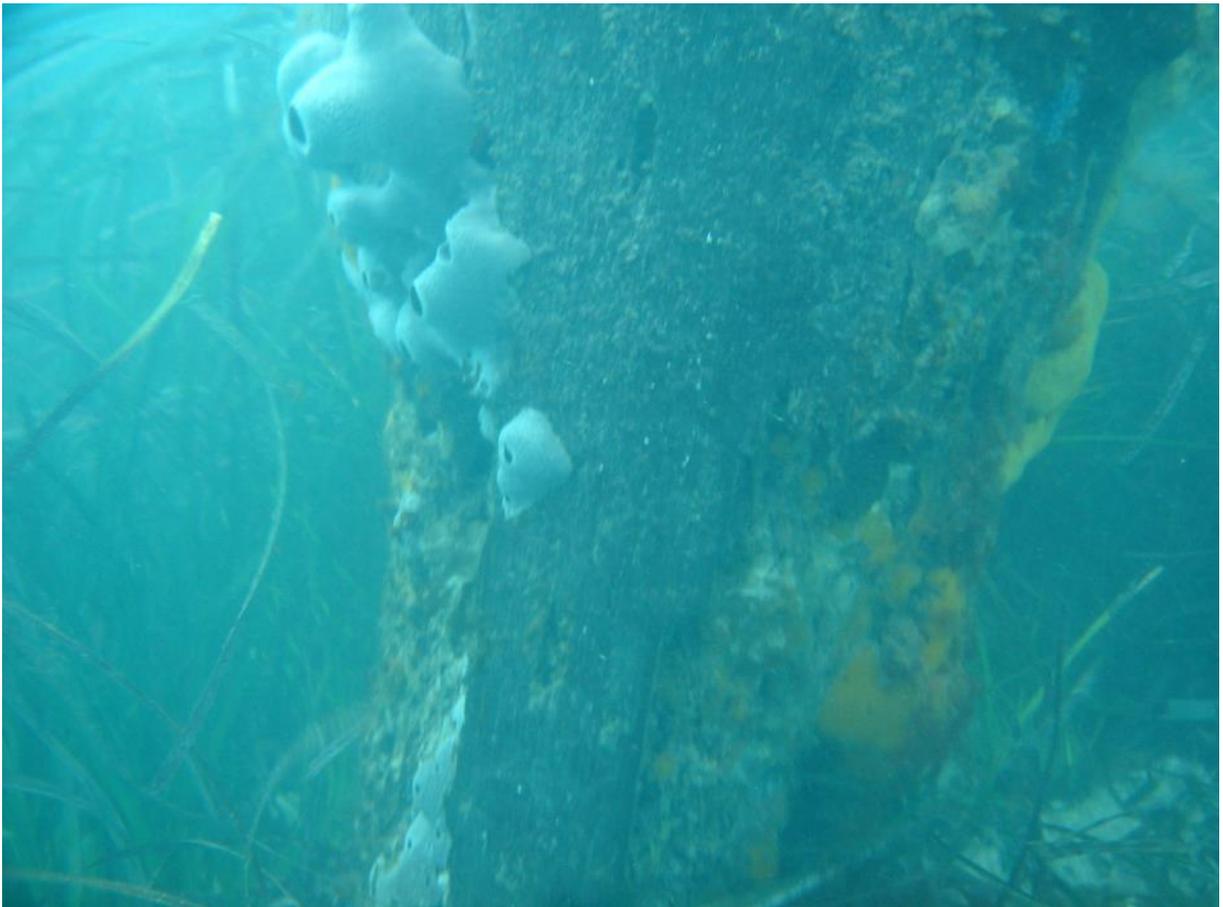
Figure 3-12: Pile 62 South

Pile 62 South has suffered significant visible section loss. There is likely to be further section loss due to Teredo worm that is not visible. A screwdriver was pushed into rotten section approximately 50mm.

The repair at this pile is to wrap the affected length of pile in a zipped jacket. The jacket and internal voids are to be filled with grout.

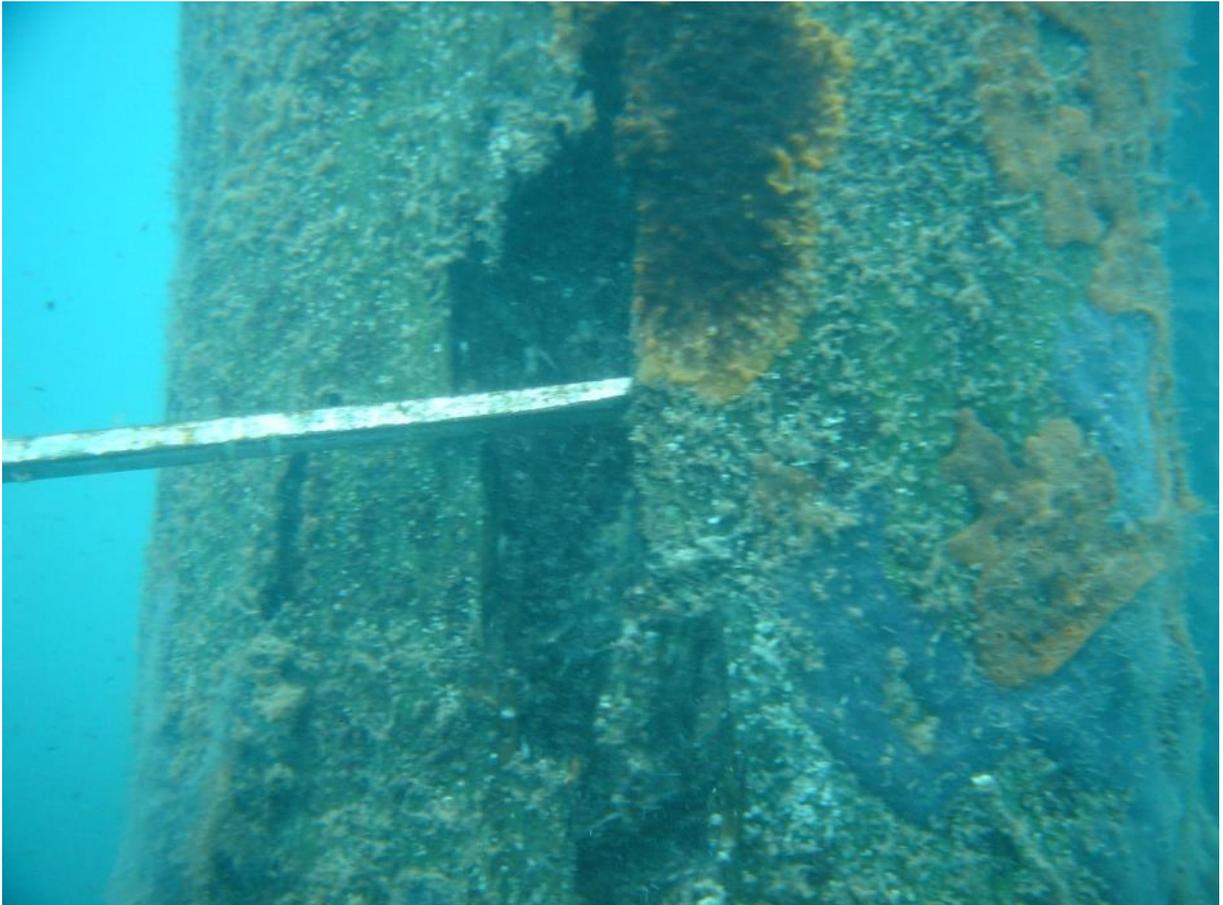
Figure 3-13: Pile 75 North

Pile 75 North has minor section loss locally a screw driver can be driven in 25mm. This pile will require remediation within 24 months, if left untreated.

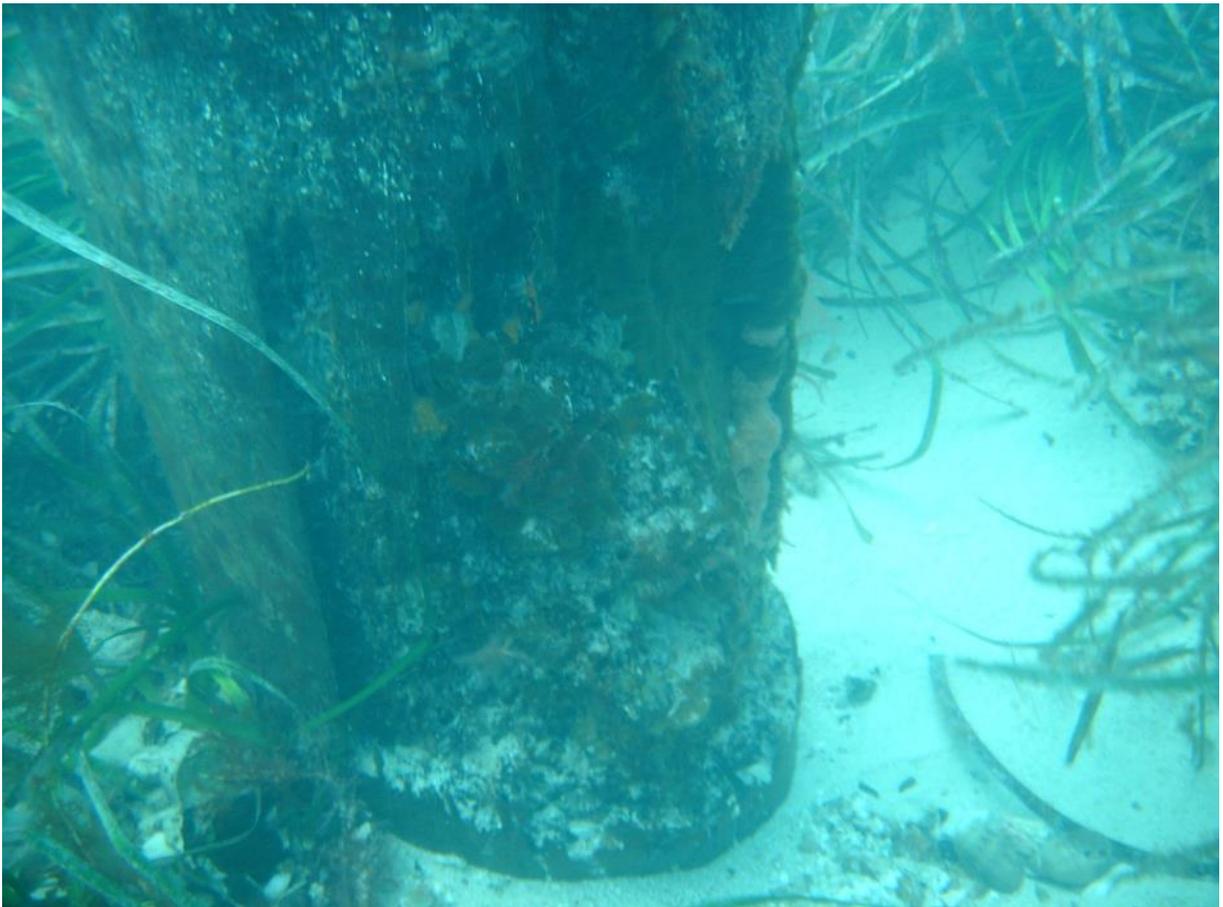
Figure 3-14: Pile 91 North

Pile 91 North has suffered significant visible section loss. There is likely to be further section loss due to Teredo worm that is not visible. Pieces of rotten timber were able to be broken off.

The repair at this pile is to wrap the affected length of pile in a zipped jacket. The jacket and internal voids are to be filled with grout.

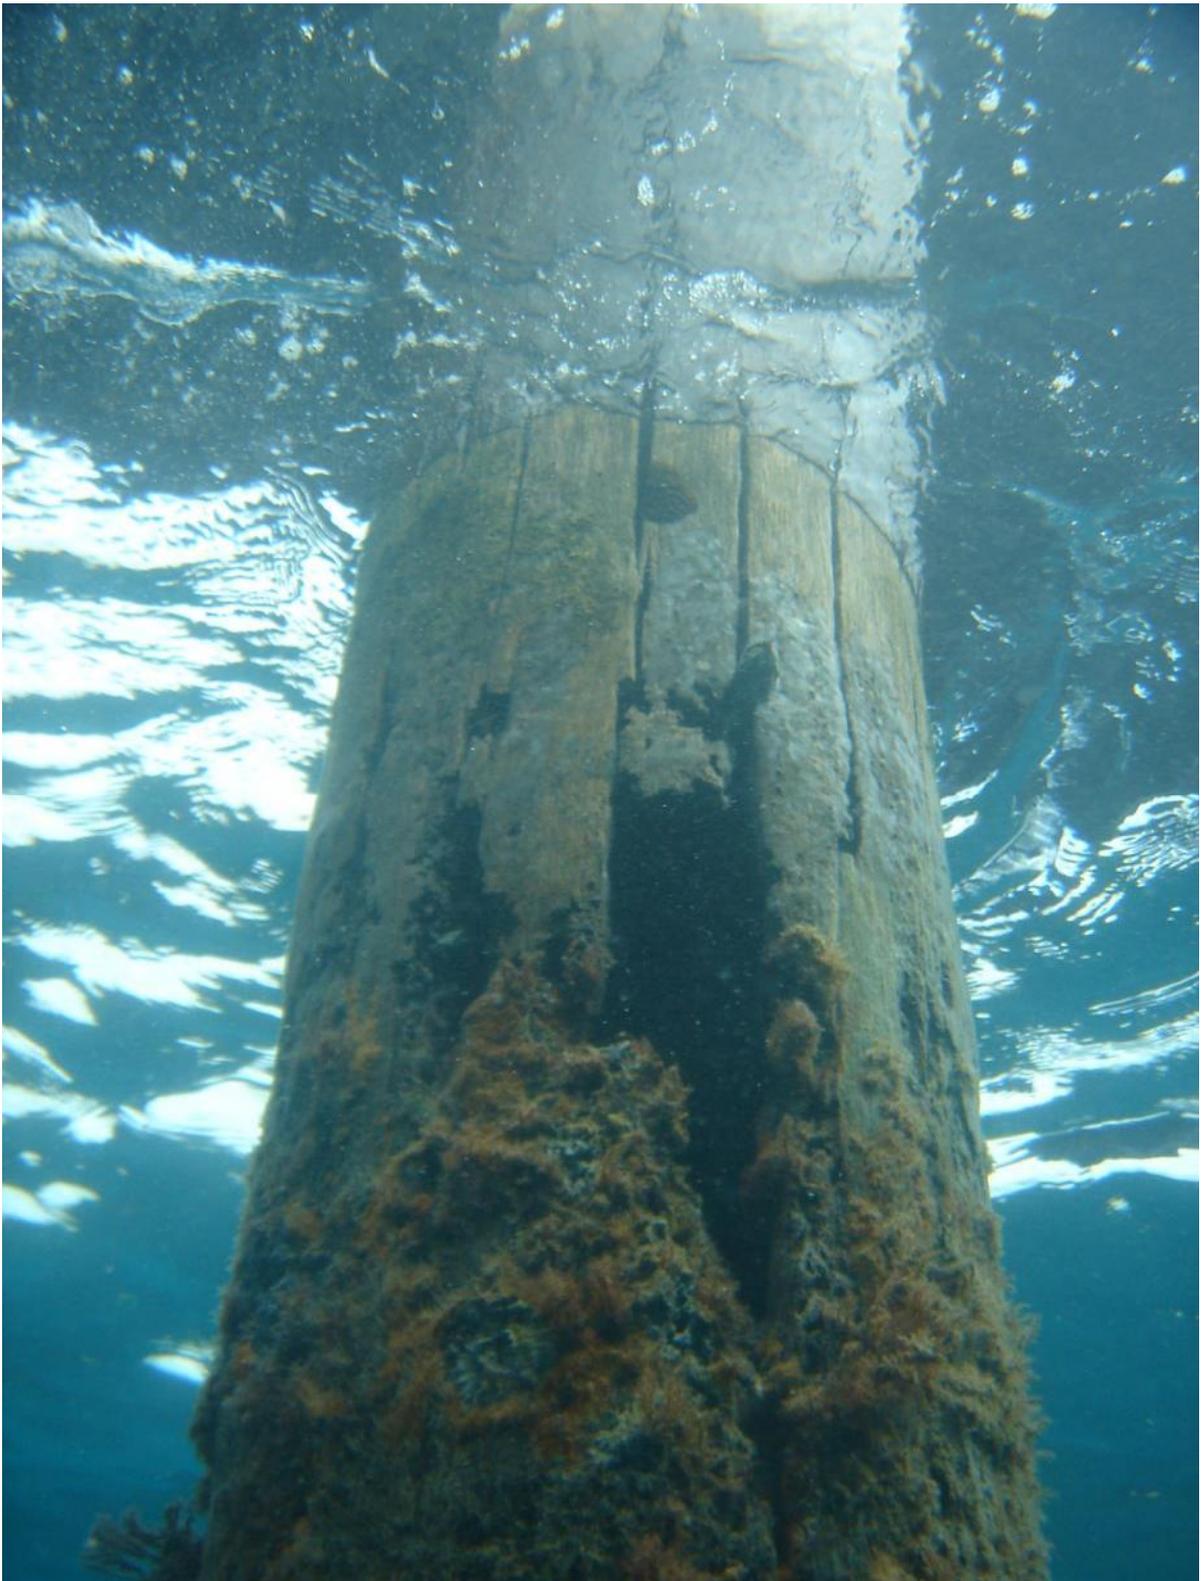
Figure 3-15: Pile 93 North

Pile 93 North was reported as having holes over its submerged length to bed level. There is likely to be significant section loss.

The repair at this pile is to wrap the affected length of pile in a zipped jacket. The jacket and internal voids are to be filled with grout.

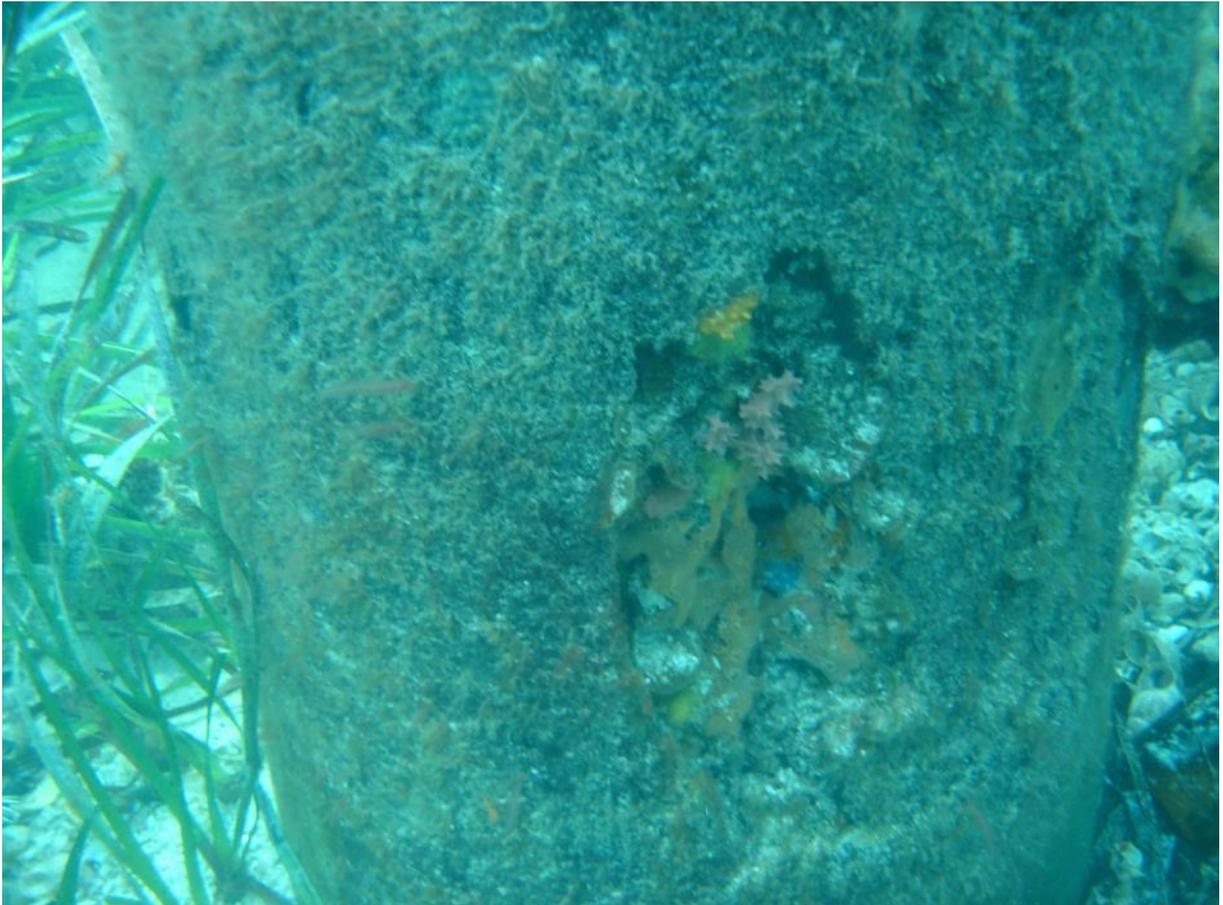
Figure 3-16: Pile 96 North

Pile 96 North has minor section loss. This pile will require remediation within 24 months, if left untreated.

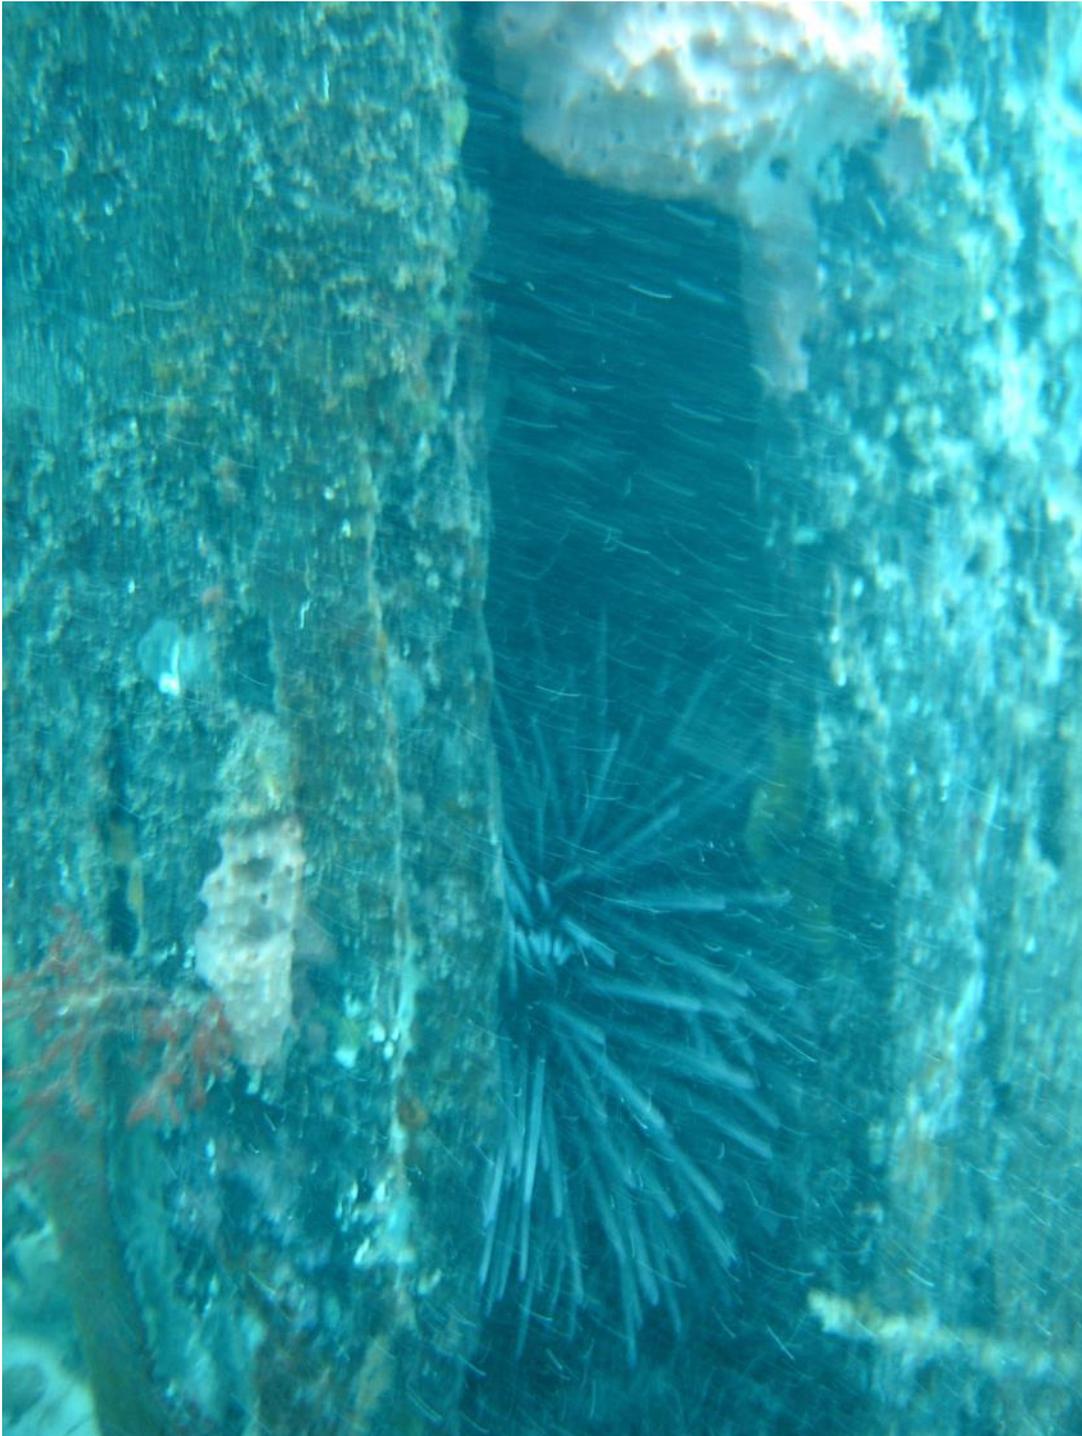
Figure 3-17: Pile 101 North

Pile 101 North has suffered significant visible section loss. Divers reported a solid centre. The repair at this pile is to wrap the affected length of pile in a zipped jacket. The jacket and internal voids are to be filled with grout.

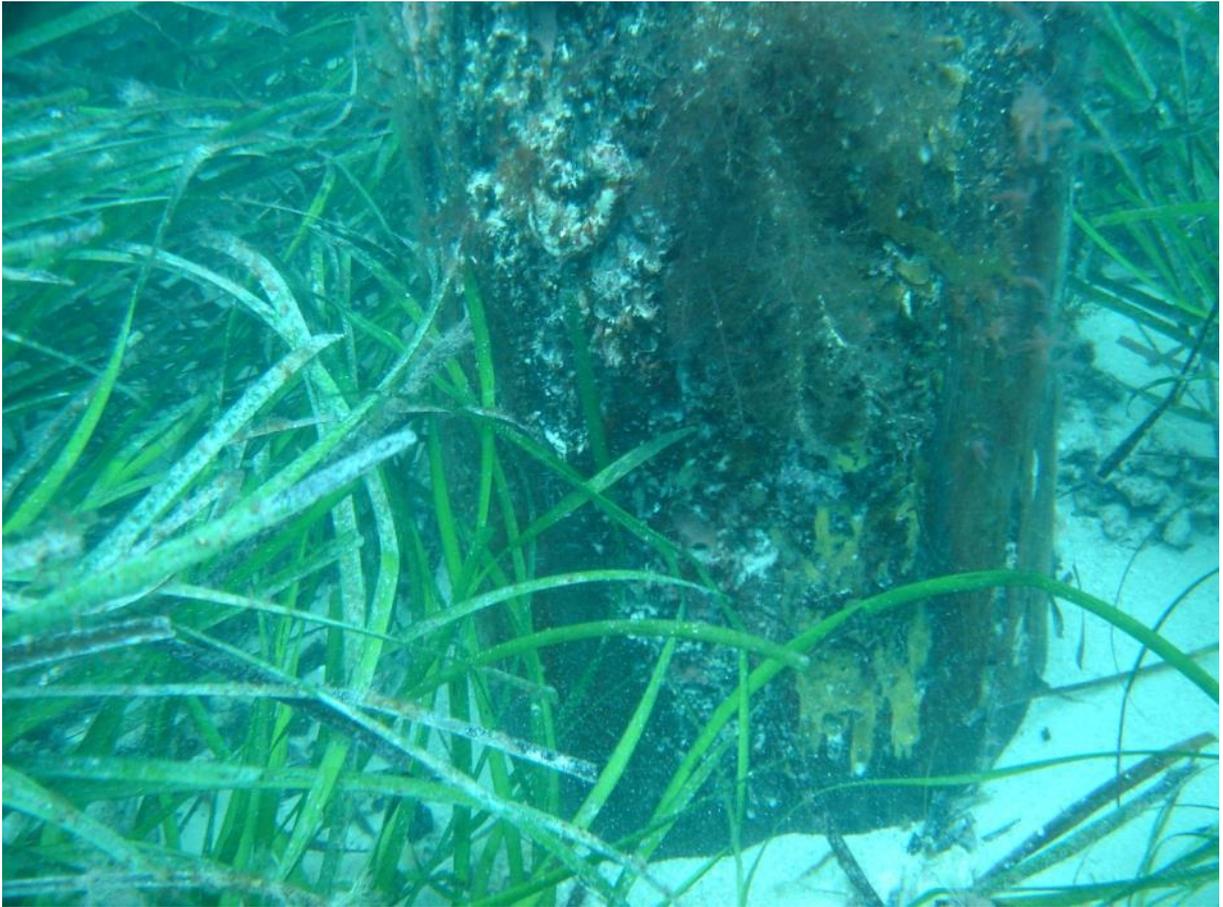
Figure 3-18: Pile 105 South

Pile 105 South has suffered significant visible section loss. Divers reported a solid centre.

The repair at this pile is to wrap the affected length of pile in a zipped jacket. The jacket and internal voids are to be filled with grout. The location of deterioration is close to the seabed, therefore, some excavation using an air lift may be required.
