ESPERANCE TANKER JETTY CONDITION

Jetty Condition Assessment Update

Reference: R-224.07-1

Date: September 2013

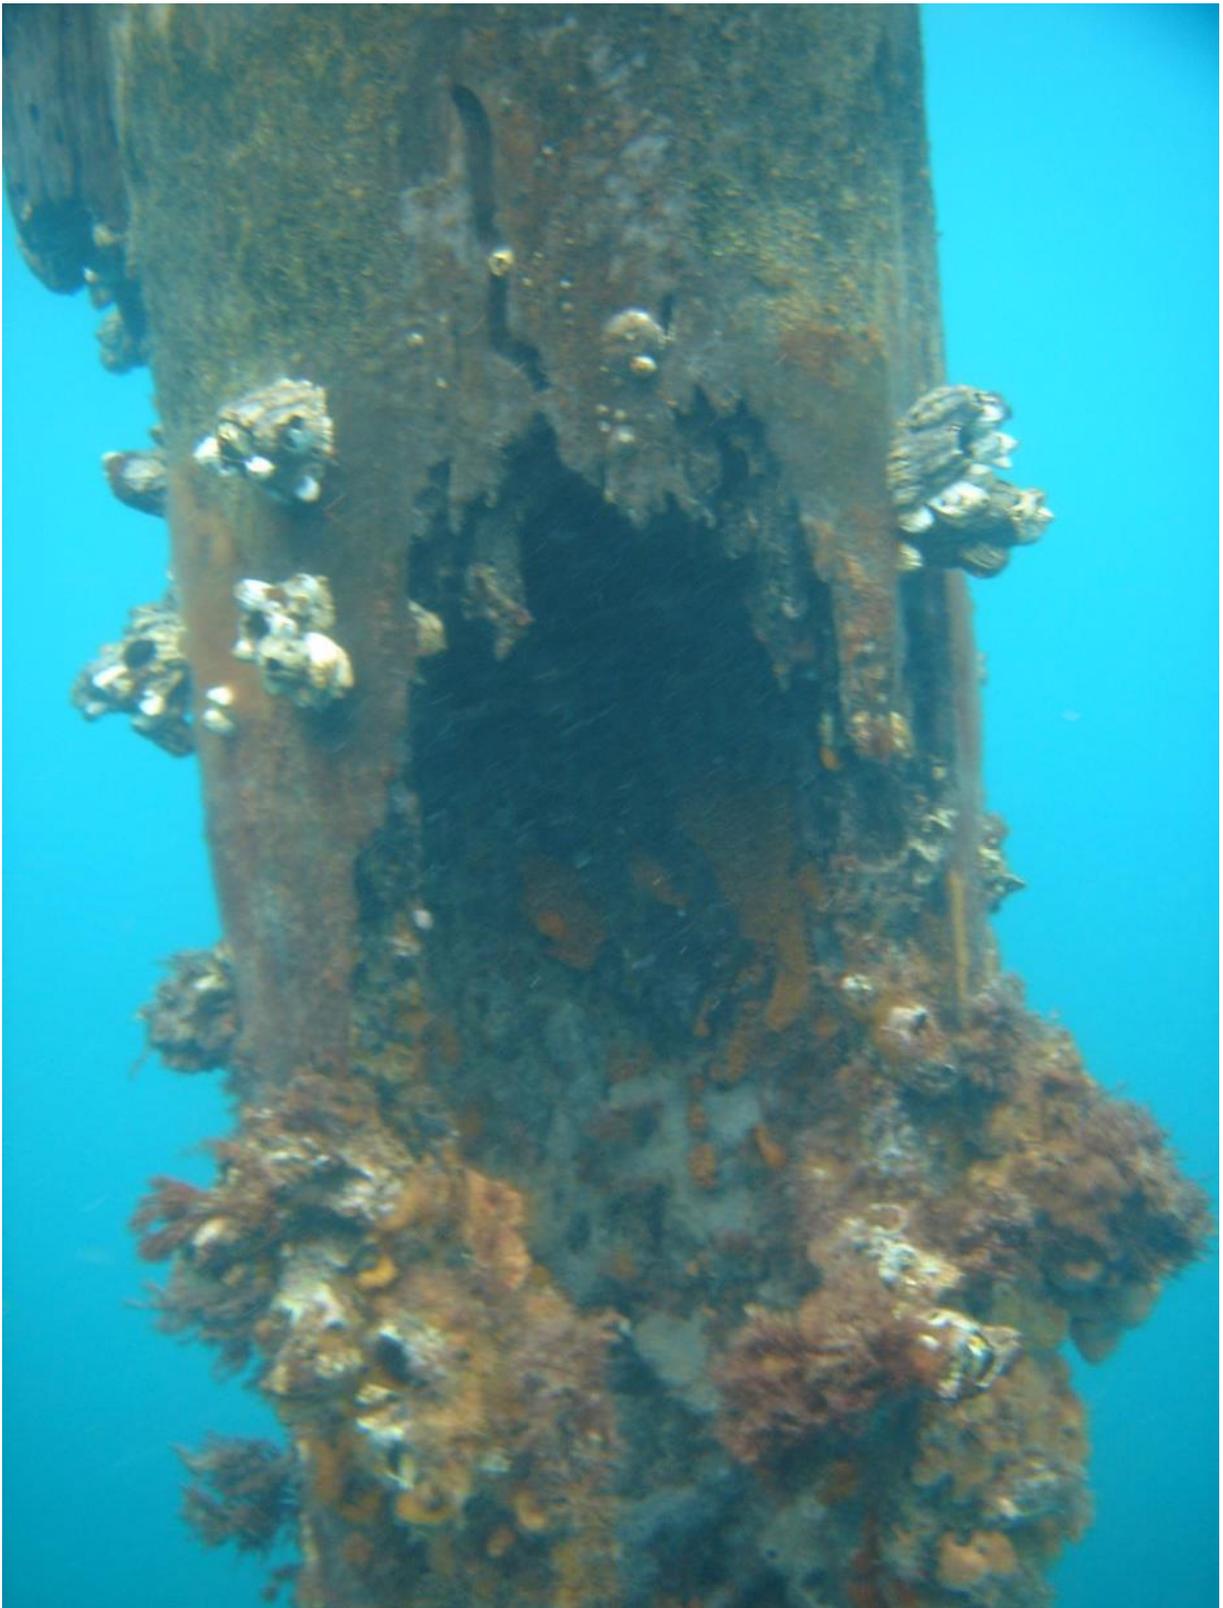
Figure 3-19: Pile 106 South

Pile 106 South has suffered significant visible section loss. There is likely to be further section loss due to Teredo worm that is not visible.

The repair at this pile is to wrap the affected length of pile in a zipped jacket. The jacket and internal voids are to be filled with grout.

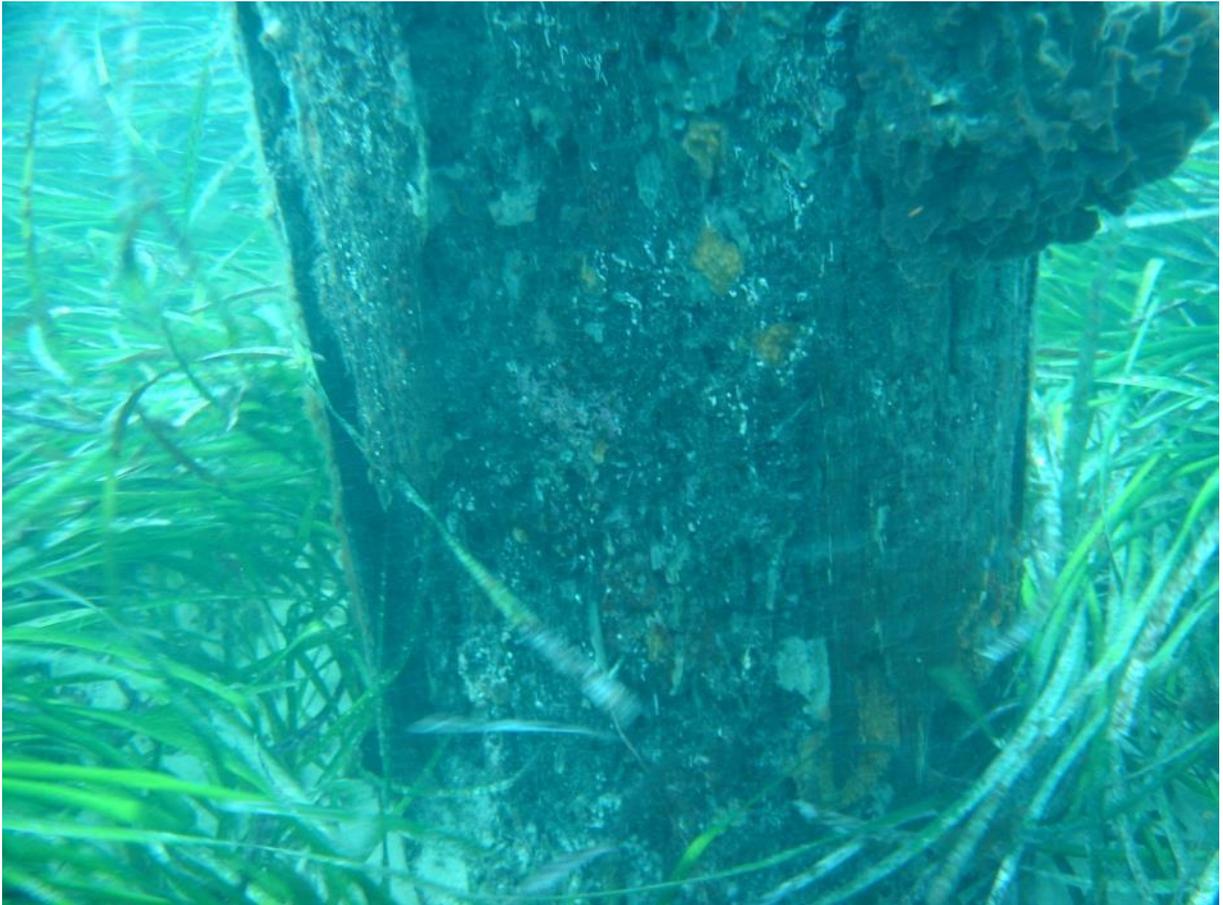
Figure 3-20: Pile 112 North

Pile 112 North has suffered some visible section loss. Divers found the affected area to be rotten and a screwdriver could be pushed approximately 40mm into pile.

The repair at this pile is to wrap the affected length of pile in a zipped jacket. The jacket and internal voids are to be filled with grout. The location of deterioration is close to the seabed, therefore, some excavation using an air lift may be required.

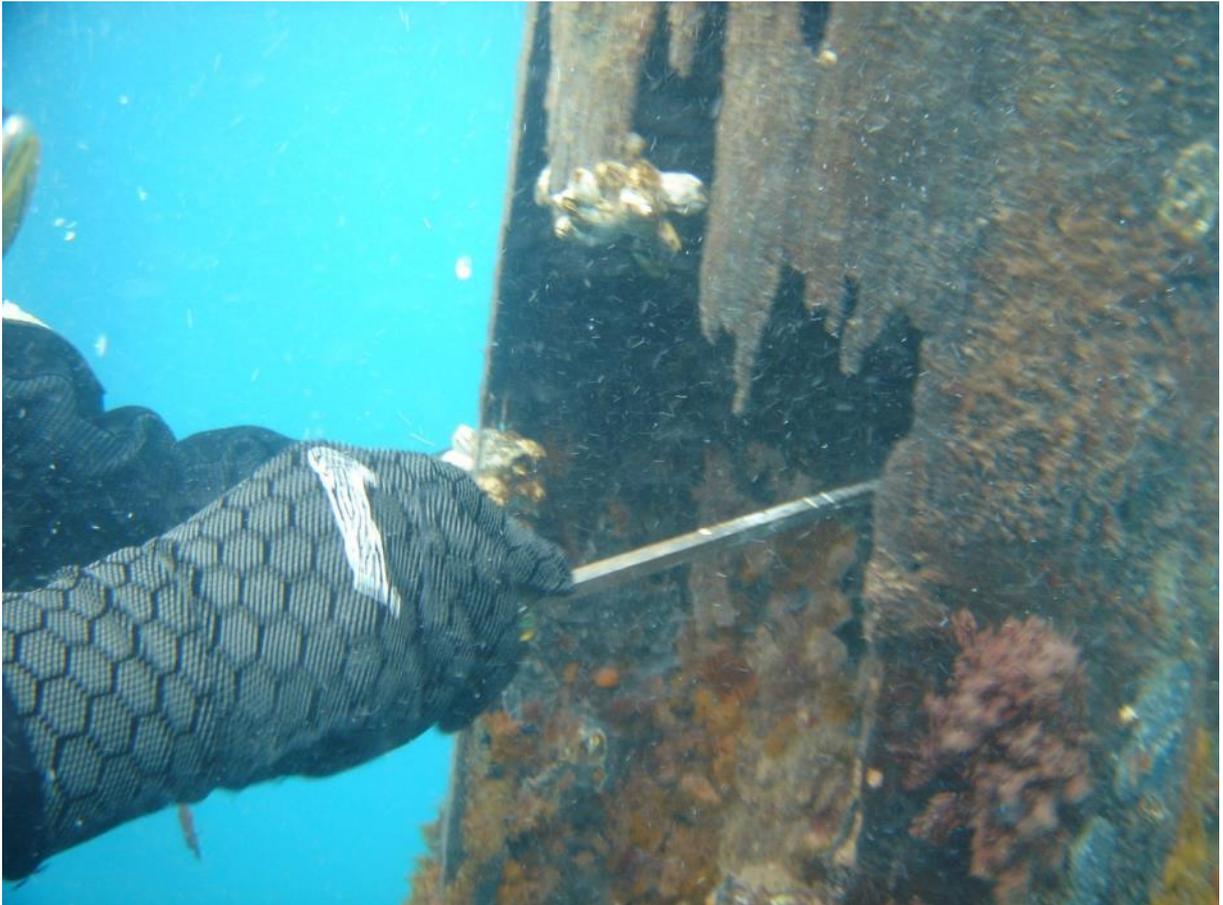
Figure 3-21: Pile 115 South

Pile 115 South has suffered very severe section loss. Divers found the affected area to be rotten and a screwdriver could be pushed into remaining section pile.

The repair at this pile is to wrap the affected length of pile in a zipped jacket. The jacket and internal voids are to be filled with grout.

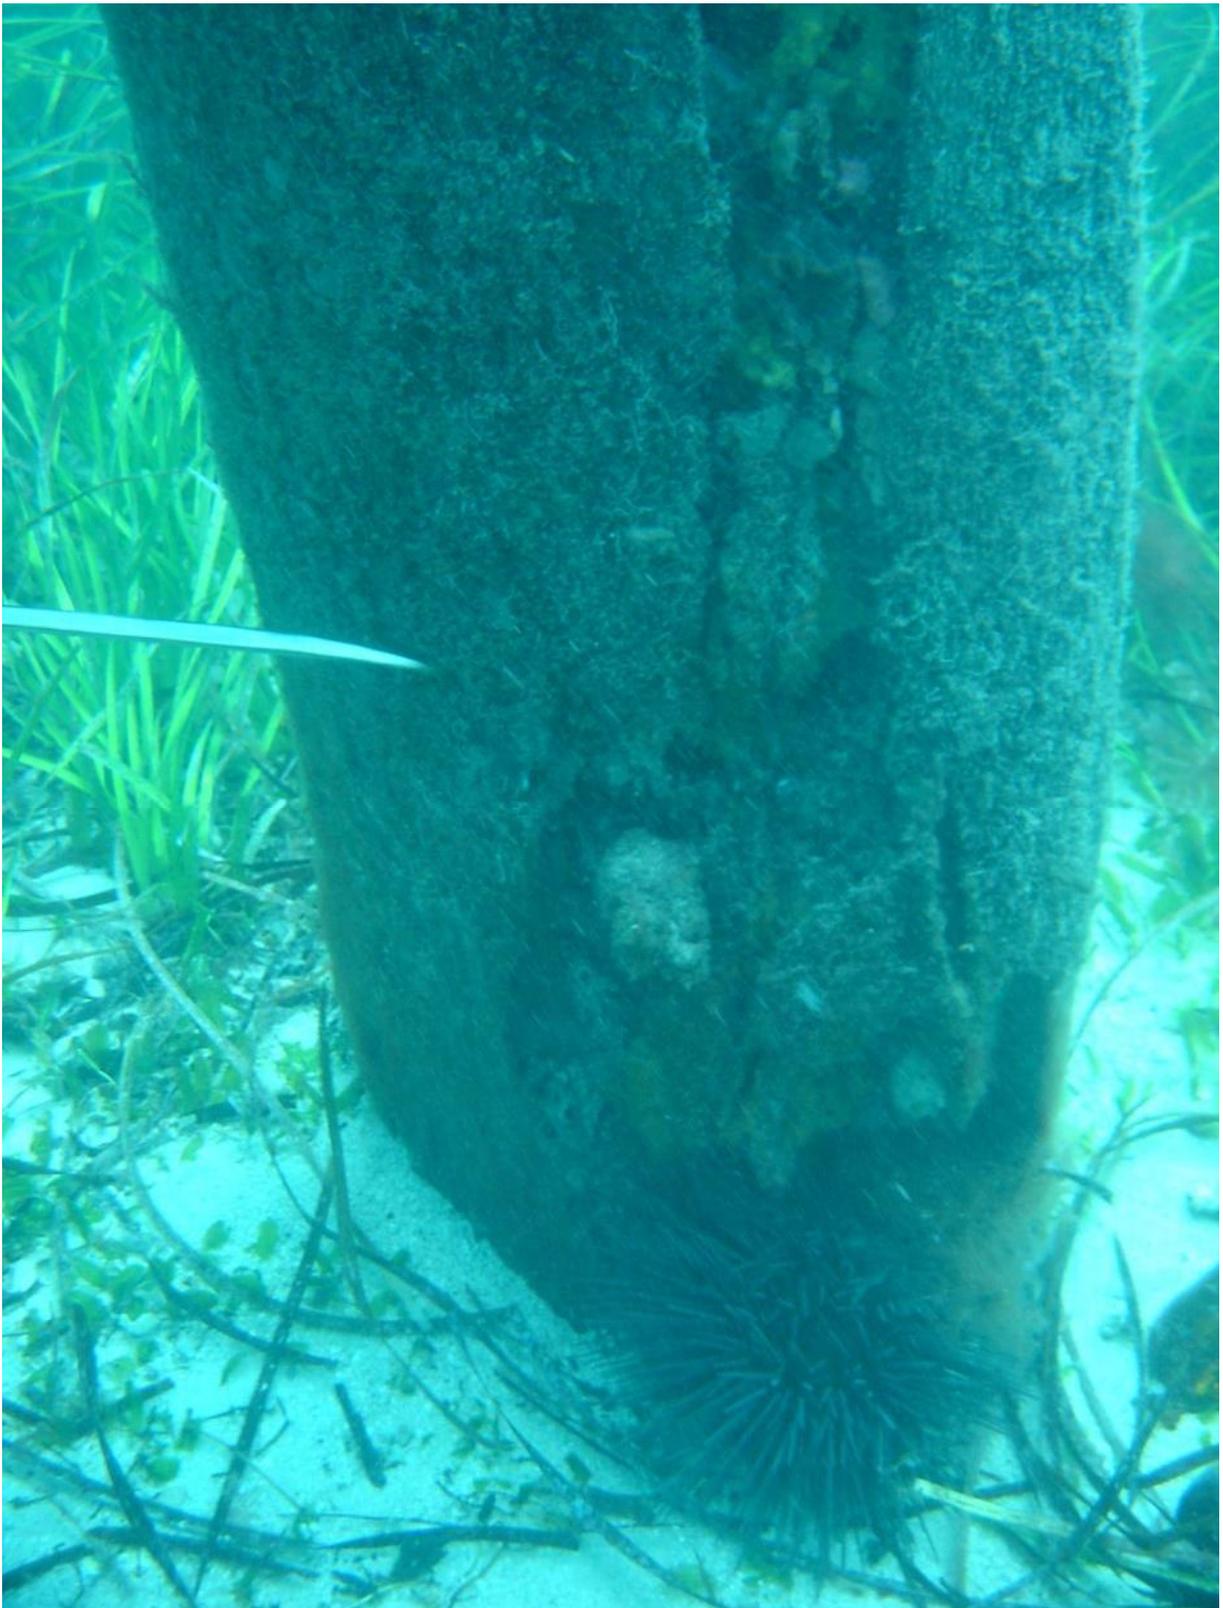
Figure 3-22: Pile 118 North

Pile 118 North has minor section loss. Divers found the affected area to be relatively solid timber with no screwdriver embedment possible.

A repair for this pile isn't necessary immediately but within 24 months it should be wrapped and grouted.

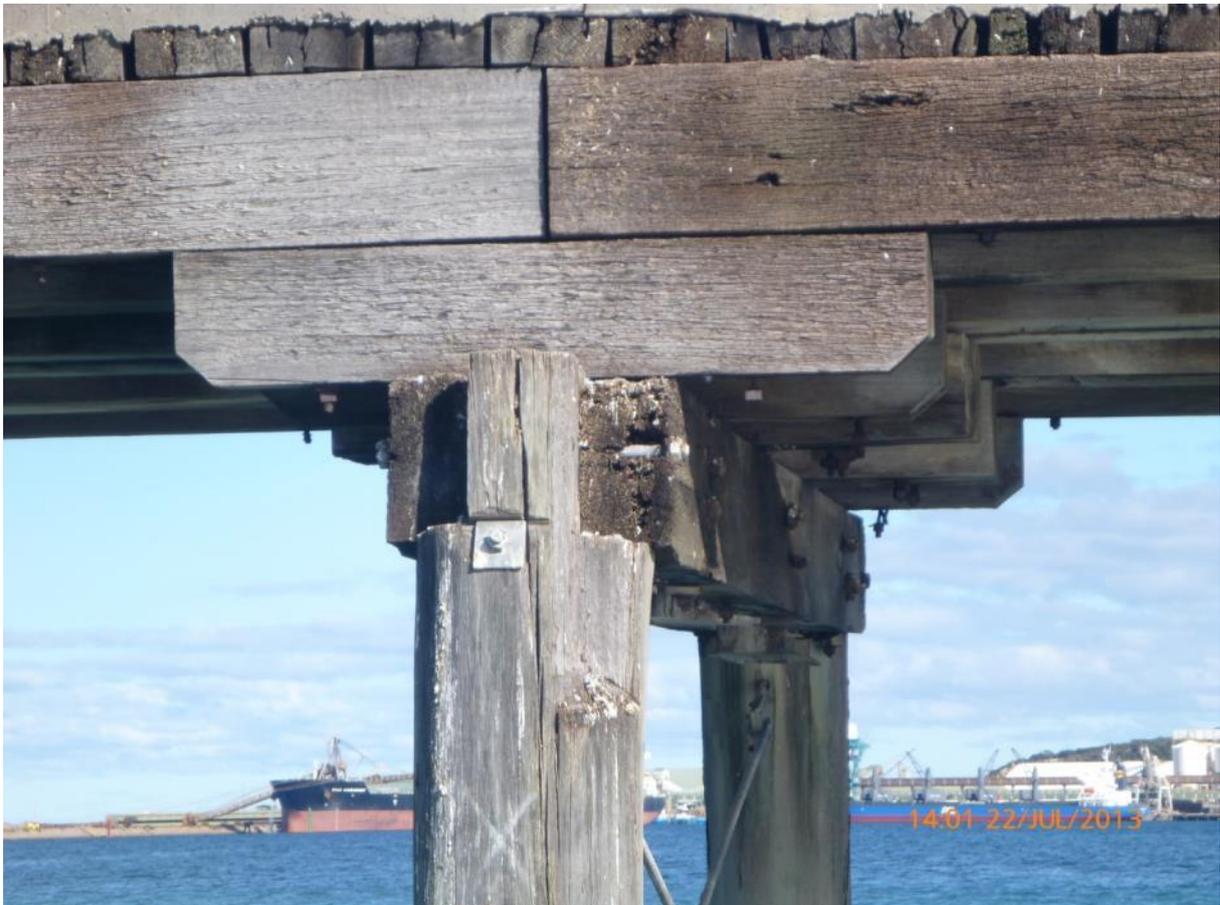
Figure 3-23: Half cap 33 Northwest

The end distance on the half cap to pile bolt connection is insufficient, and with the weathering to the half caps, the connection is no longer effective. The remedial should be in order of preference where possible;

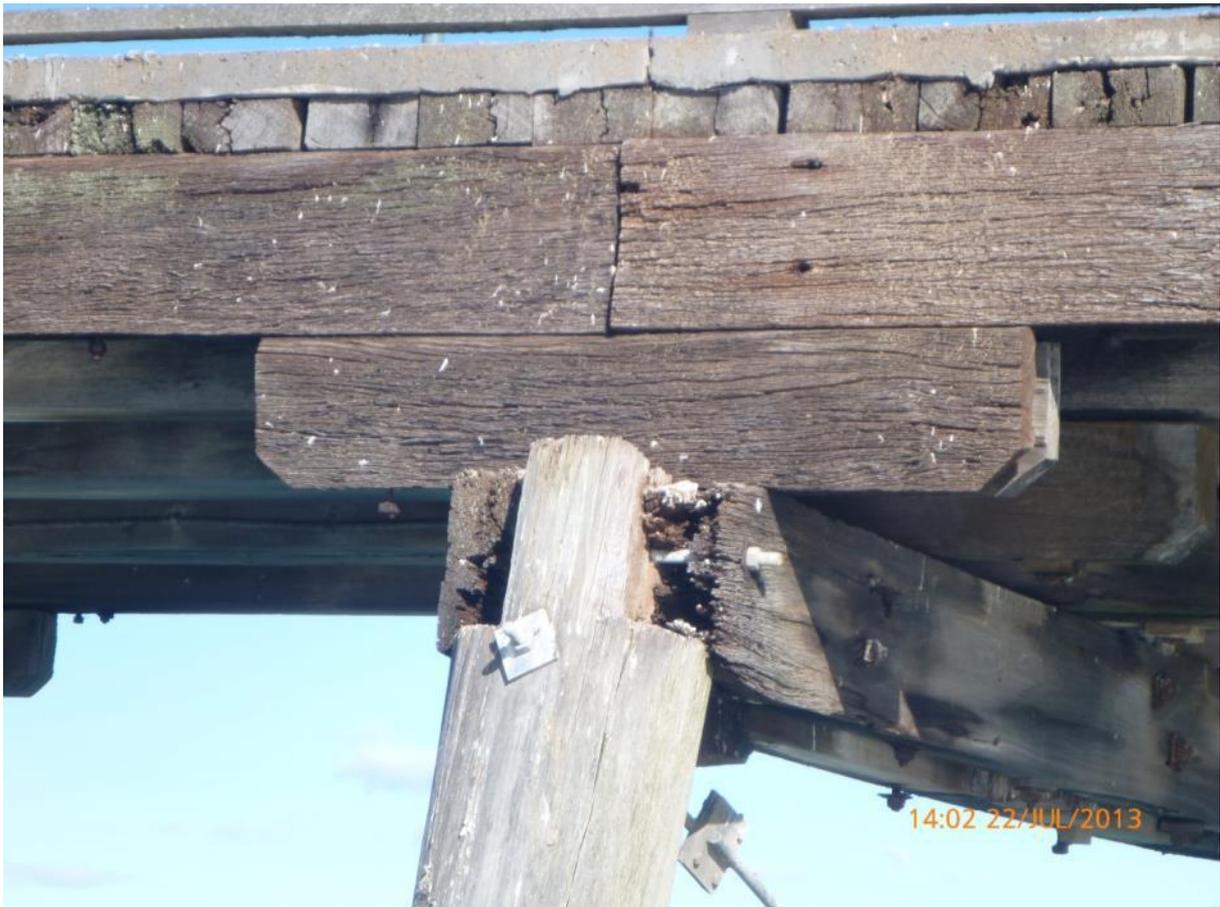
Figure 3-24: Half cap 35 North both

The end distance on the half cap to pile bolt connection is insufficient, and with the weathering to the half caps, the connection is no longer effective. In addition, the rot to the northern half caps has reduced the bearing strength sufficiently for crushing to occur. The remedial should be in order of preference where possible;

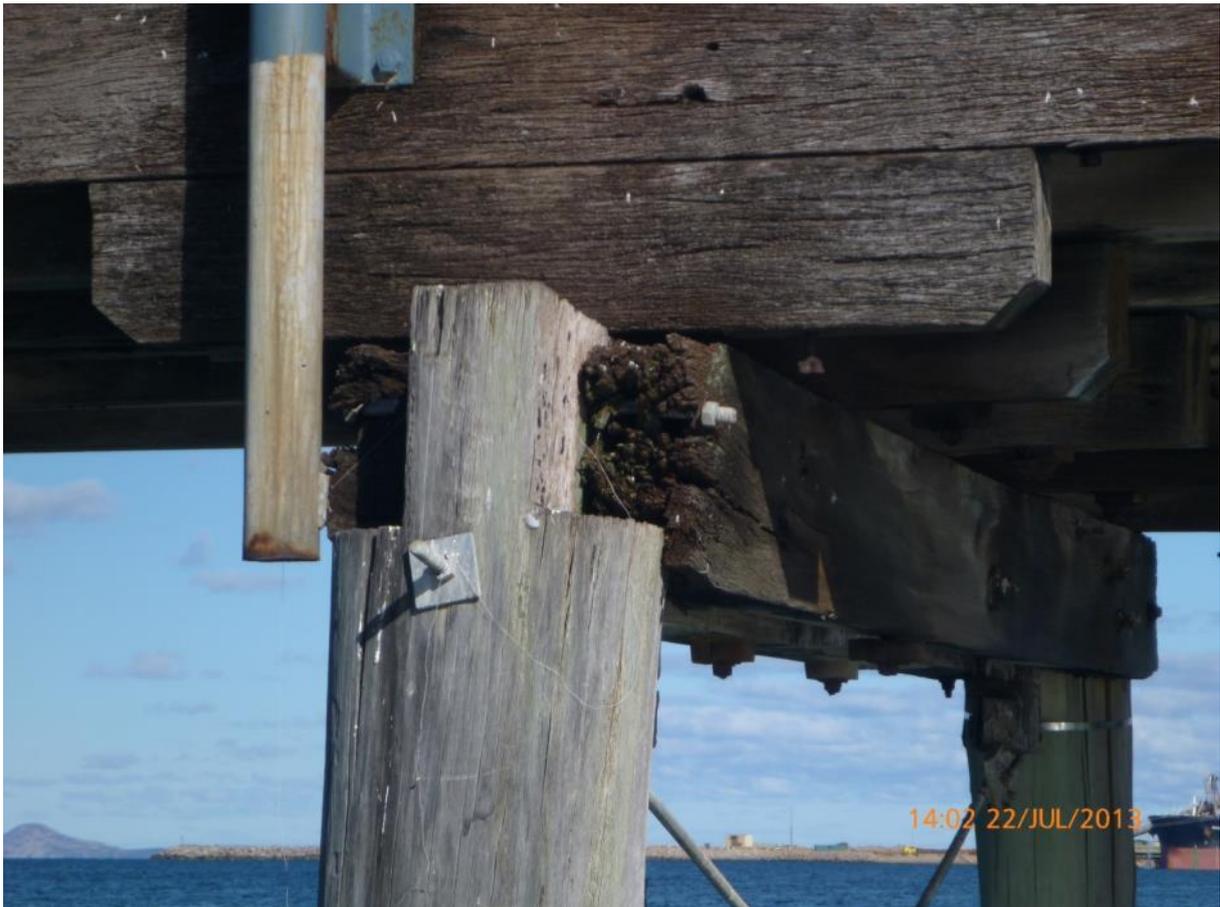
Figure 3-25: Half cap 36 North both

The end distance on the half cap to pile bolt connection is insufficient, and with the weathering to the half caps, the connection is no longer effective. In addition the rot to the northern half caps has reduced the bearing strength sufficiently for crushing to occur. The remedial should be in order of preference where possible;

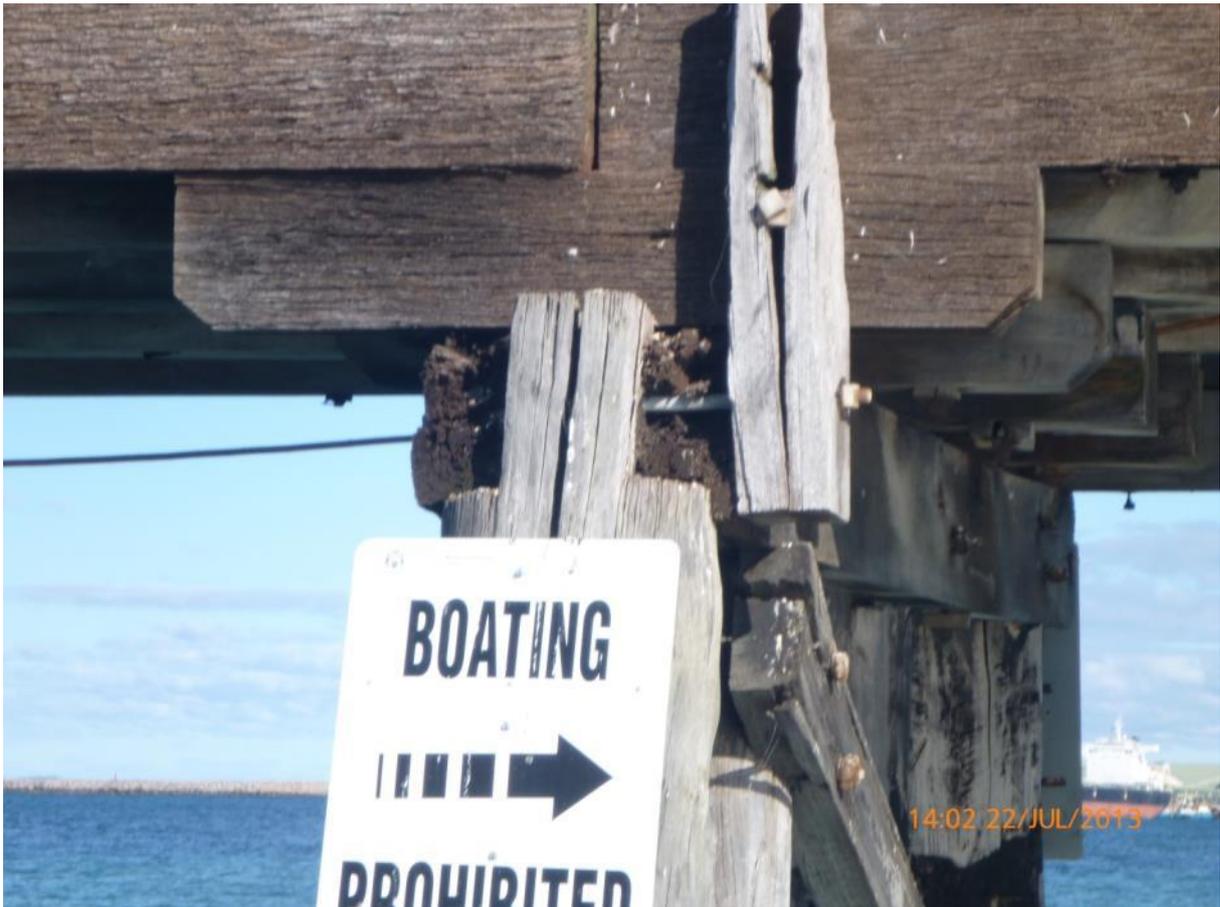
Figure 3-26: Half cap 37 North both

The end distance on the half cap to pile bolt connection is insufficient, and with the weathering to the half caps, the connection is no longer effective. The remedial should be in order of preference where possible;

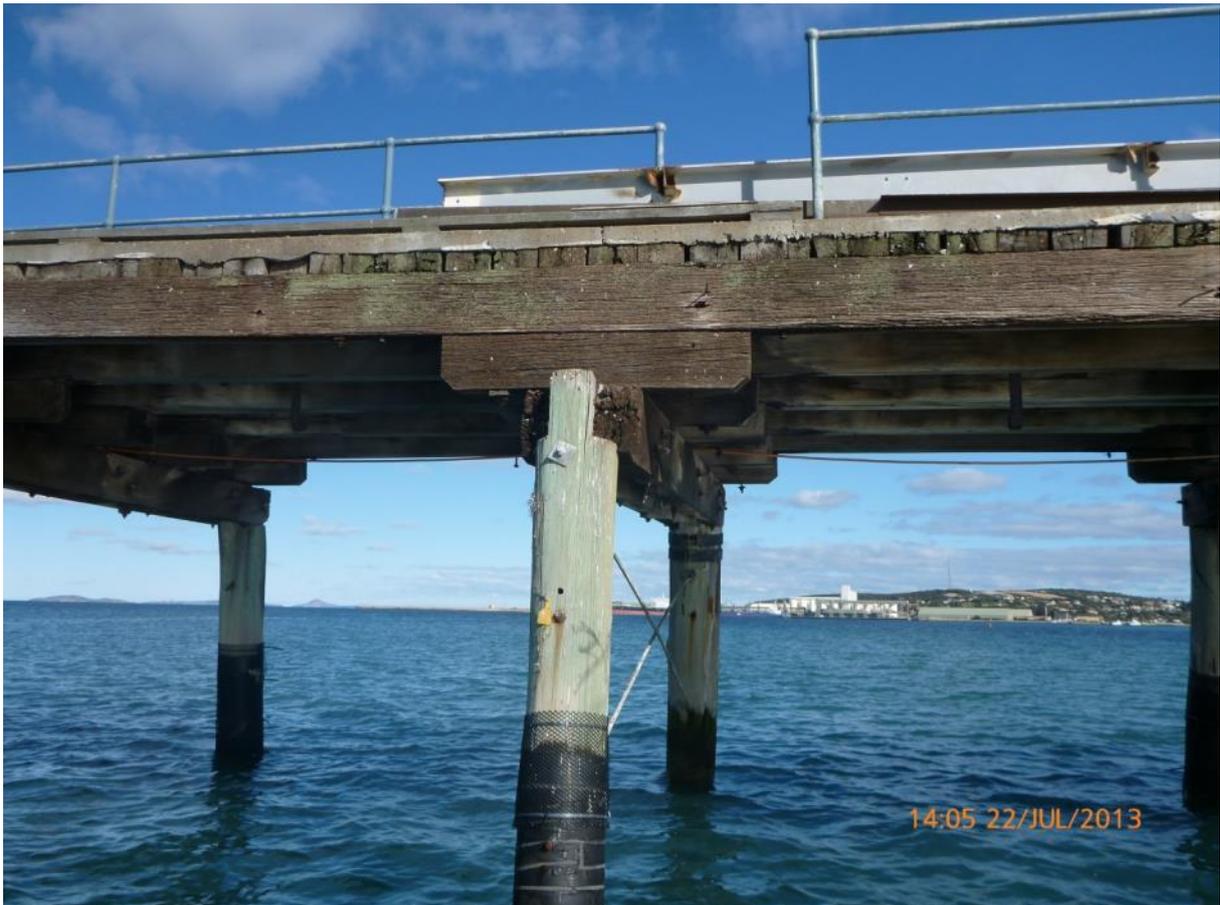
Figure 3-27: Half cap 40 North both

The end distance on the half cap to pile bolt connection is insufficient, and with the weathering to the half caps, the connection is no longer effective. In addition the rot to the northern half cap has reduced the bearing strength sufficiently for crushing to occur. This pier is adjacent to the missing pile which adds extra load to all elements below the bridging beam increasing the chance of failure. The remedial should be in order of preference where possible;

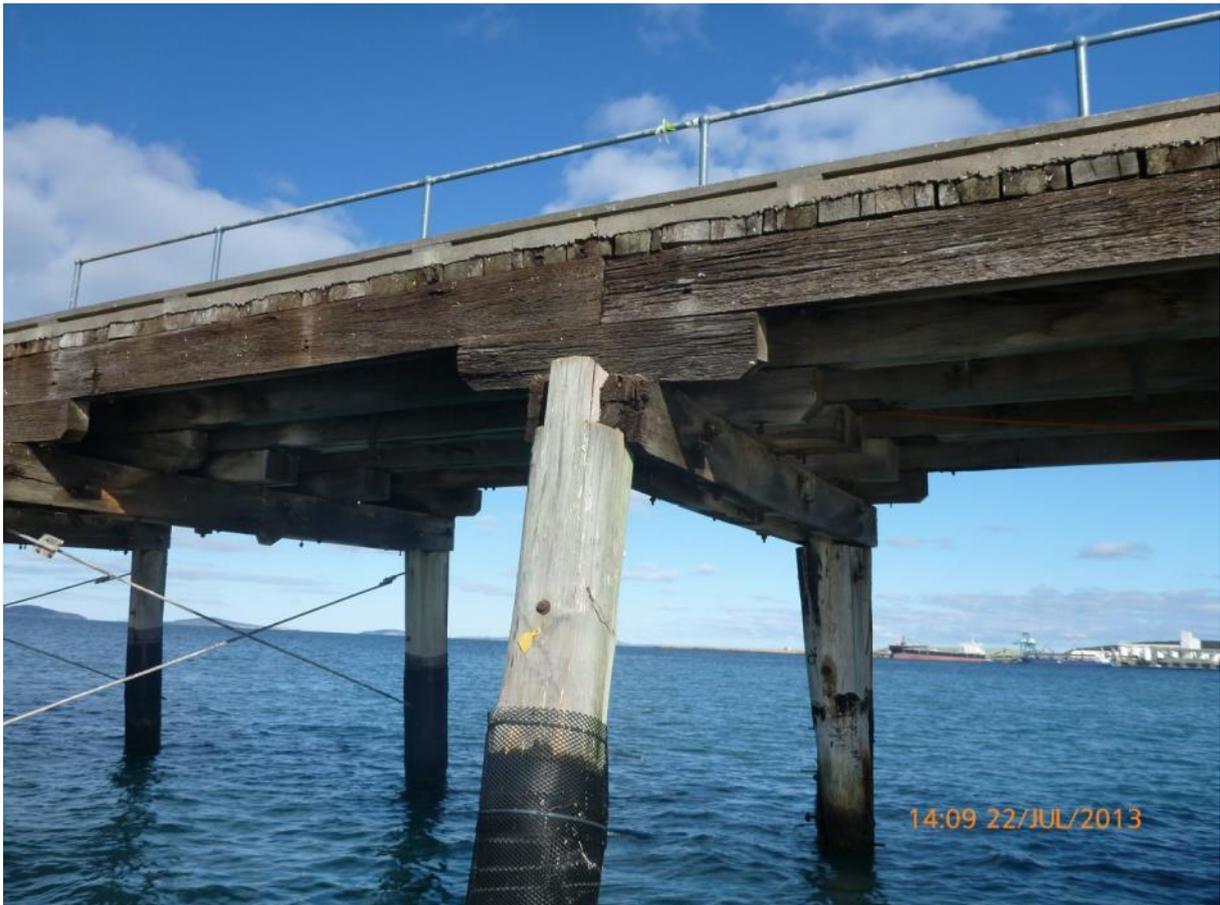
Figure 3-28: Half cap 43 Northwest

The end distance on the half cap to pile bolt connection is insufficient, and with the weathering to the half caps, the connection is no longer effective. In addition, the rot to the northwestern half cap has reduced the bearing strength sufficiently for crushing to occur. The remedial should be in order of preference where possible;

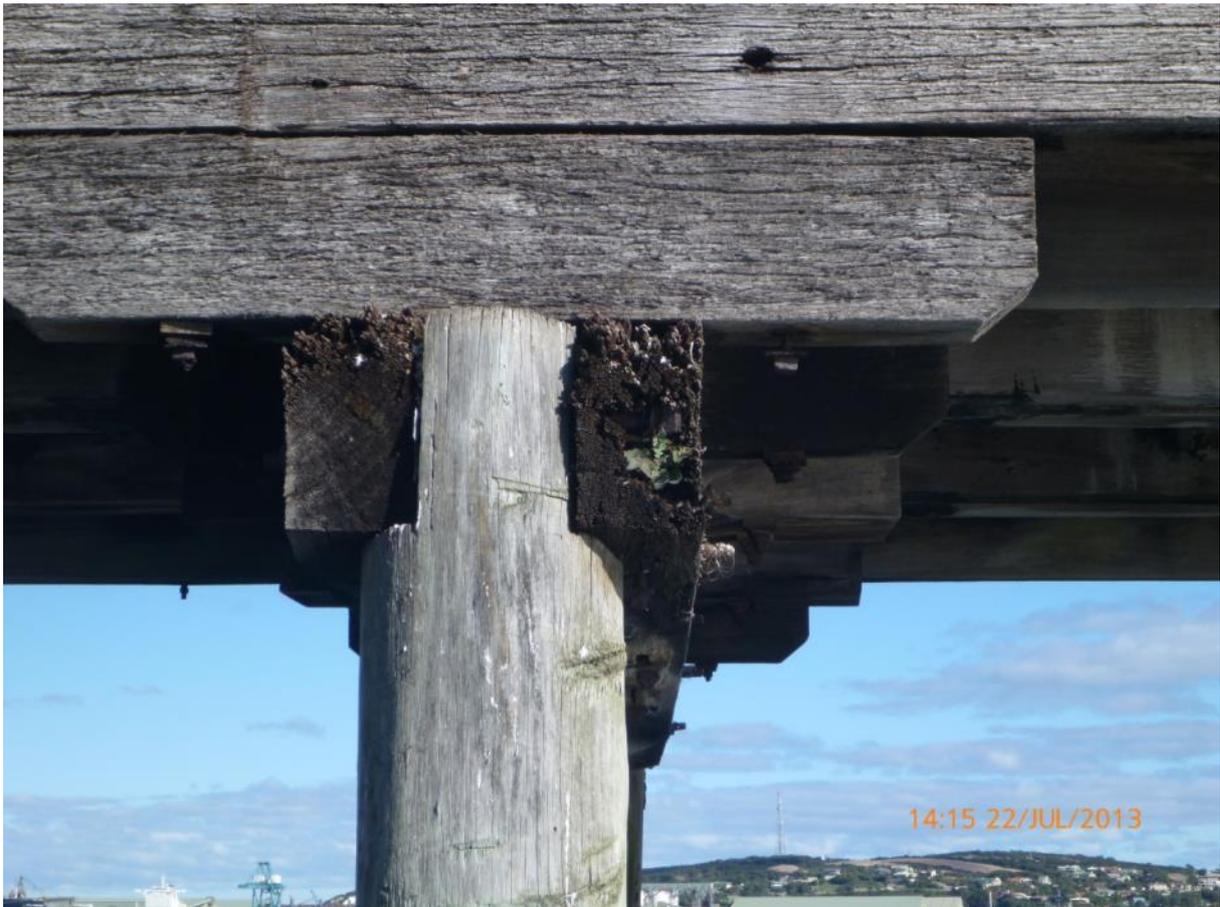
Figure 3-29: Half cap 60 Northwest

The end distance on the half cap to pile bolt connection is insufficient, and with the weathering to the half caps, the connection is no longer effective. The remedial should be;

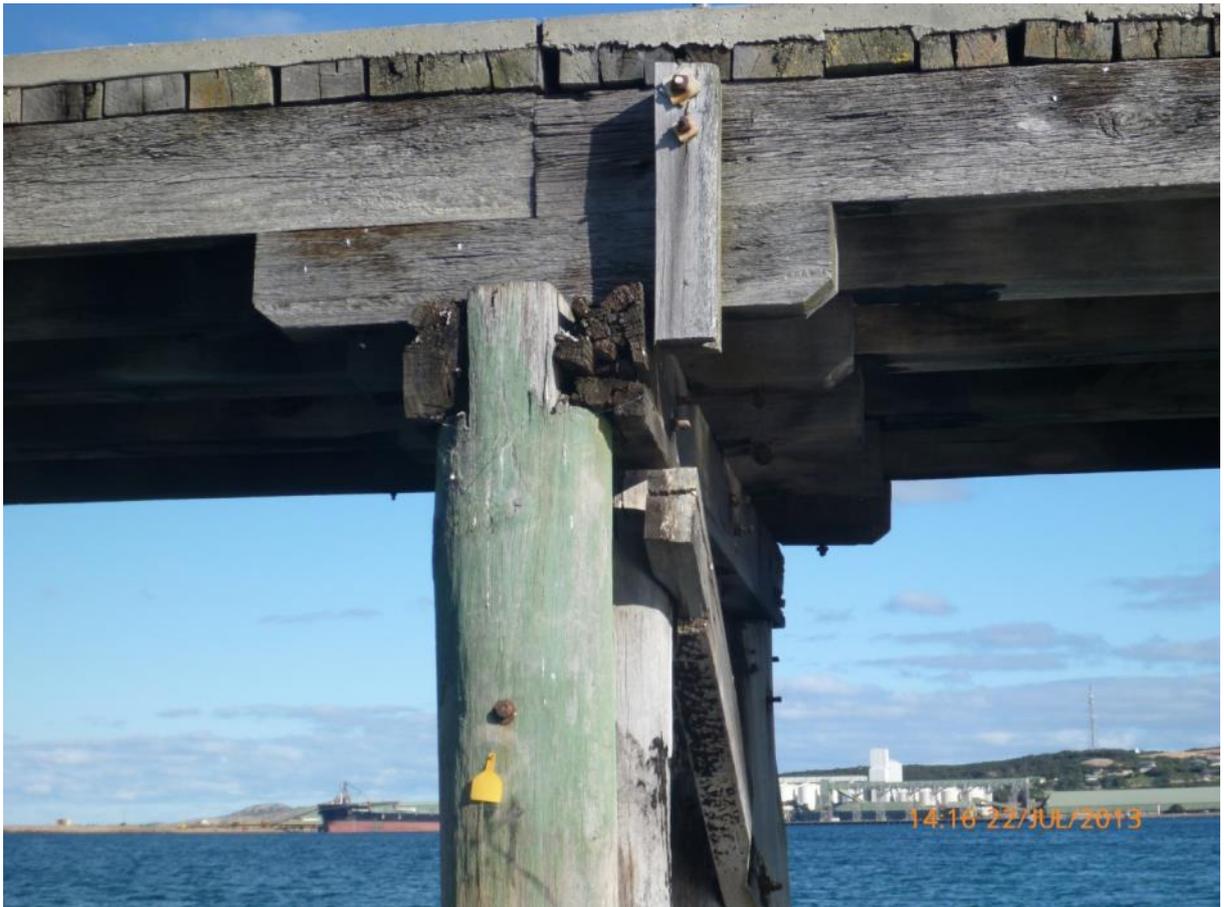
Figure 3-30: Half cap 63 Northwest

The end distance on the half cap to pile bolt connection is insufficient, and with the weathering to the half caps, the connection is no longer effective. In addition, the northwestern half cap has crushed. The north-eastern half cap appears in good condition so the bearing loads can be transferred to this element. The remedial should be in order of preference where possible;

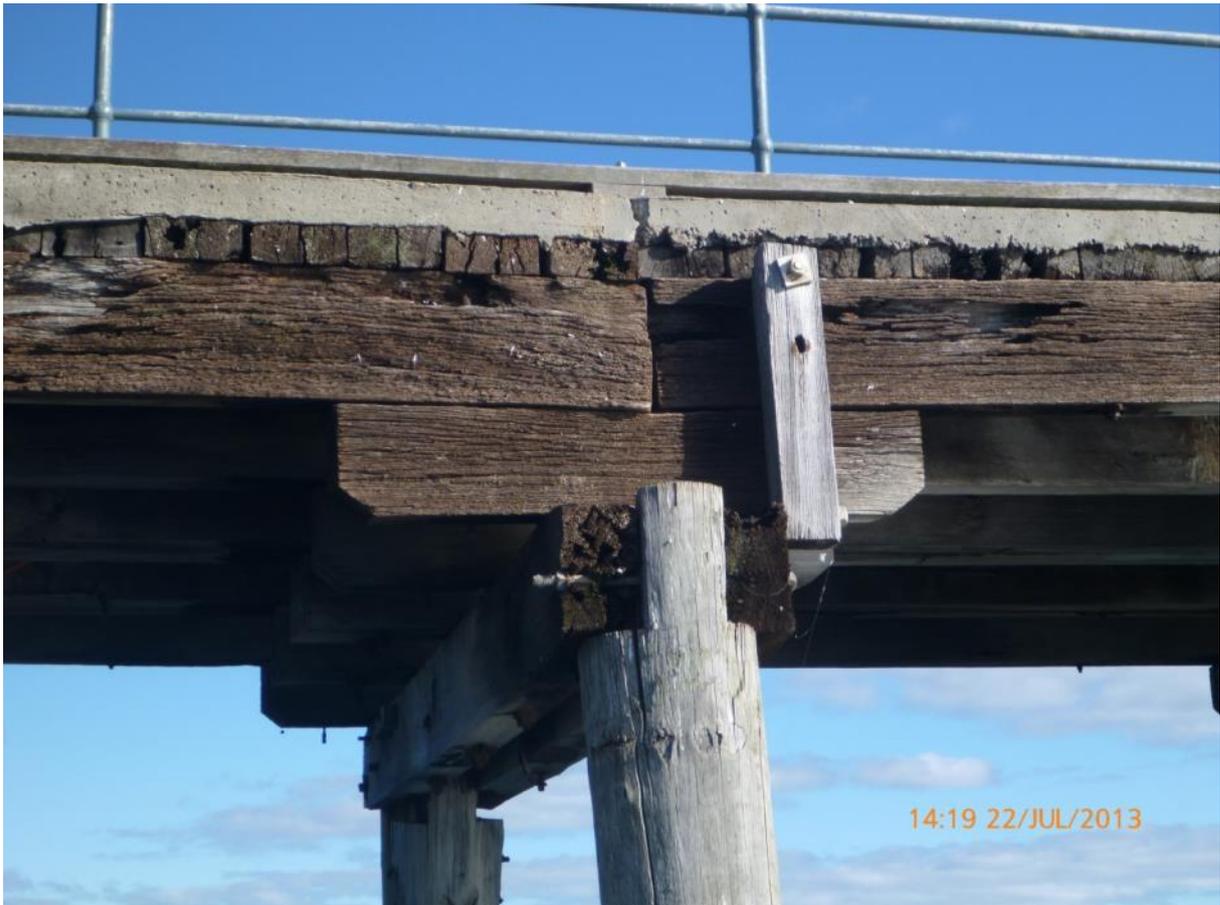
Figure 3-31: Half cap 71 Both

The end distance on the half cap to pile bolt connection is insufficient, and with the weathering to the half caps, the connection is no longer effective. The remedial should be in order of preference where possible;

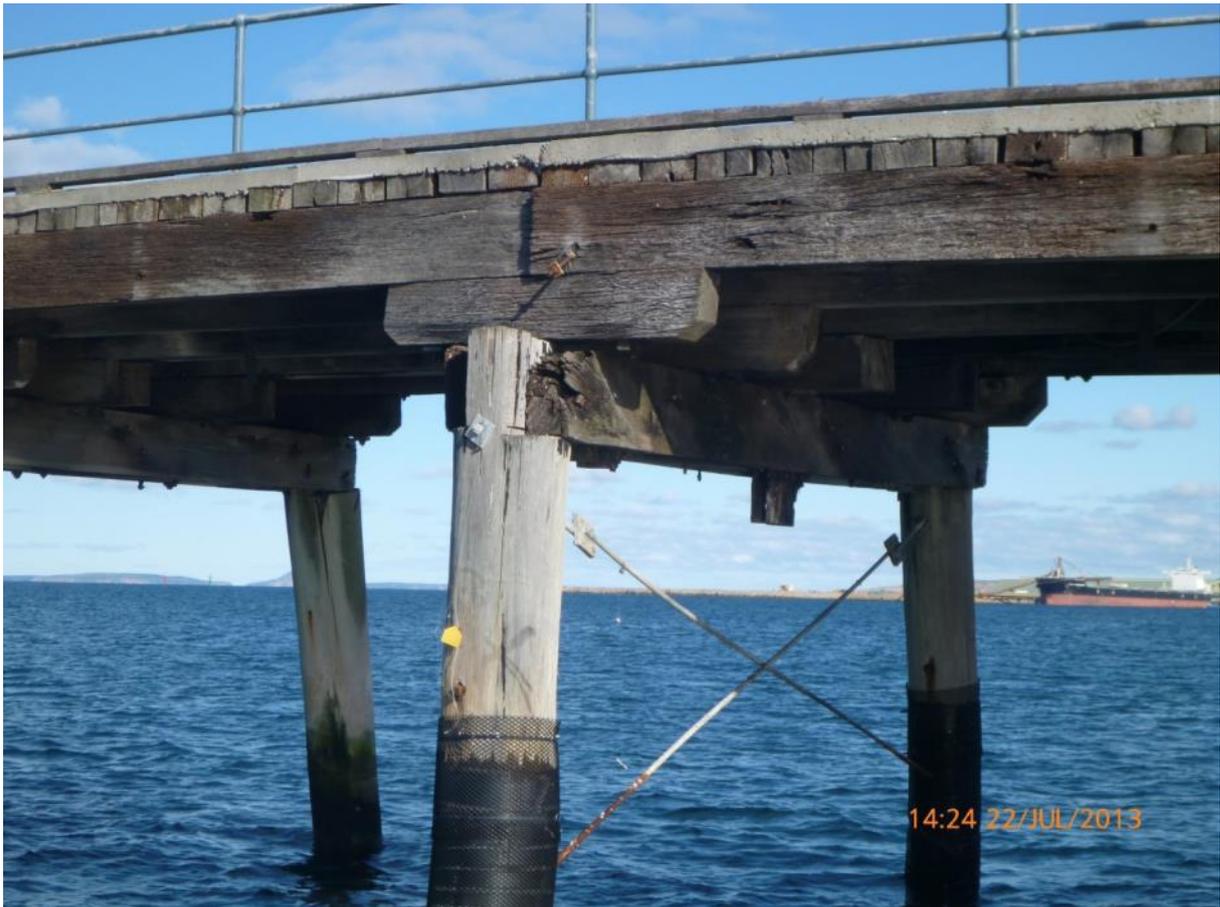
Figure 3-32: Half cap 73 Northwest

The end distance on the half cap to pile bolt connection is insufficient, and with the weathering to the half caps, the connection is no longer effective. The remedial should be in order of preference where possible;

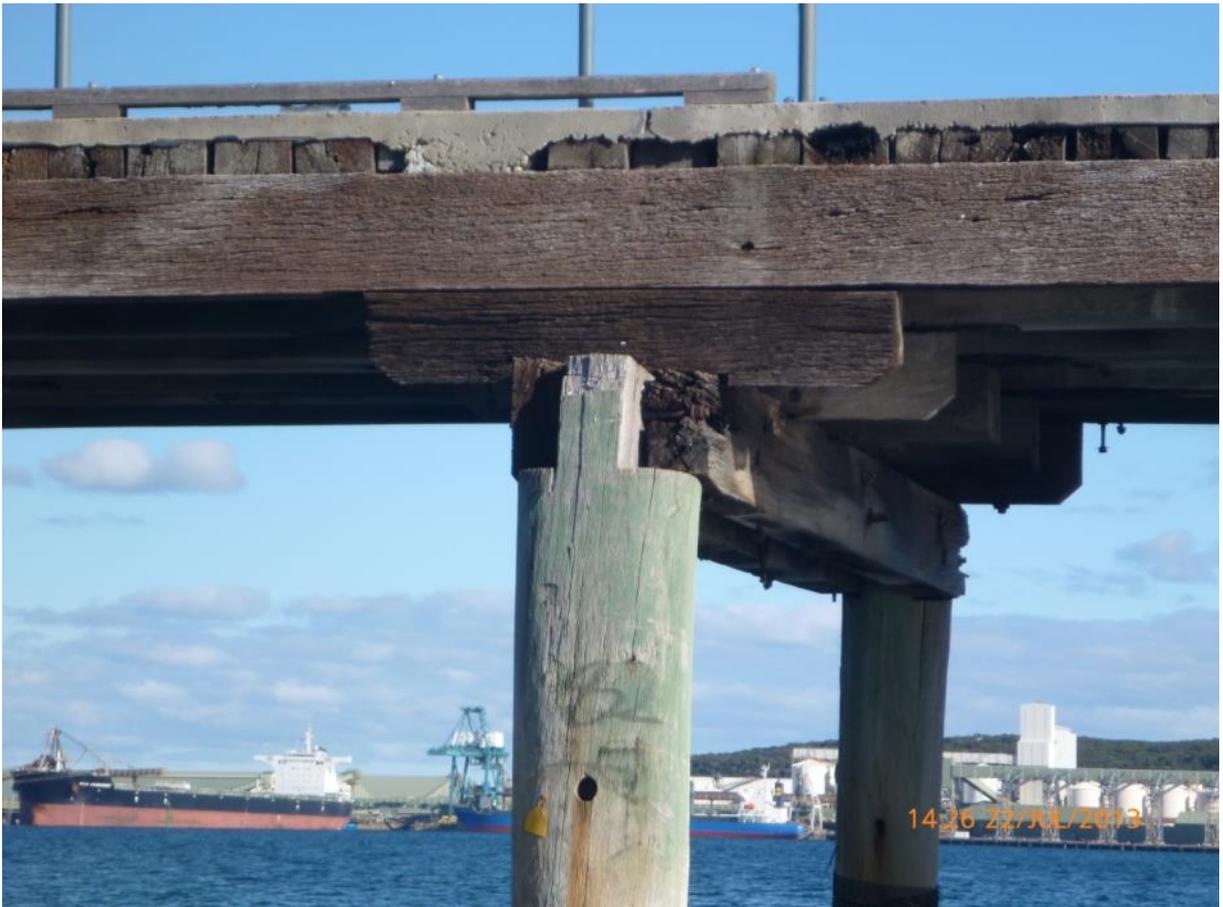
Figure 3-33: Half cap 82 Northwest

The end distance on the half cap to pile bolt connection is insufficient, and with the weathering to the half caps, the connection is no longer effective. There is evidence that the west half cap bolt has slipped in relative to the pile. The remedial should be in order of preference where possible;

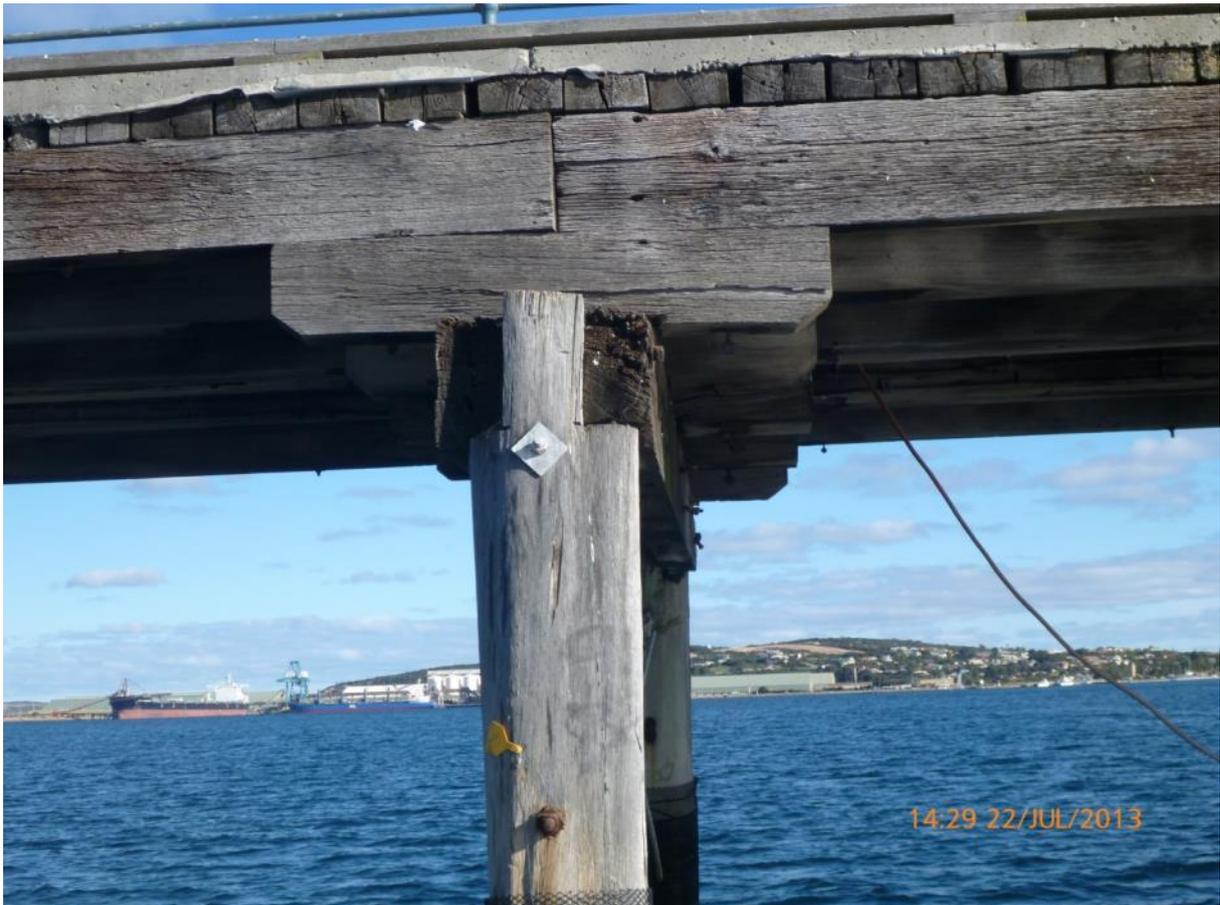
Figure 3-34: Half cap 91 Northwest

The end distance on the half cap to pile bolt connection is insufficient, and with the weathering to the half caps, the connection is no longer effective. The remedial should be in order of preference where possible;

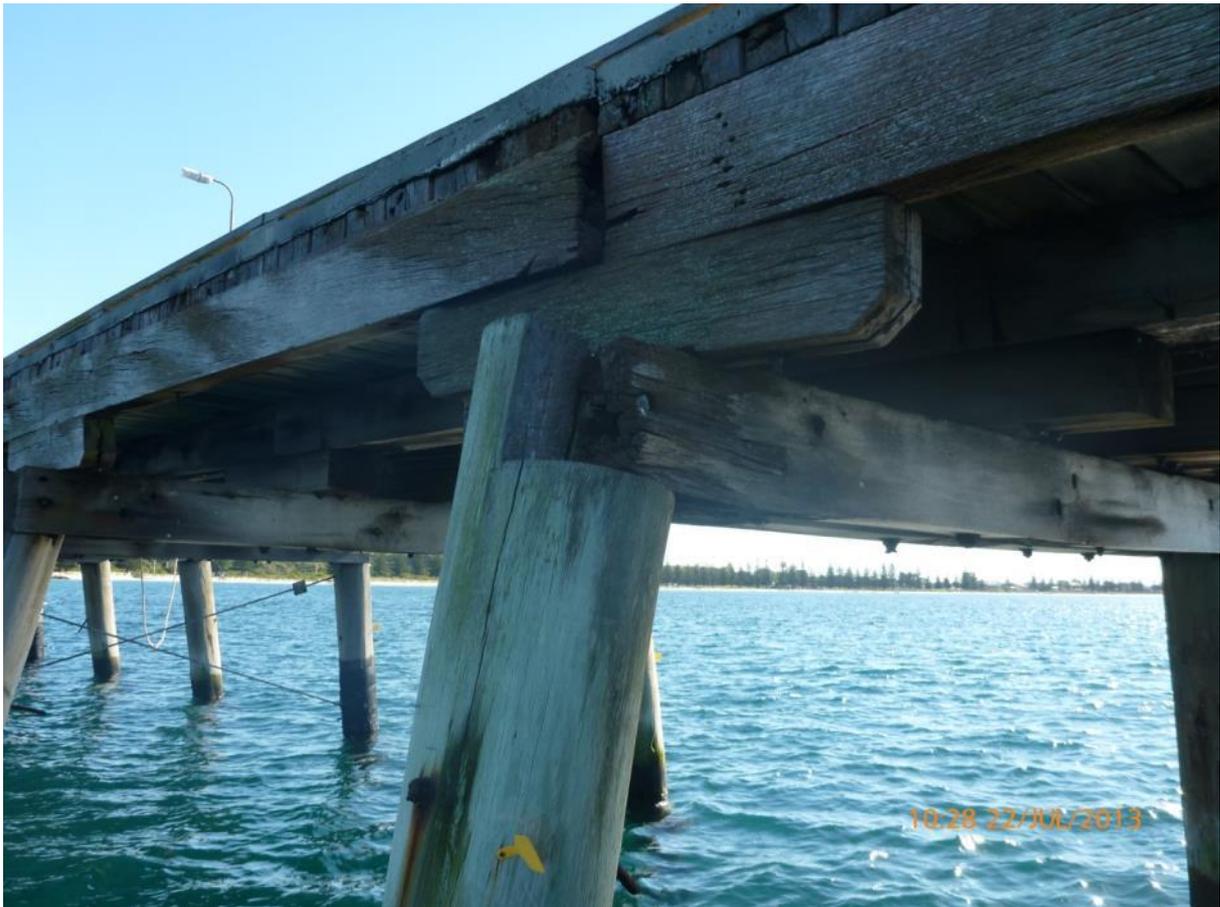
Figure 3-35: Half cap 93 Southeast

The end distance on the half cap to pile bolt connection is insufficient, and with the weathering to the half caps, the connection is no longer effective. In addition, the rot to the south-eastern half caps has reduced the bearing strength sufficiently for crushing to occur. The remedial should be in order of preference where possible;
