ESPERANCE TANKER JETTY CONDITION

Jetty Condition Assessment Update

Reference: R-224.07-1

Date: September 2013

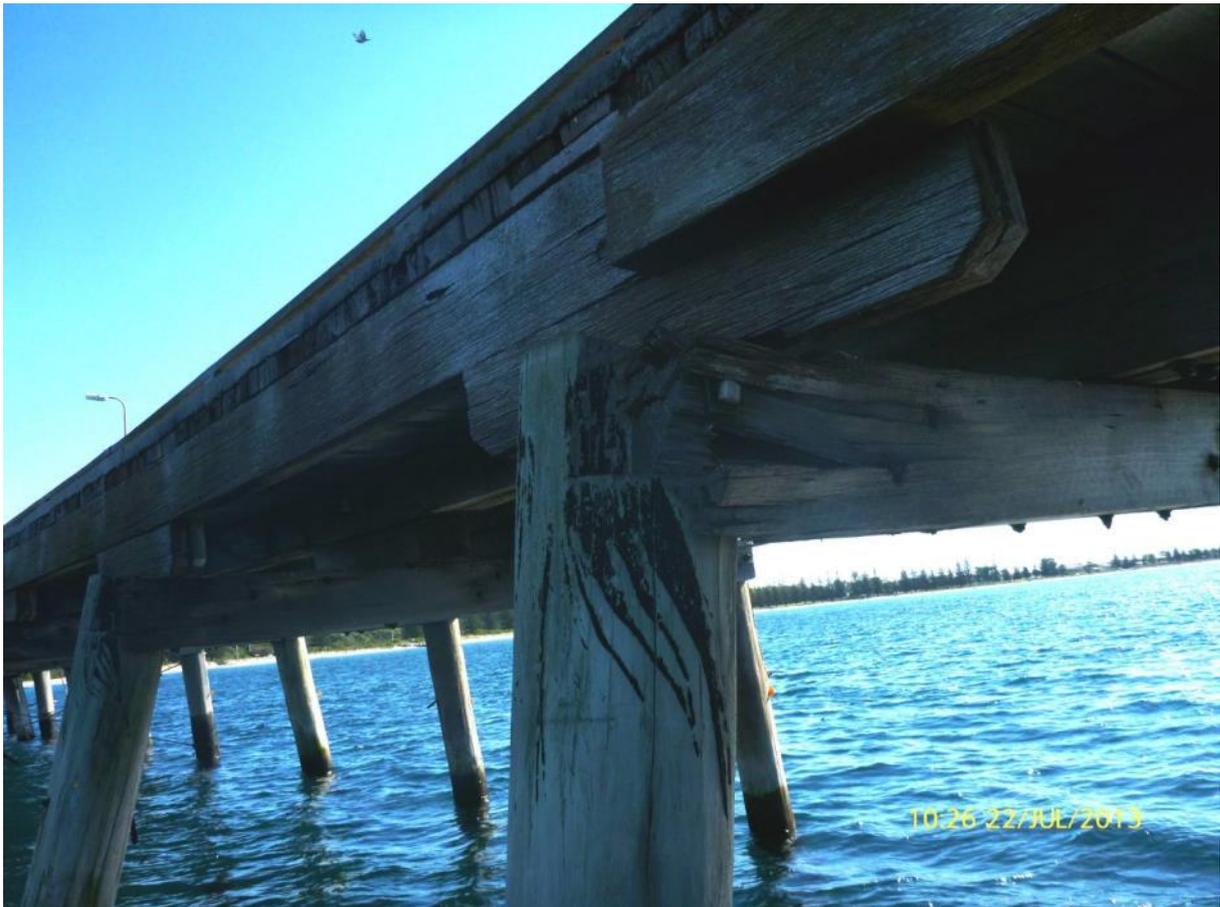
Figure 3-36: Half cap 95 Southeast

The end distance on the half cap to pile bolt connection is insufficient, and with the weathering to the half caps, the connection is no longer effective. In addition, the rot to the south-eastern half cap has reduced the bearing strength sufficiently for crushing to occur. The remedial should be in order of preference where possible;

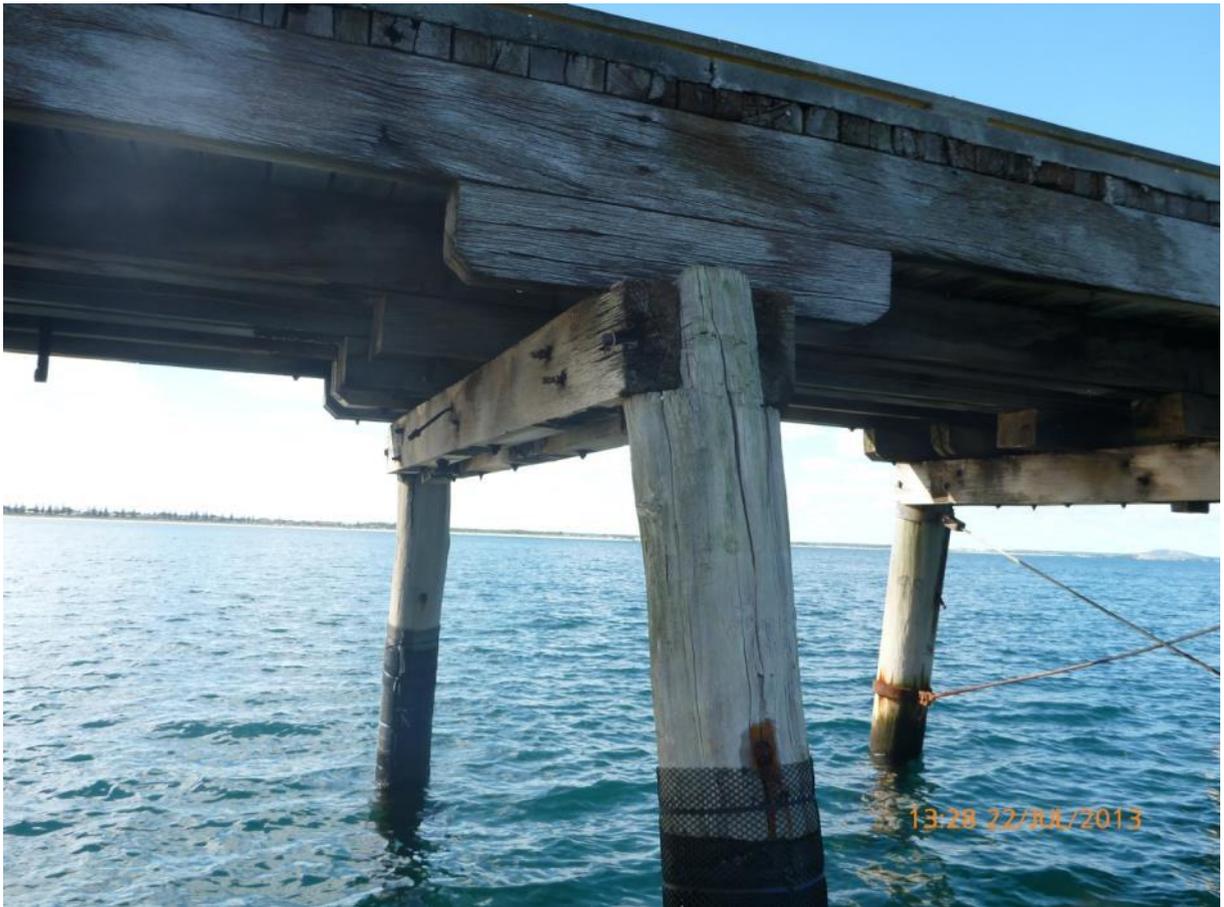
Figure 3-37: Half cap 98 Southwest

The end distance on the half cap to pile bolt connection is insufficient, and with the weathering to the half caps, the connection is no longer effective. The remedial should be in order of preference where possible;

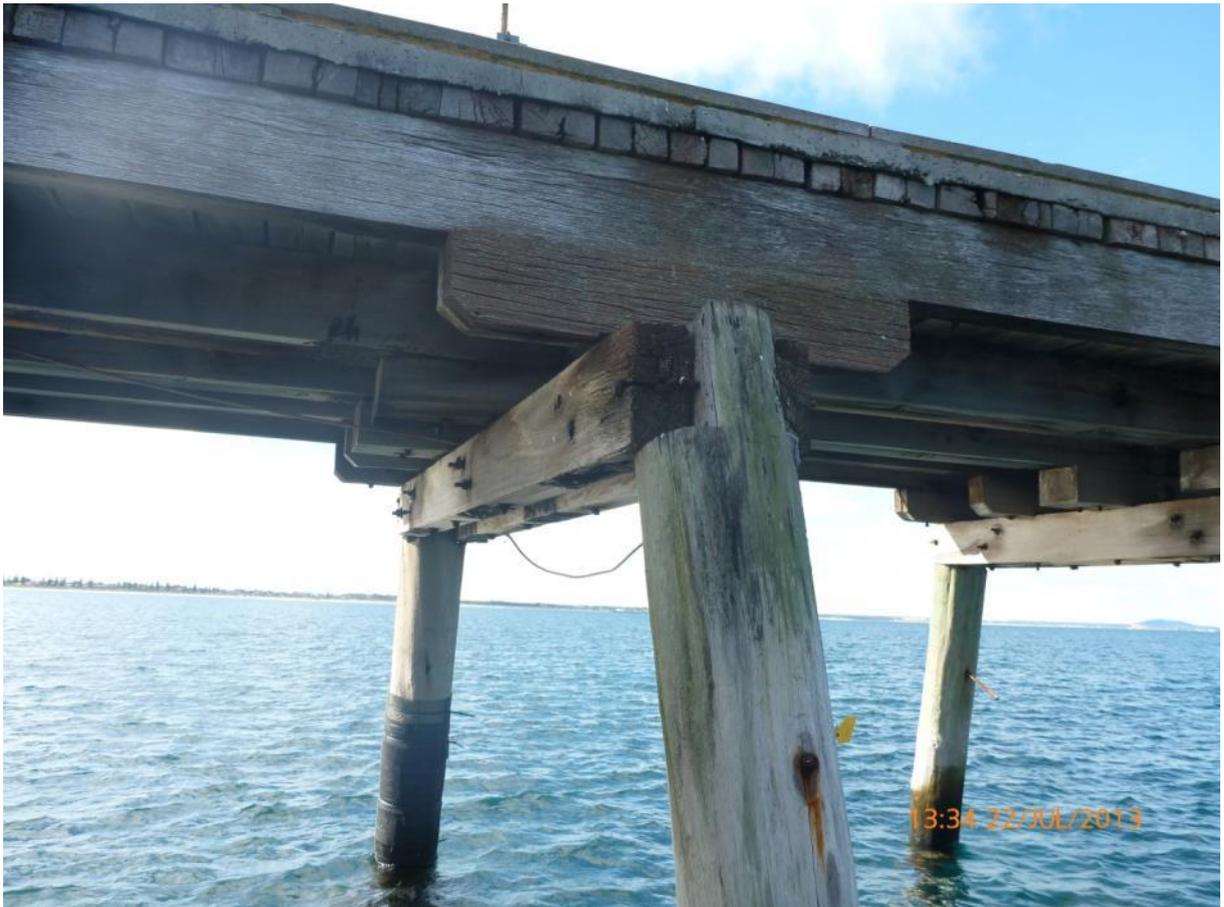
Figure 3-38: Half cap 108 Both

The end distance on the half cap to pile bolt connection is insufficient, and with the weathering to the half caps, the connection is no longer effective. The remedial should be in order of preference where possible;

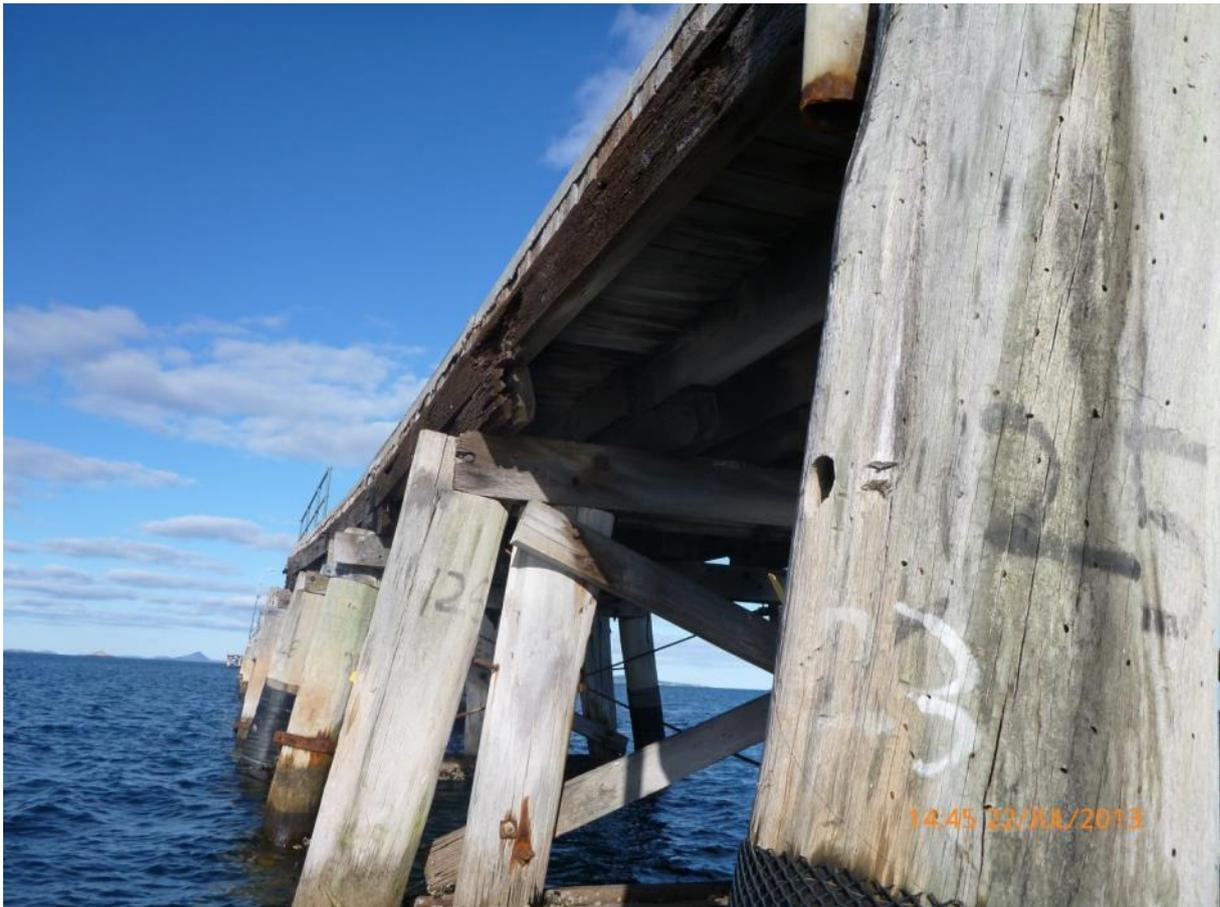
The end distance on the half cap to pile bolt connection is insufficient, and with the weathering to the half caps, the connection is no longer effective. The remedial should be in order of preference where possible;

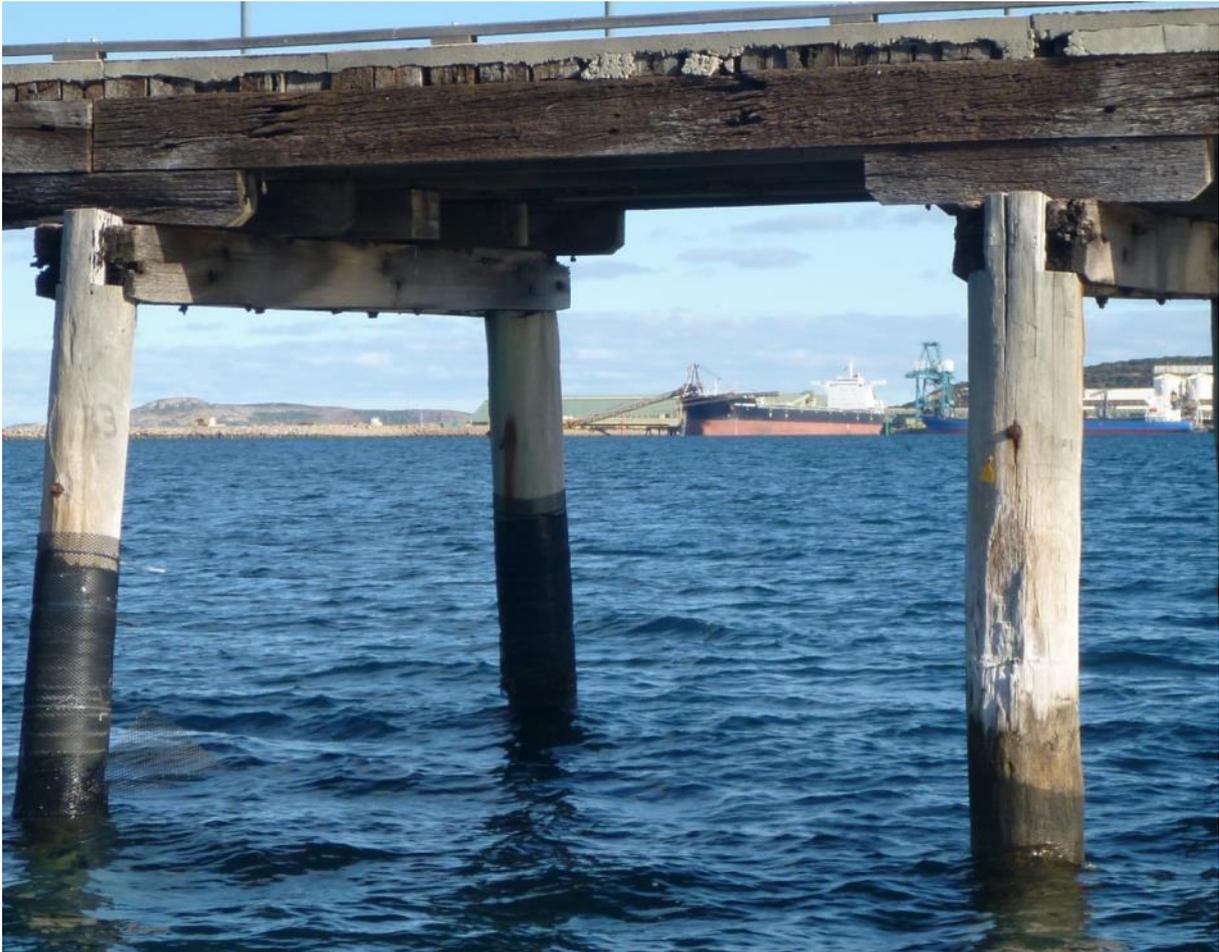
Pier 132, the north end of both half caps the pile bolt connection has insufficient end distance, and with the weathering to the half caps, the connection is no longer effective. The remedial should be in order of preference where possible;

Pier 133, the end distance on the half caps to pile bolt connection is insufficient, and with the weathering to the half caps, the connection is no longer effective. In addition, the rot and lack of bearing length of the northern half caps has reduced the bearing strength sufficiently for crushing to occur. The remedial should be in order of preference where possible;

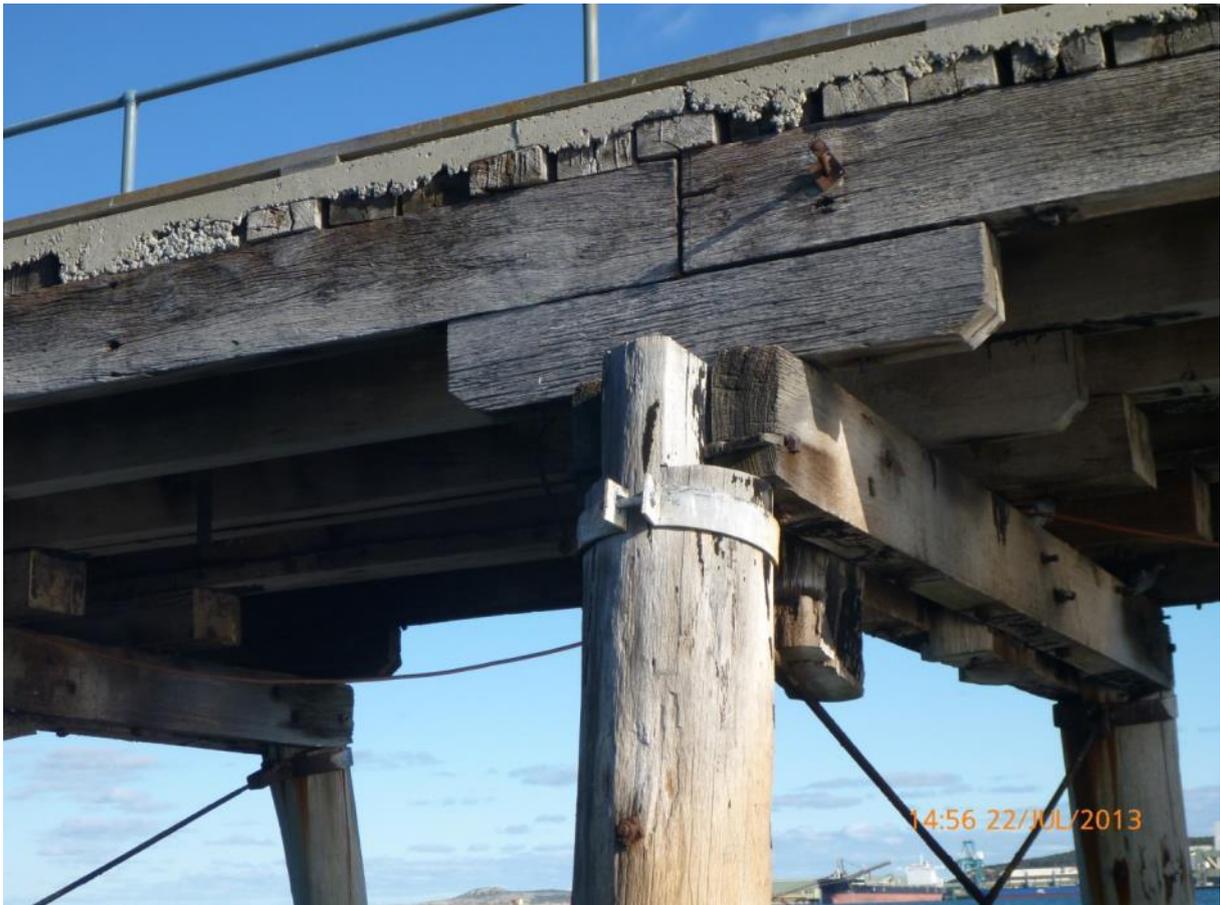
The end distance on the half cap to pile bolt connection is insufficient. There has been a shear failure of the timber suggesting that the half caps have been sliding relative to the piles. The remedial should be in order of preference where possible;

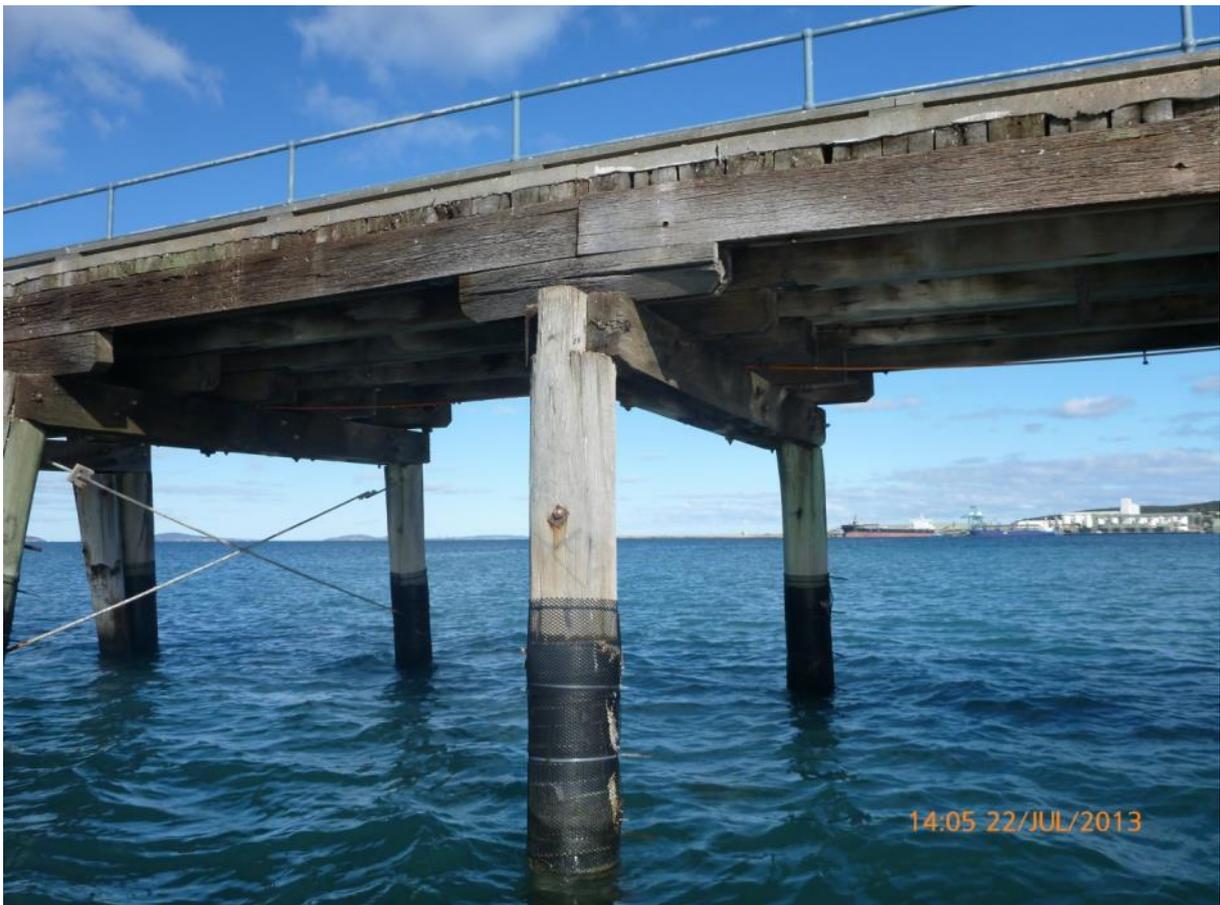
The corbel has split and crushed. The remedial should be in order of preference where possible;

- Replace corbel
- Reinforce corbel with steel plates.

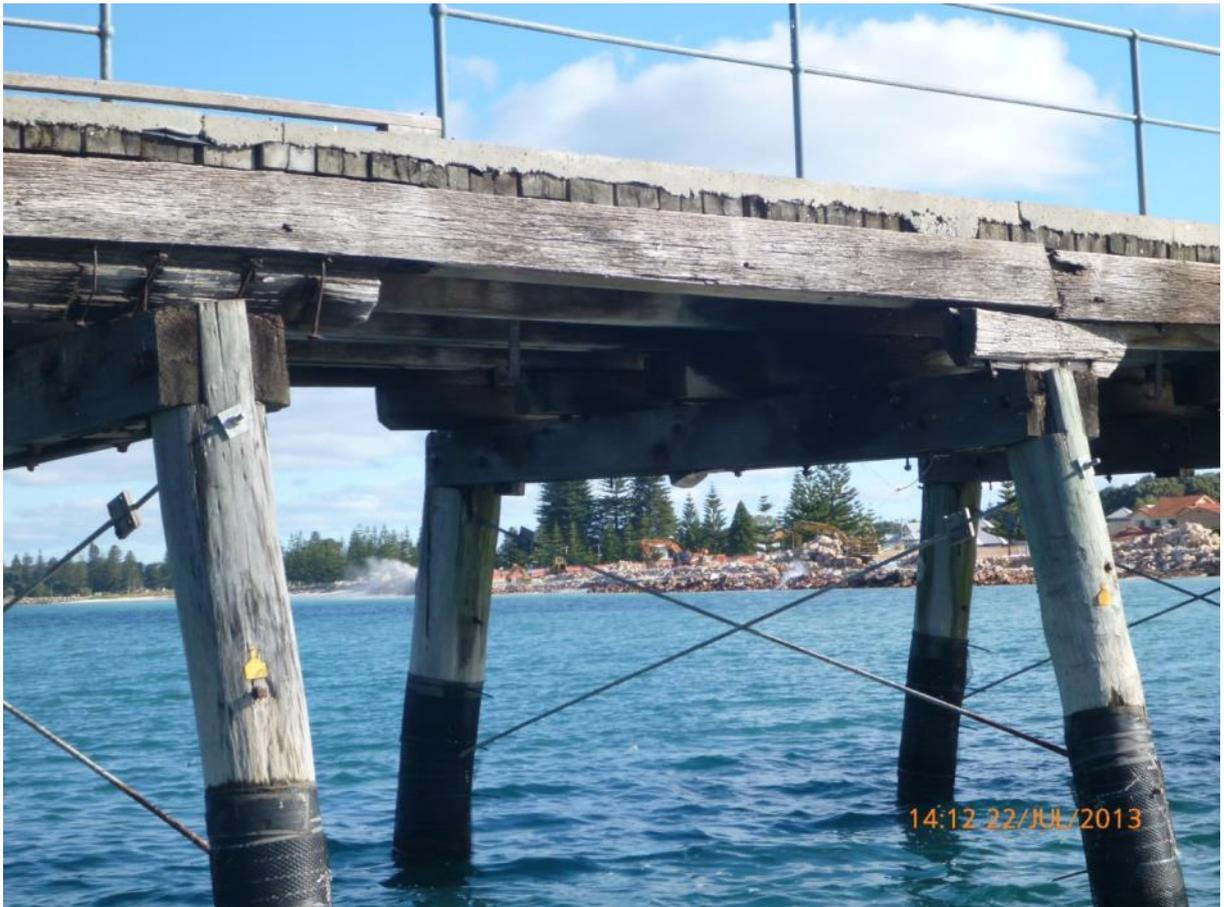
The corbels have split and rotated about the longitudinal axis. The remedial should be in order of preference where possible;

- Replace corbel.

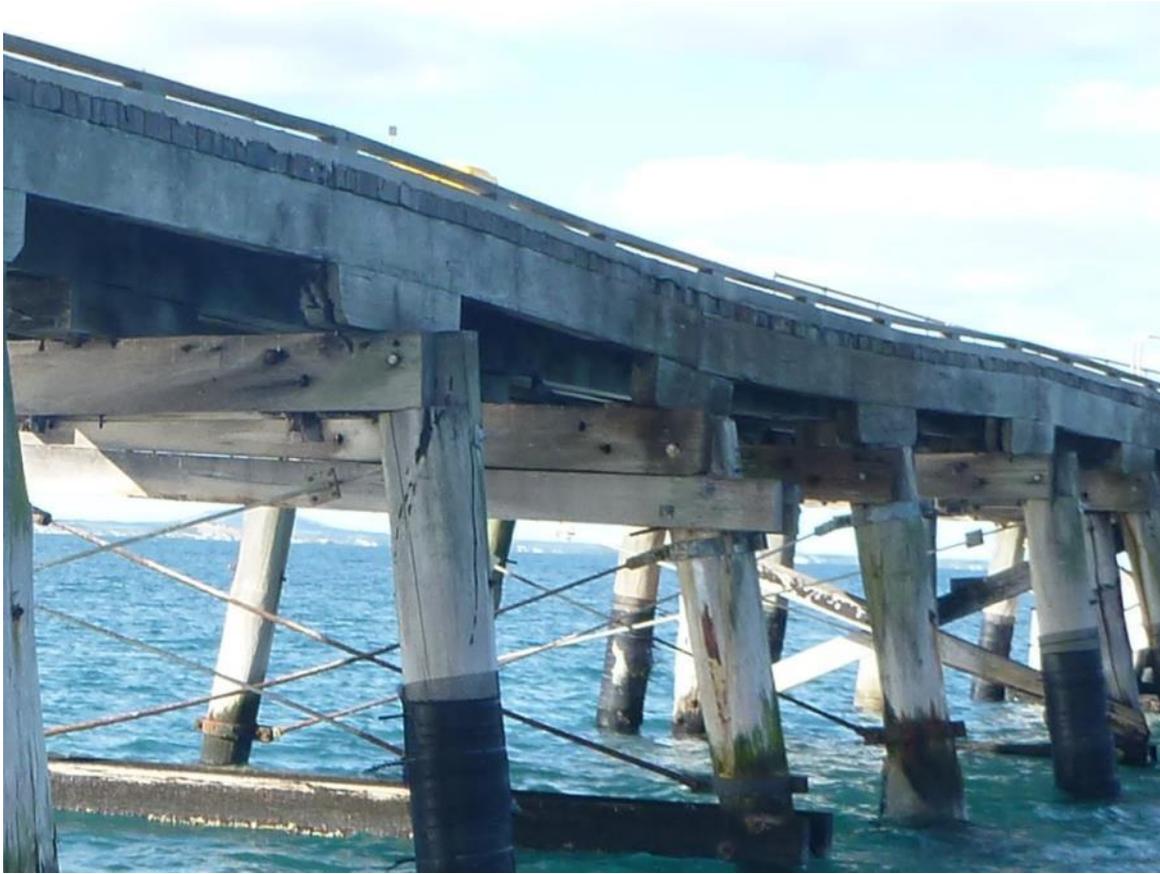
The corbel has split. The remedial should be in order of preference where possible;

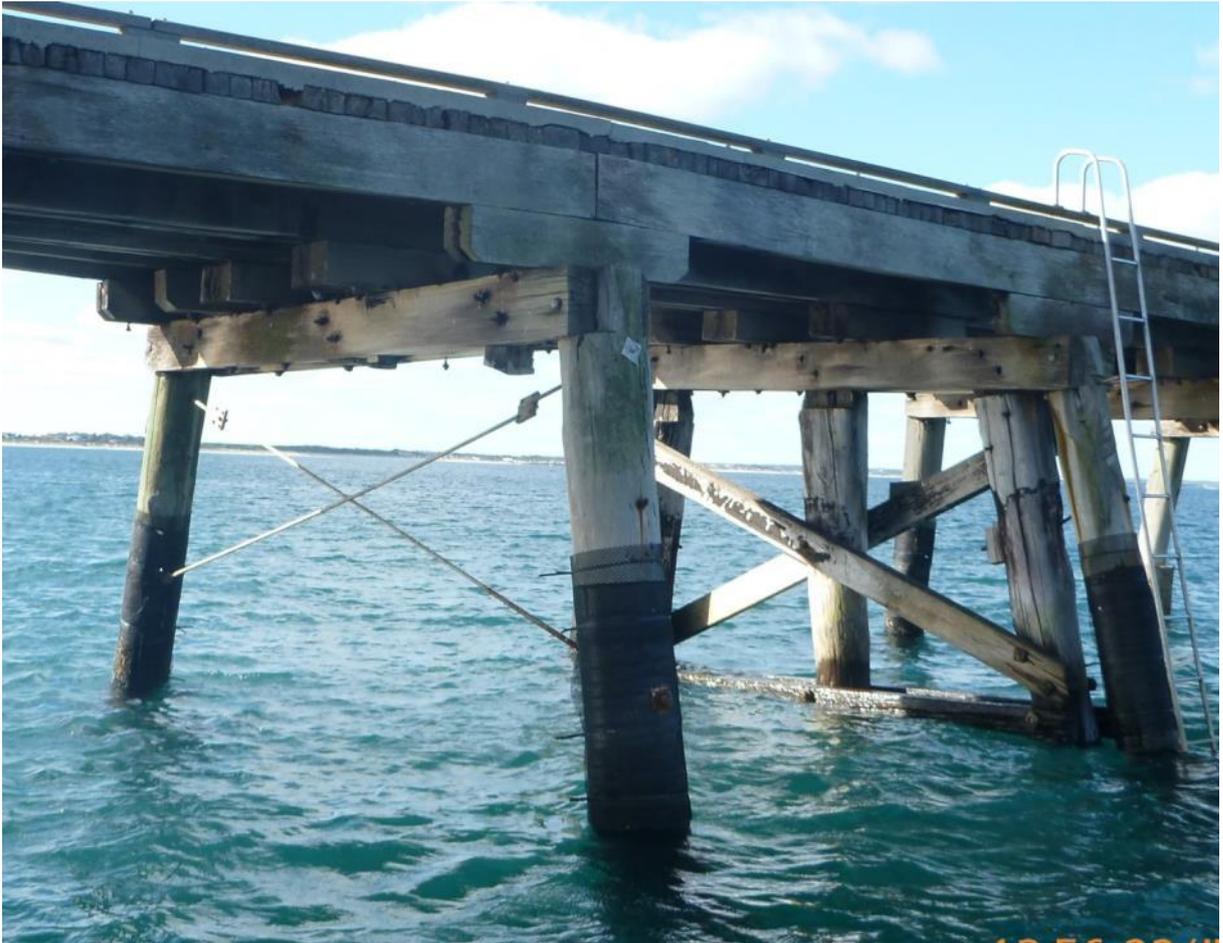
The corbel has split. The remedial should be in order of preference where possible;

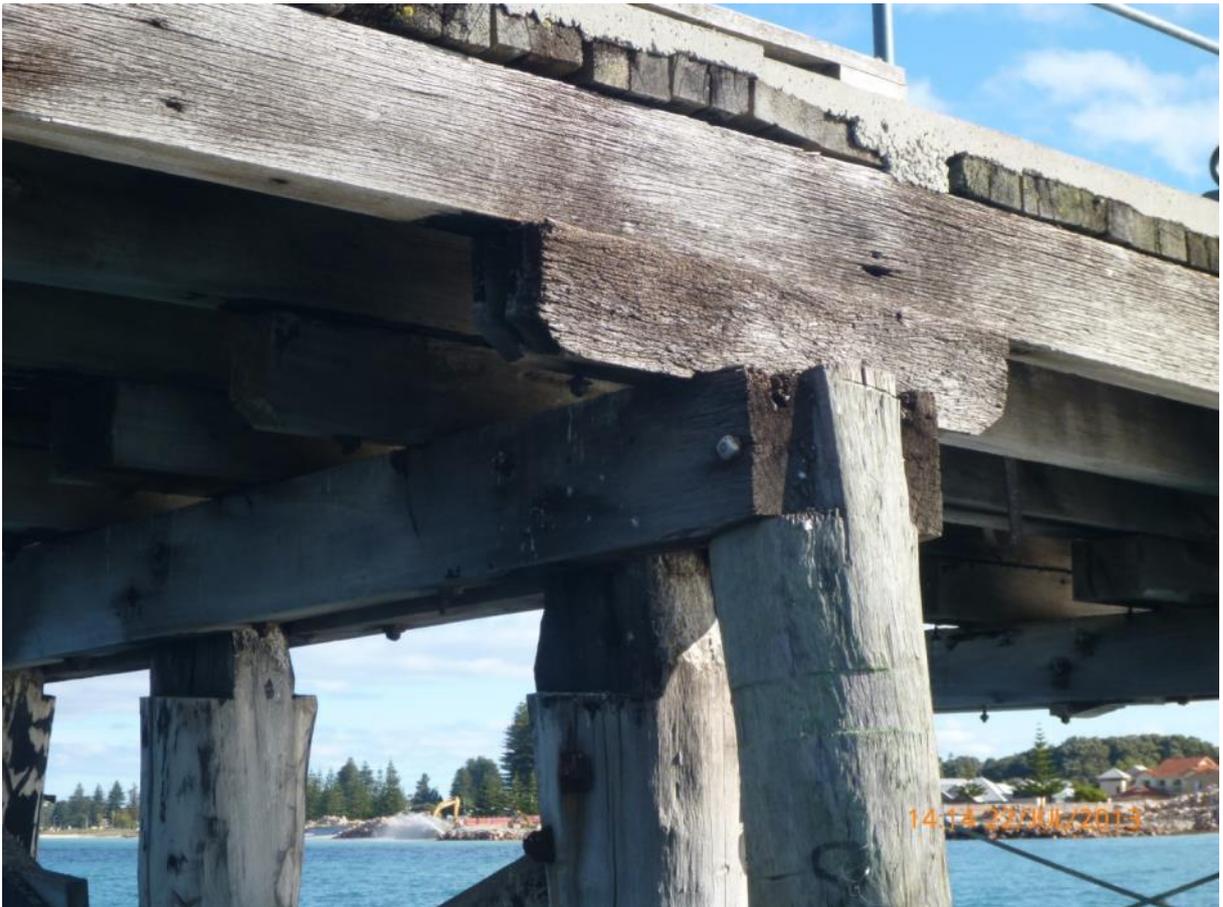
The corbel has split. The remedial should be in order of preference where possible;

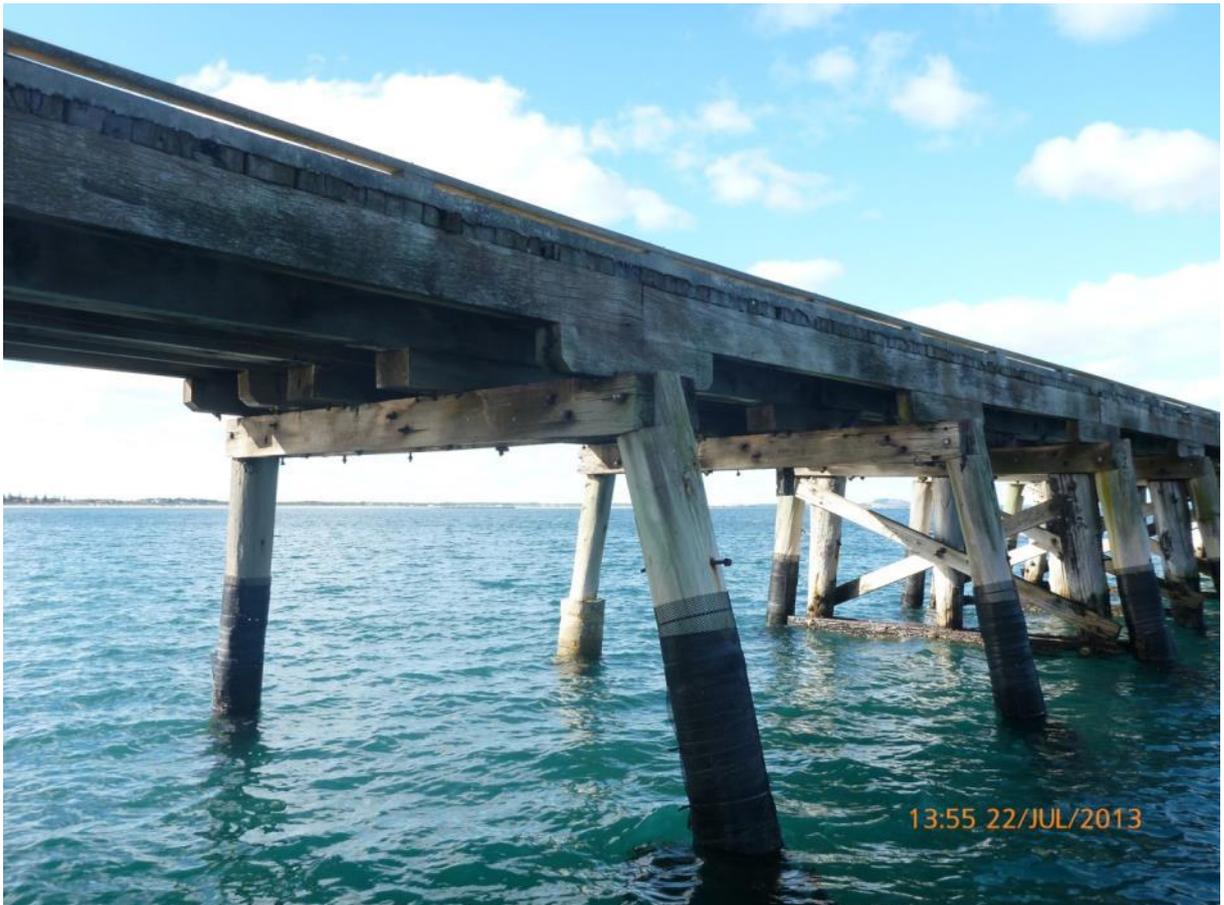
The corbel has split. The remedial should be in order of preference where possible;

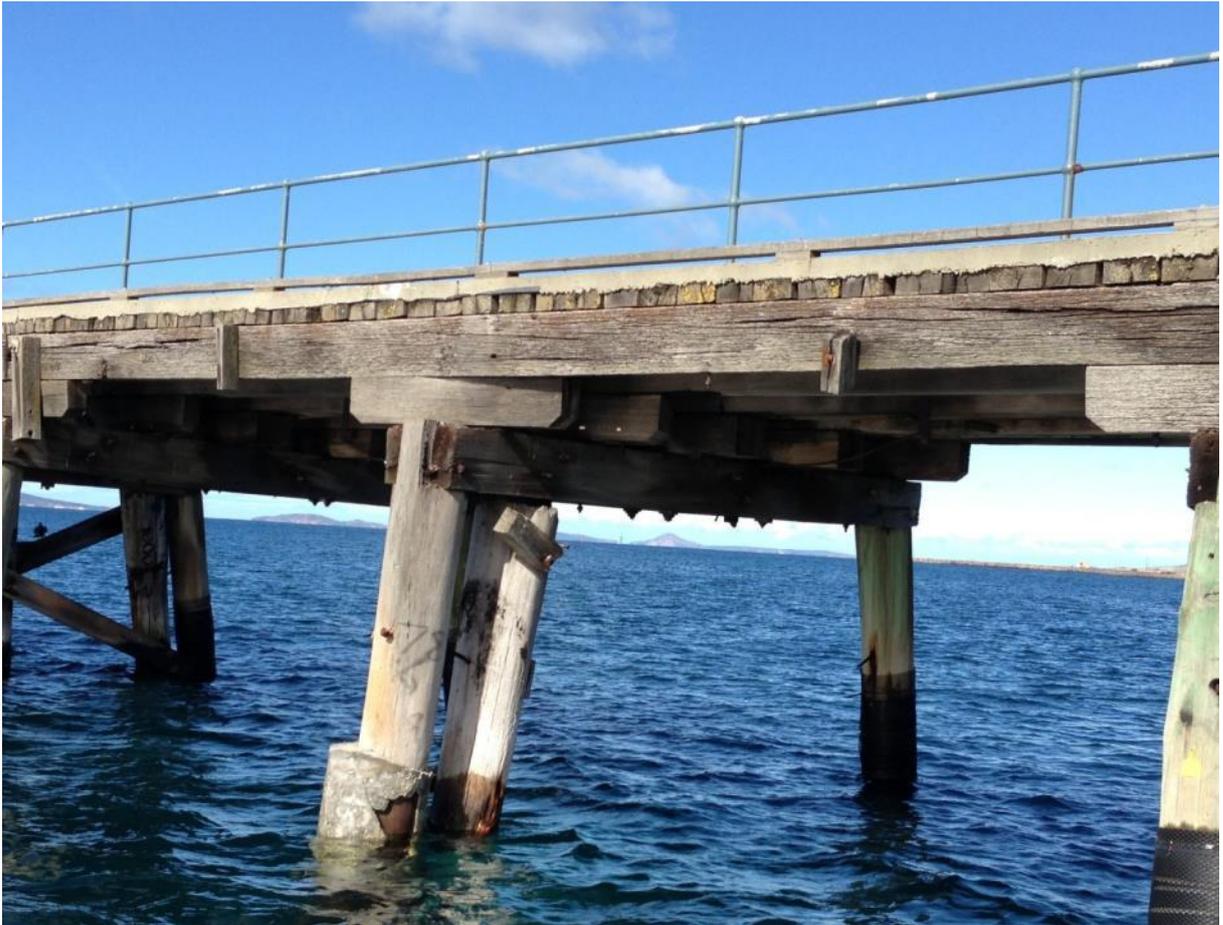
The corbel has split. The remedial should be in order of preference where possible;

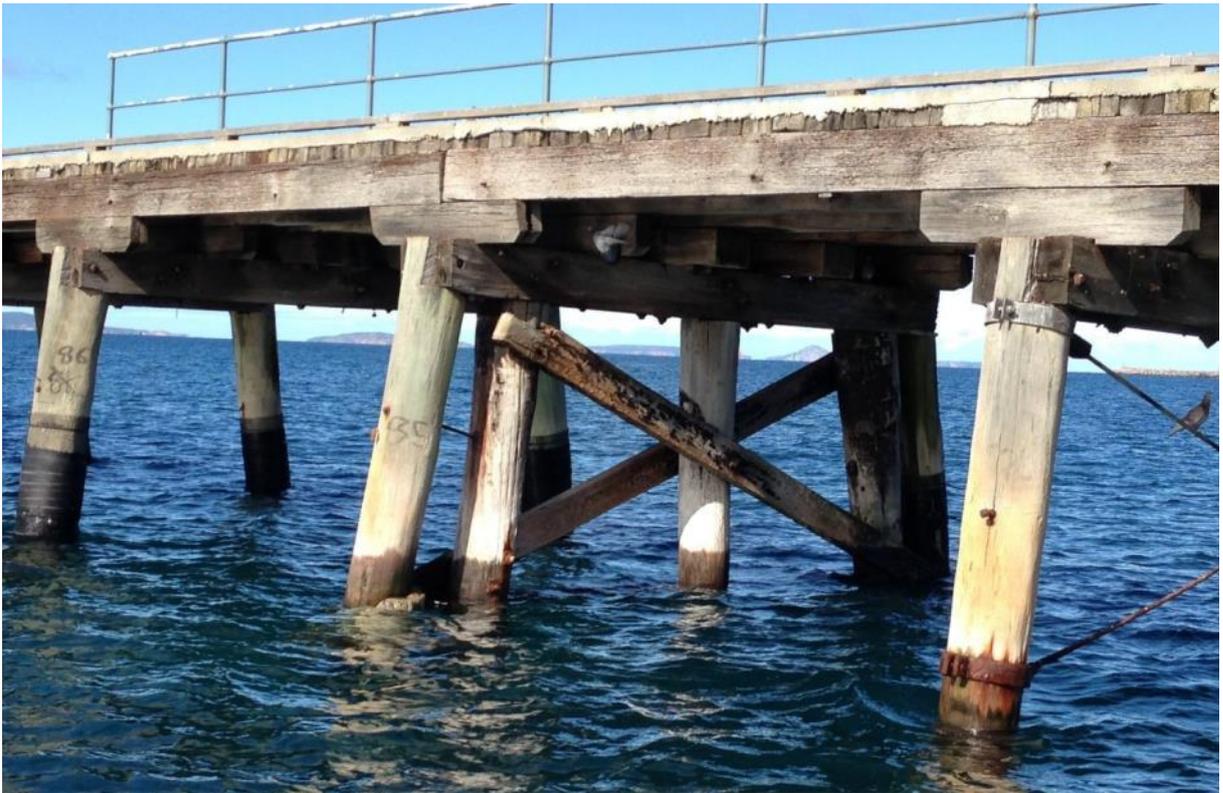
The corbel has split. The remedial should be in order of preference where possible;

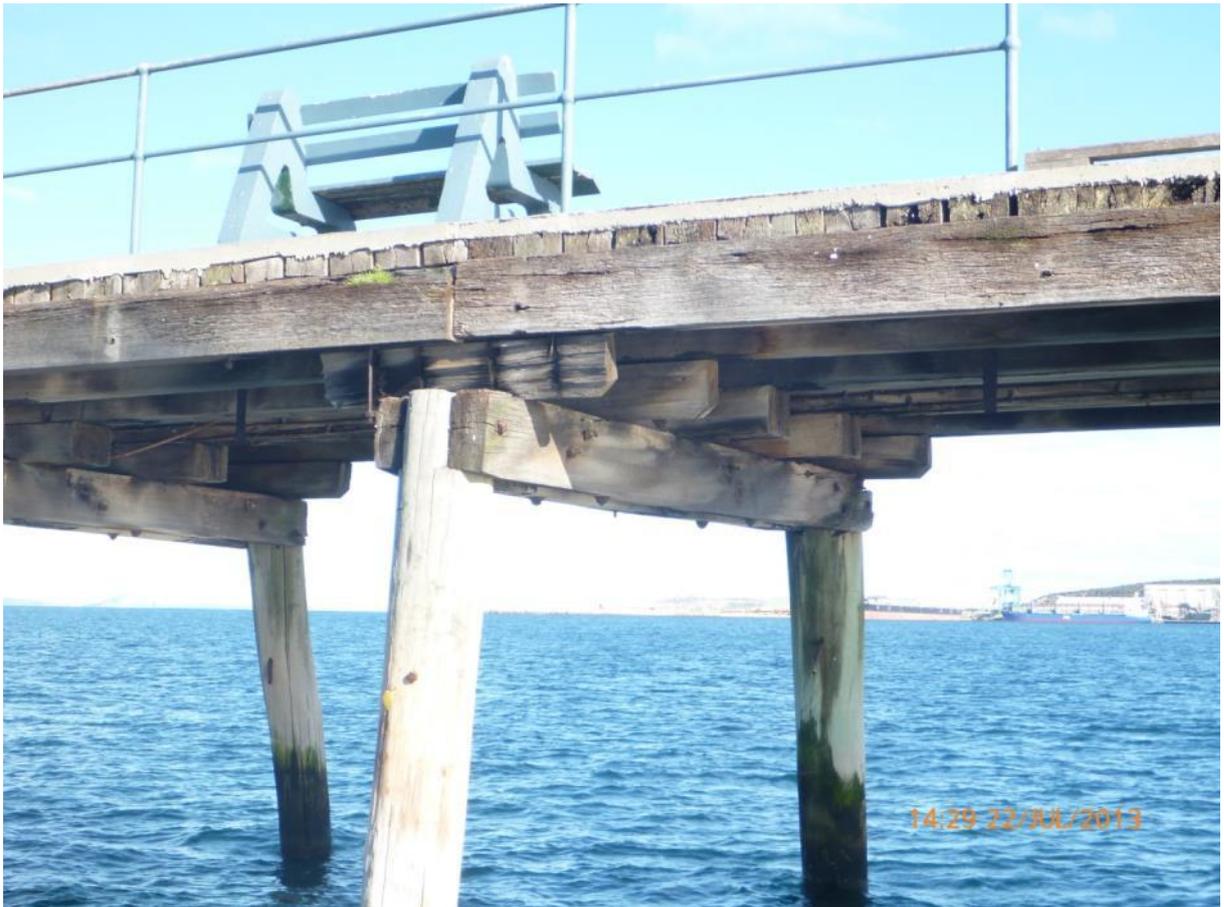
The corbel has split with loss of half of section. The remedial should be in order of preference where possible;

- Replace corbel.

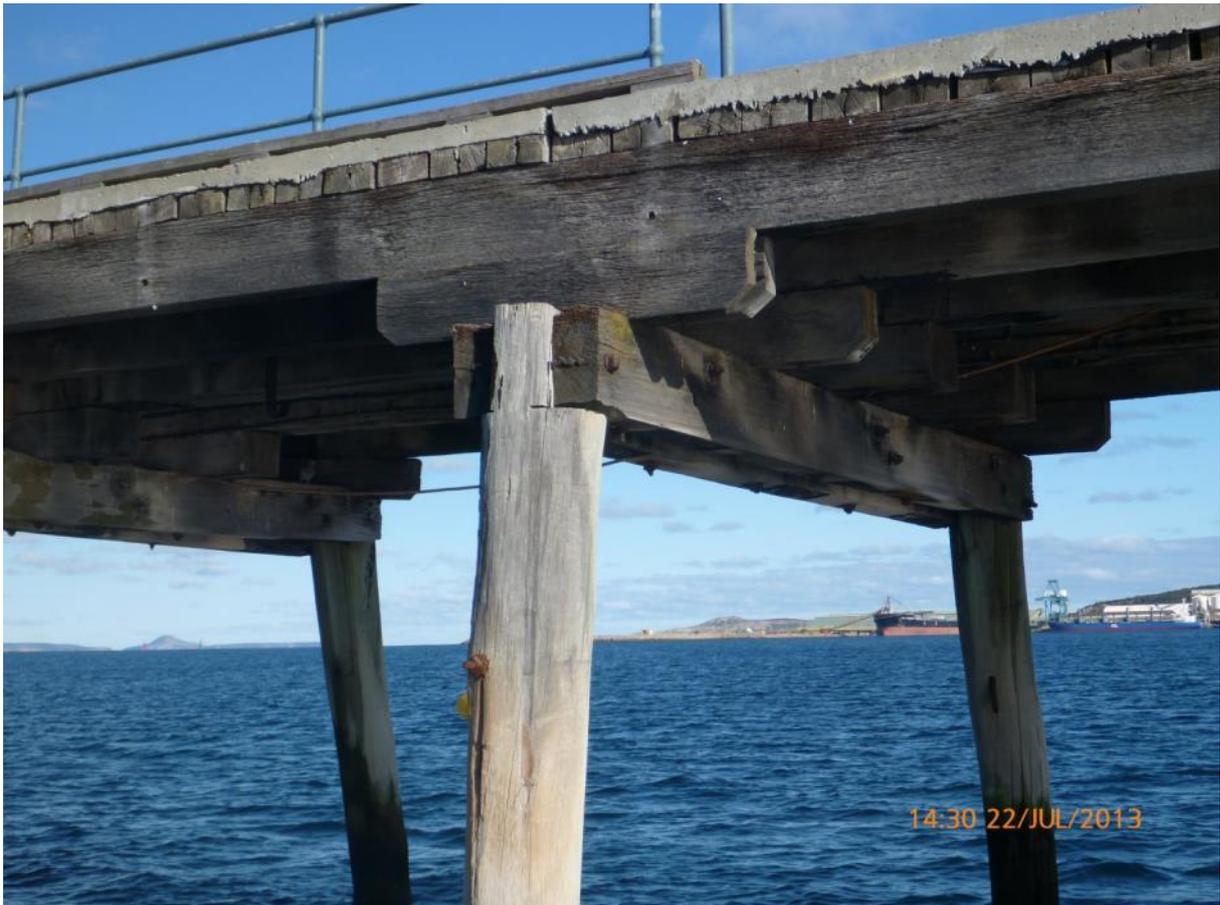
The corbel has split. The remedial should be in order of preference where possible;

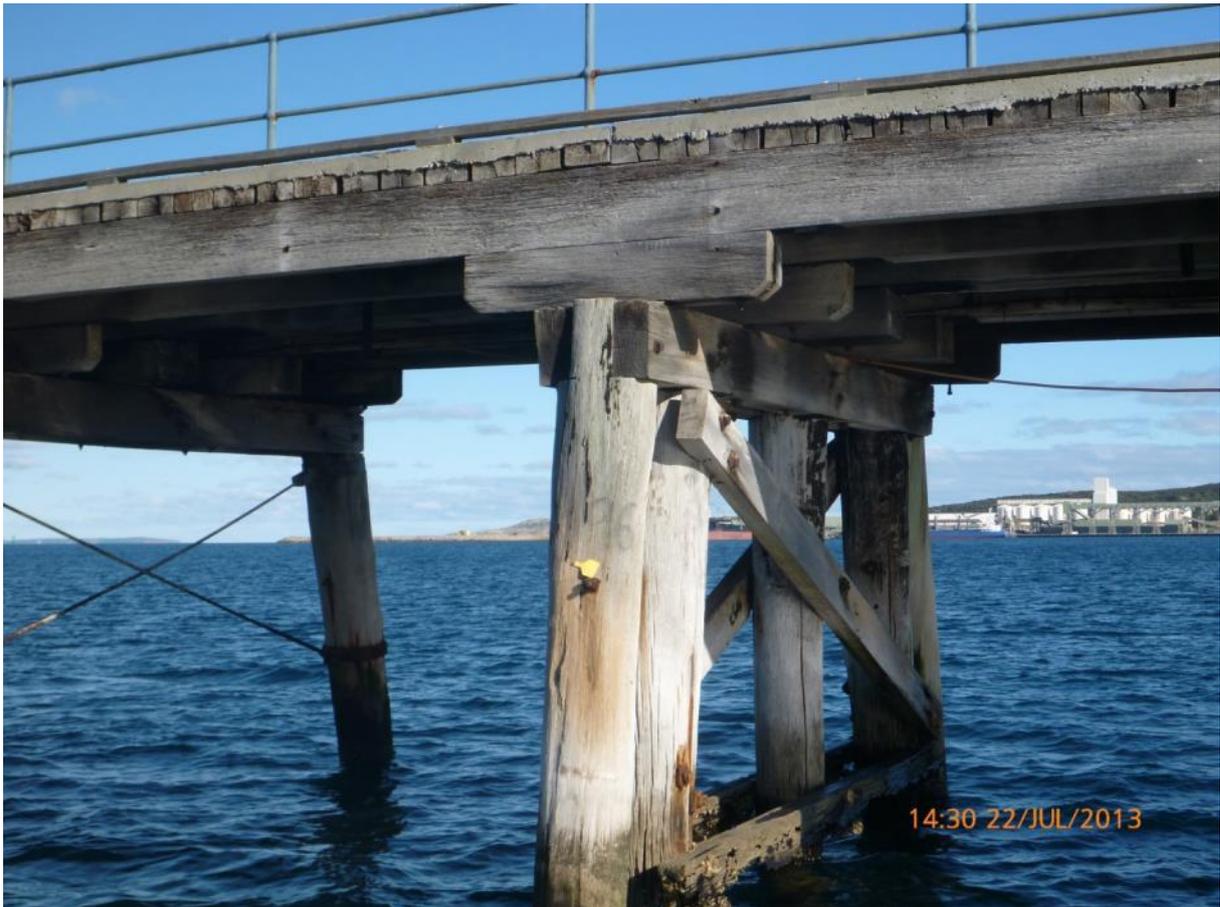
The corbel has split. The remedial should be in order of preference where possible;

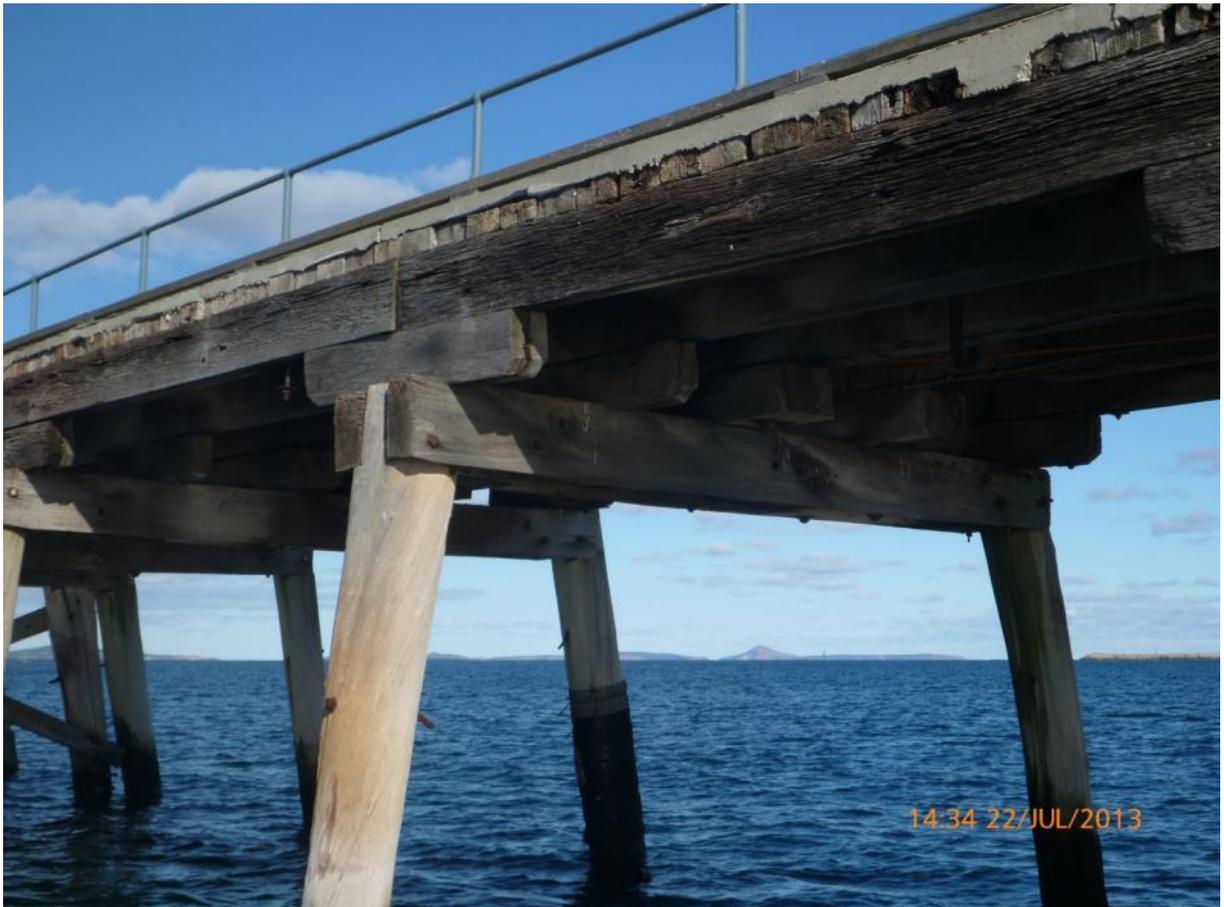
The corbel has split. The remedial should be in order of preference where possible;

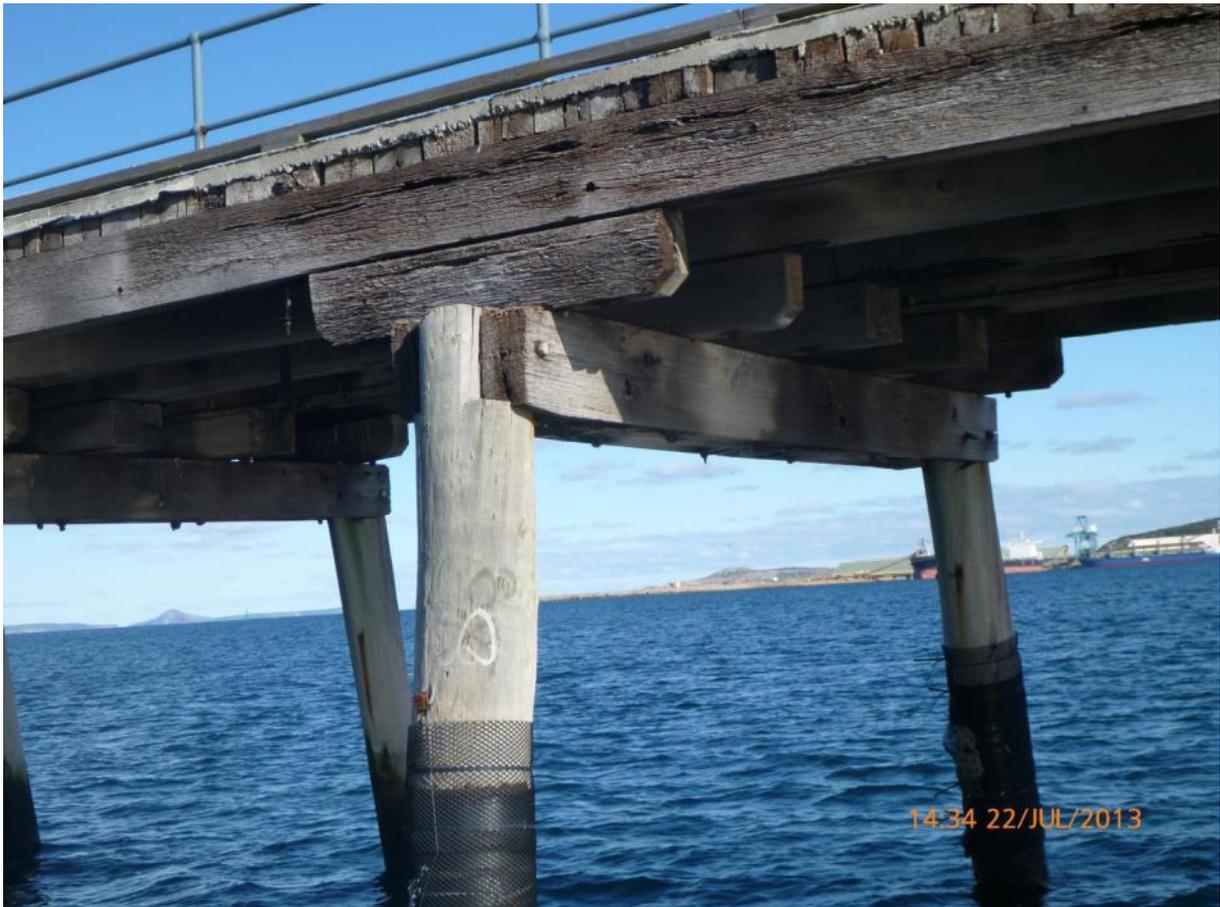
The corbel has split. The remedial should be in order of preference where possible;

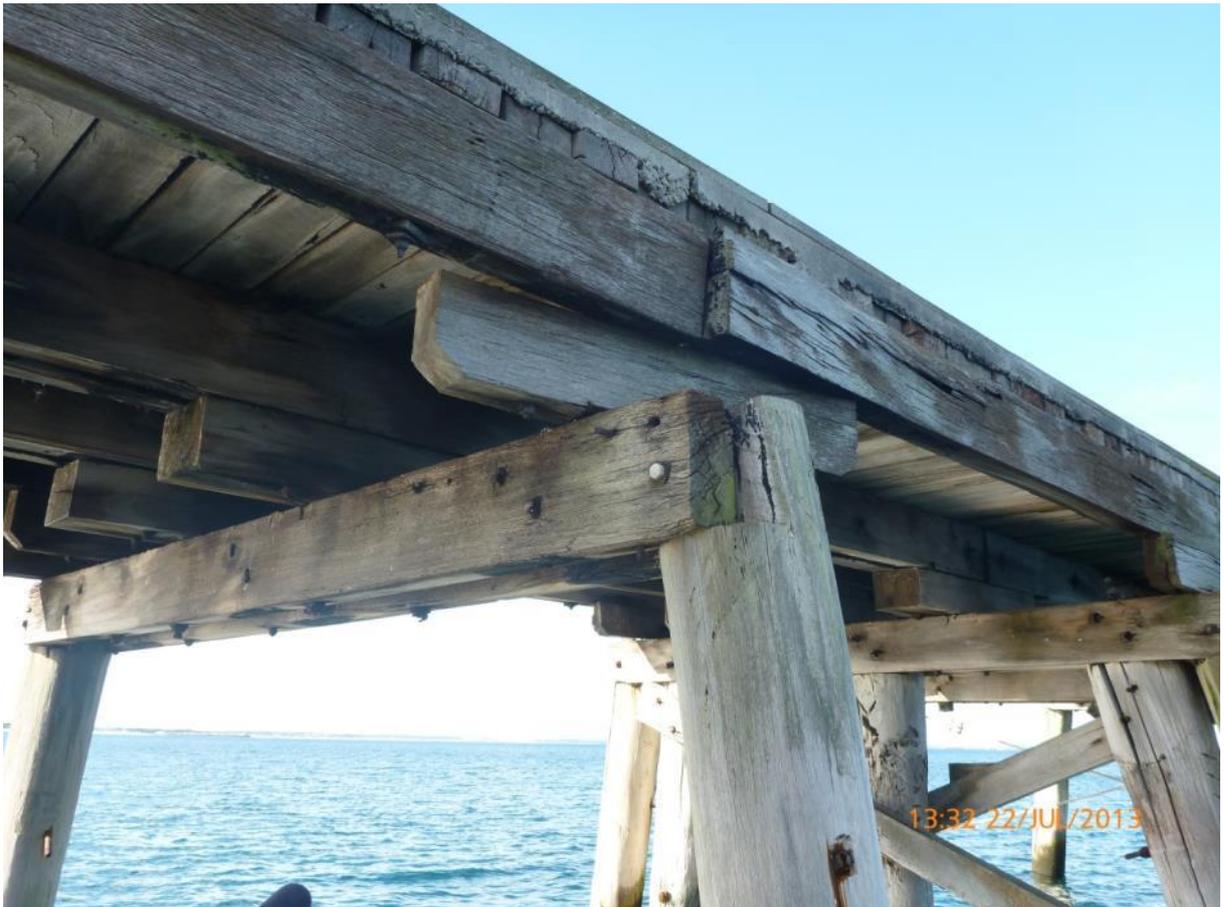
Corbel has rotated on plan. . The remedial should be in order of preference where possible;
