ESPERANCE TANKER JETTY CONDITION

Jetty Condition Assessment Update

Reference: R-224.07-1

Date: September 2013

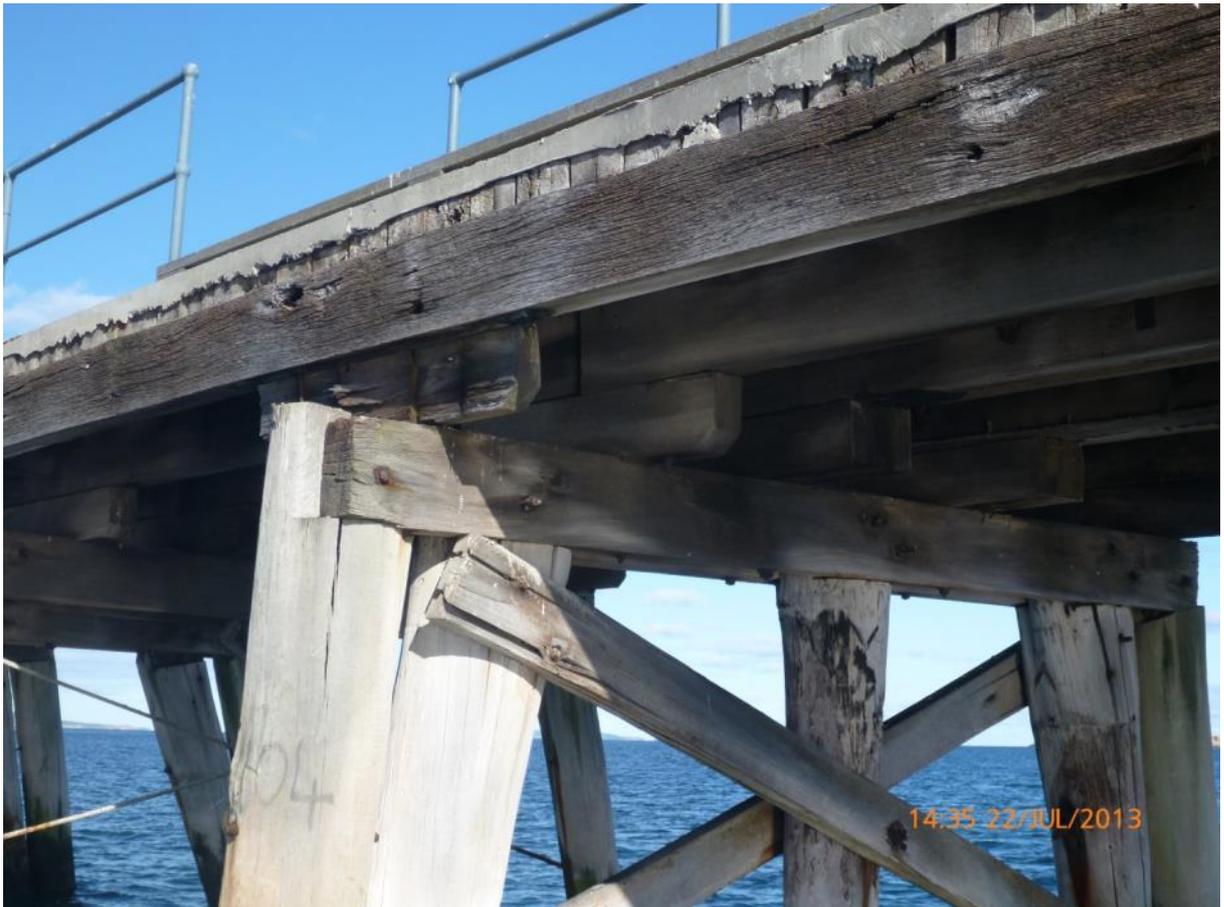
The corbel has split with loss of half of section. The remedial should be in order of preference where possible;

- Replace corbel.

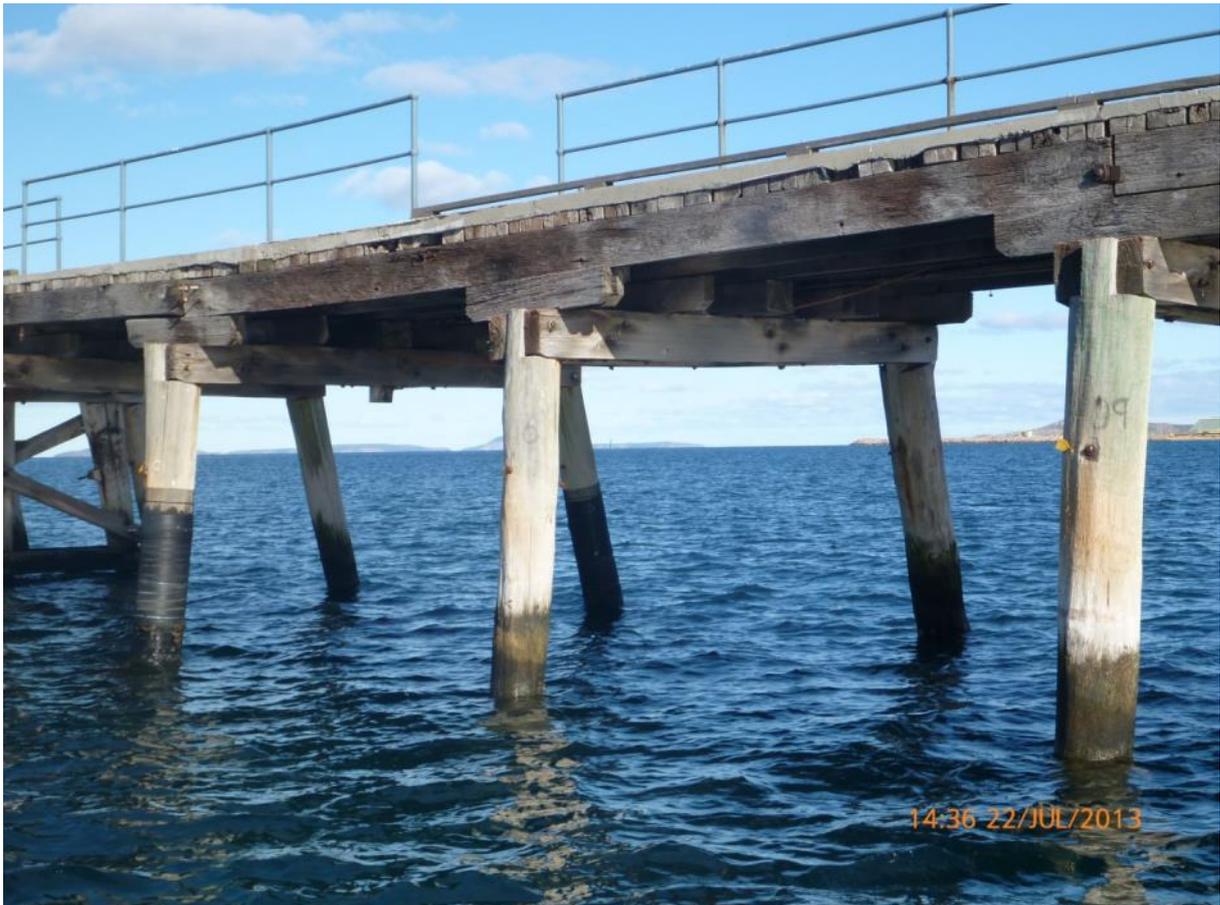
The corbels have split. The remedial to the corbels should be in order of preference where possible;

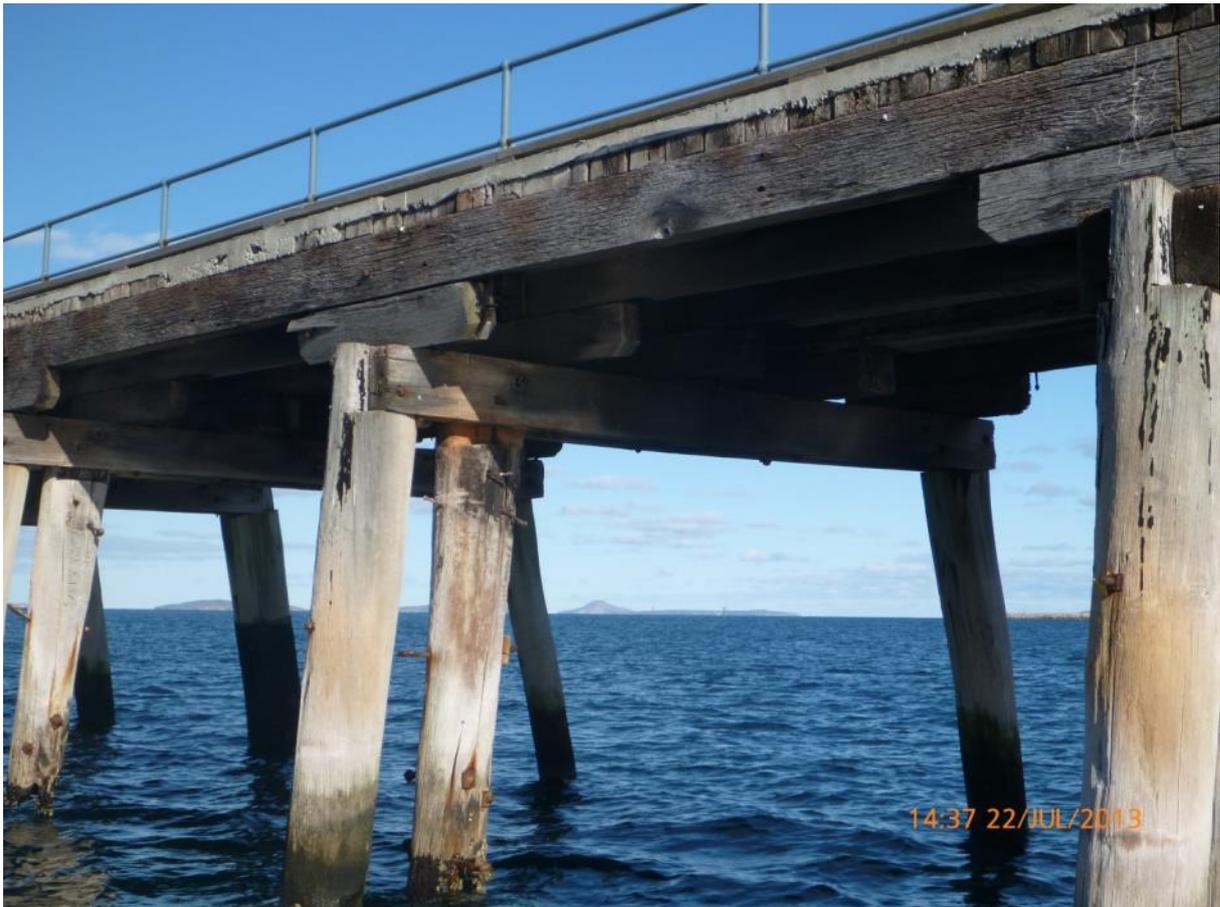
The corbel has split and rotated about the longitudinal axis. The remedial should be in order of preference where possible;

- Replace corbel
- Bolt corbel together at each end.

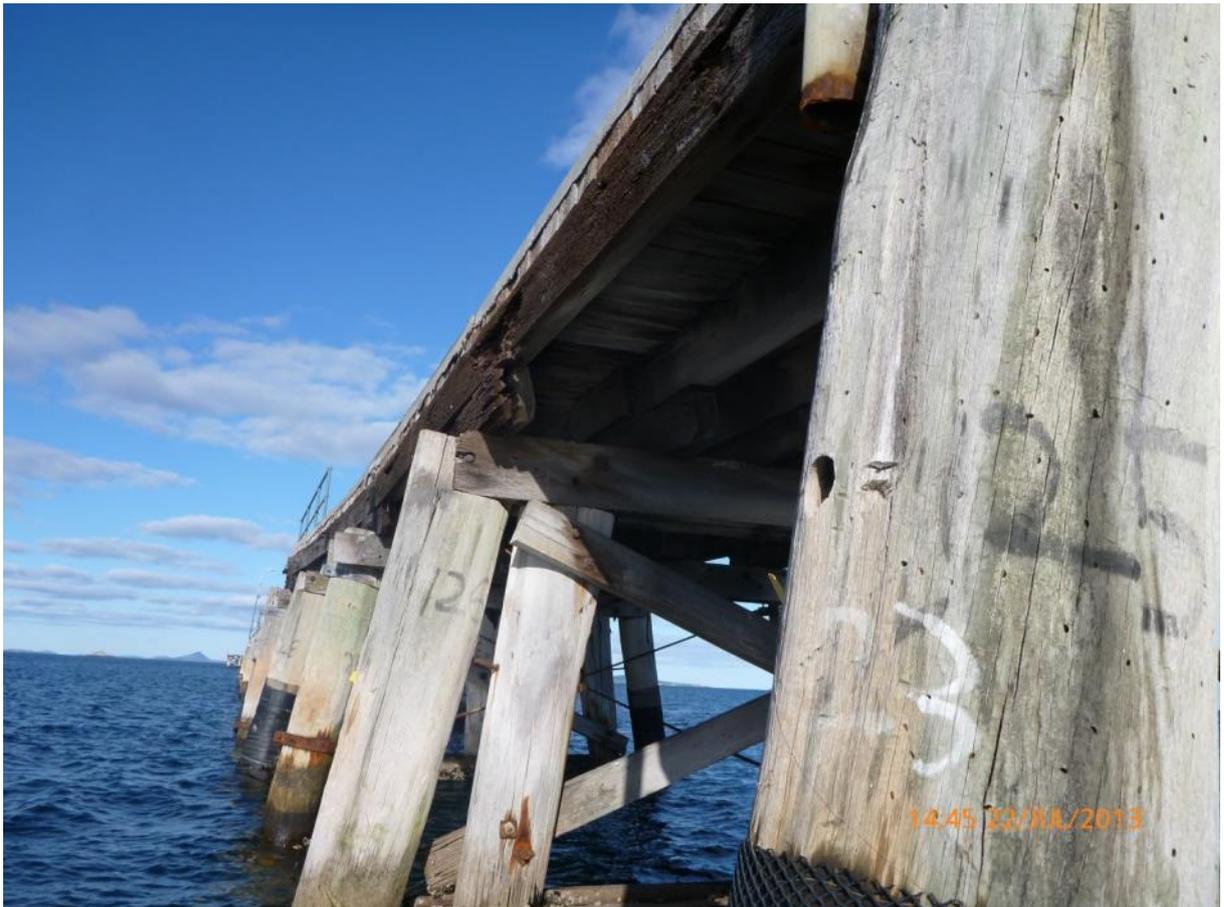
The corbel has split, has rotted and rotated about the longitudinal axis. The remedial should be in order of preference where possible;

- Replace corbel.

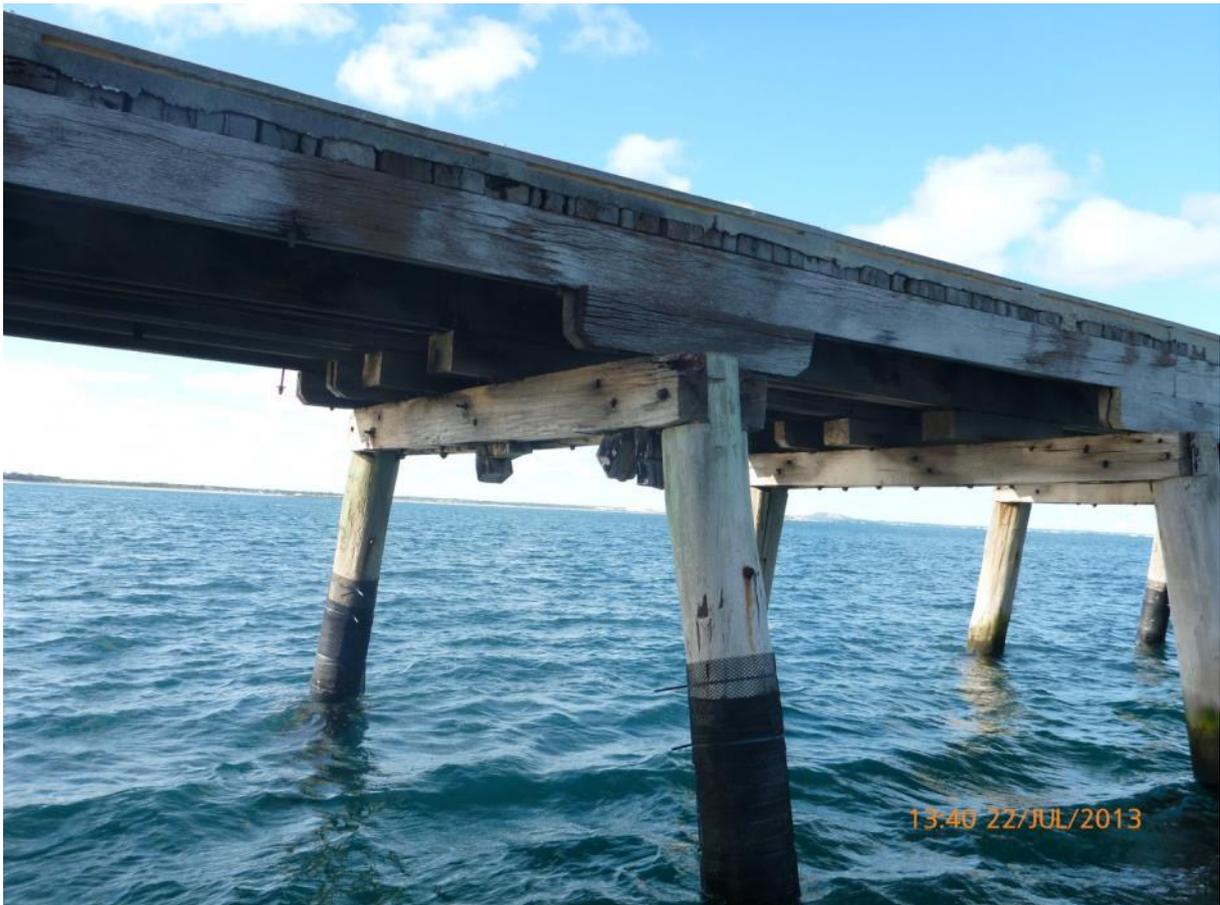
The corbel has split. The remedial should be in order of preference where possible;

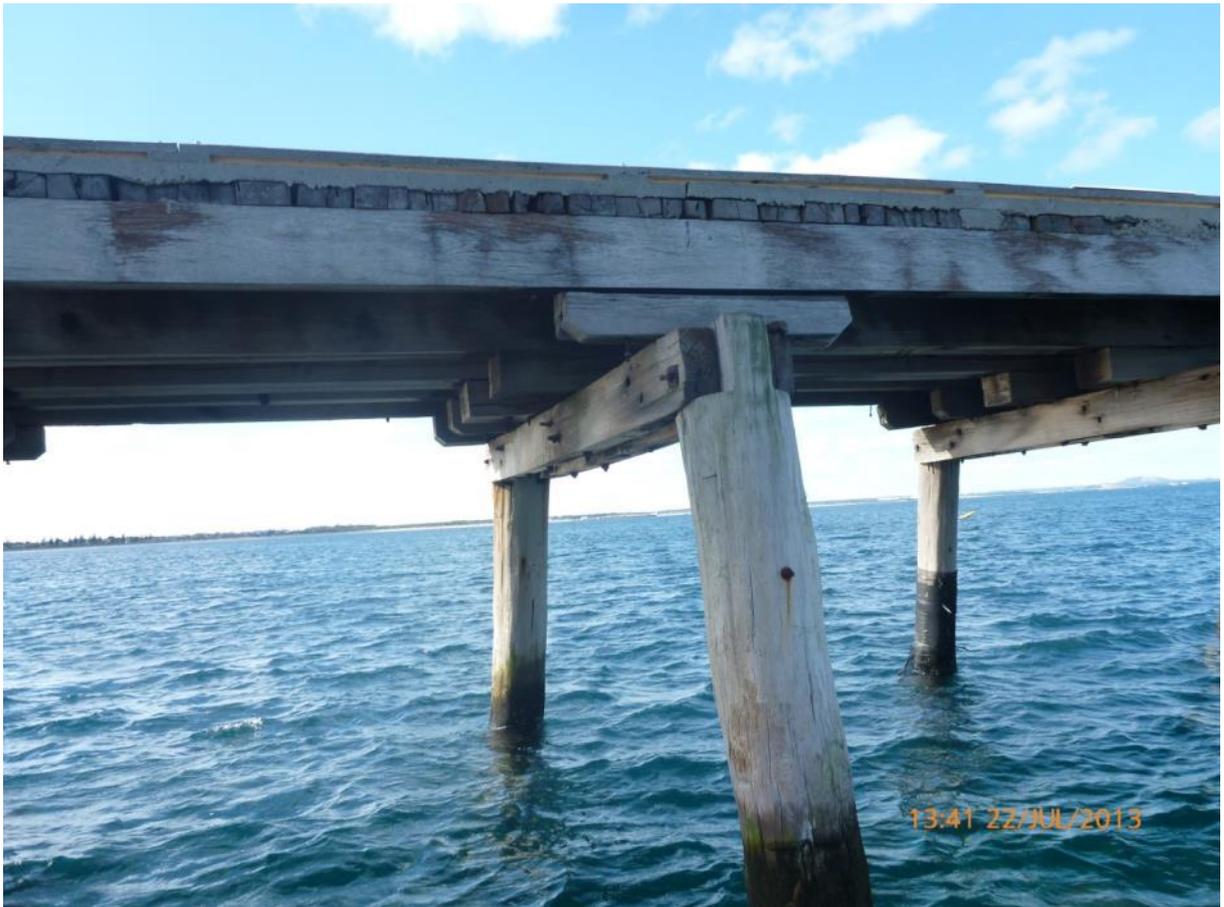
The corbel has split. The remedial should be in order of preference where possible;

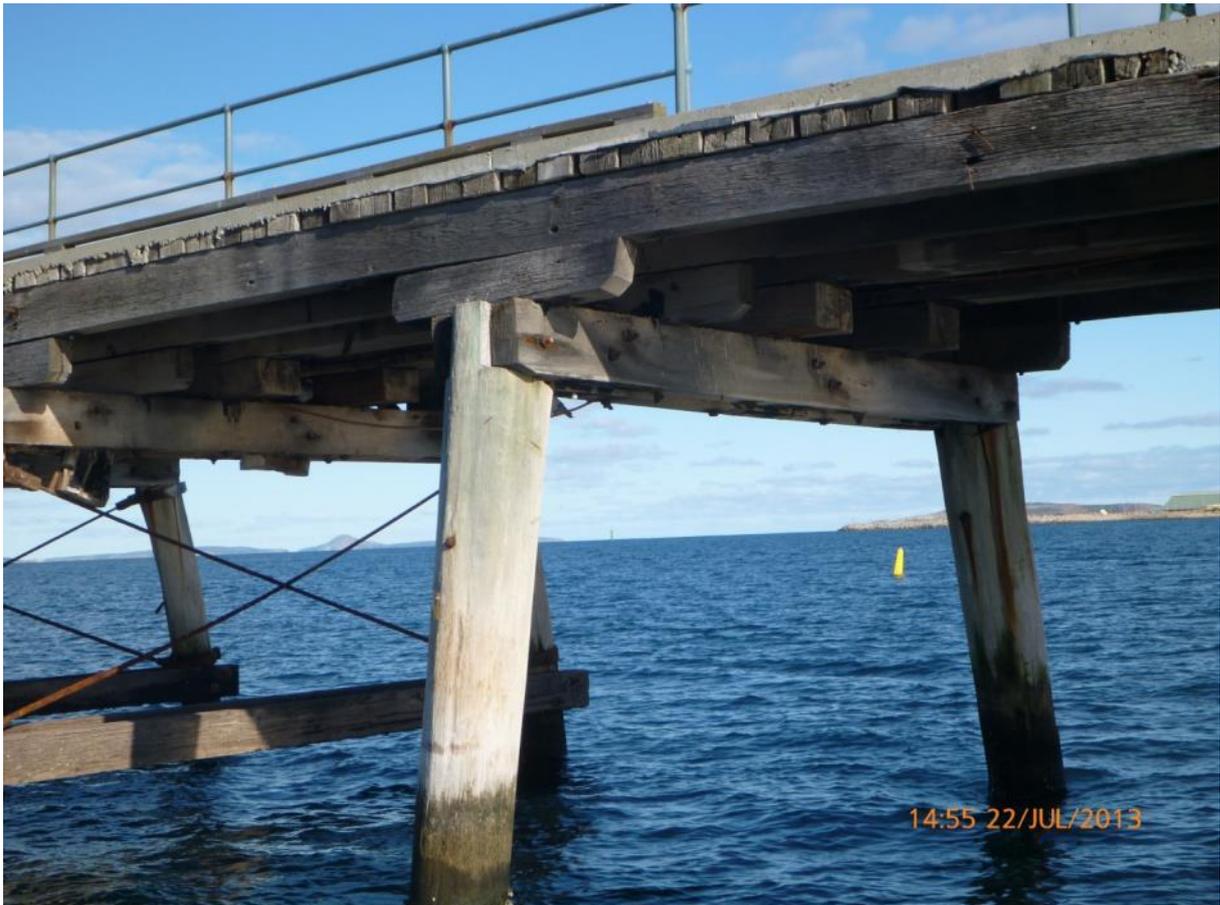
The corbel has rotated. The remedial should be in order of preference where possible;

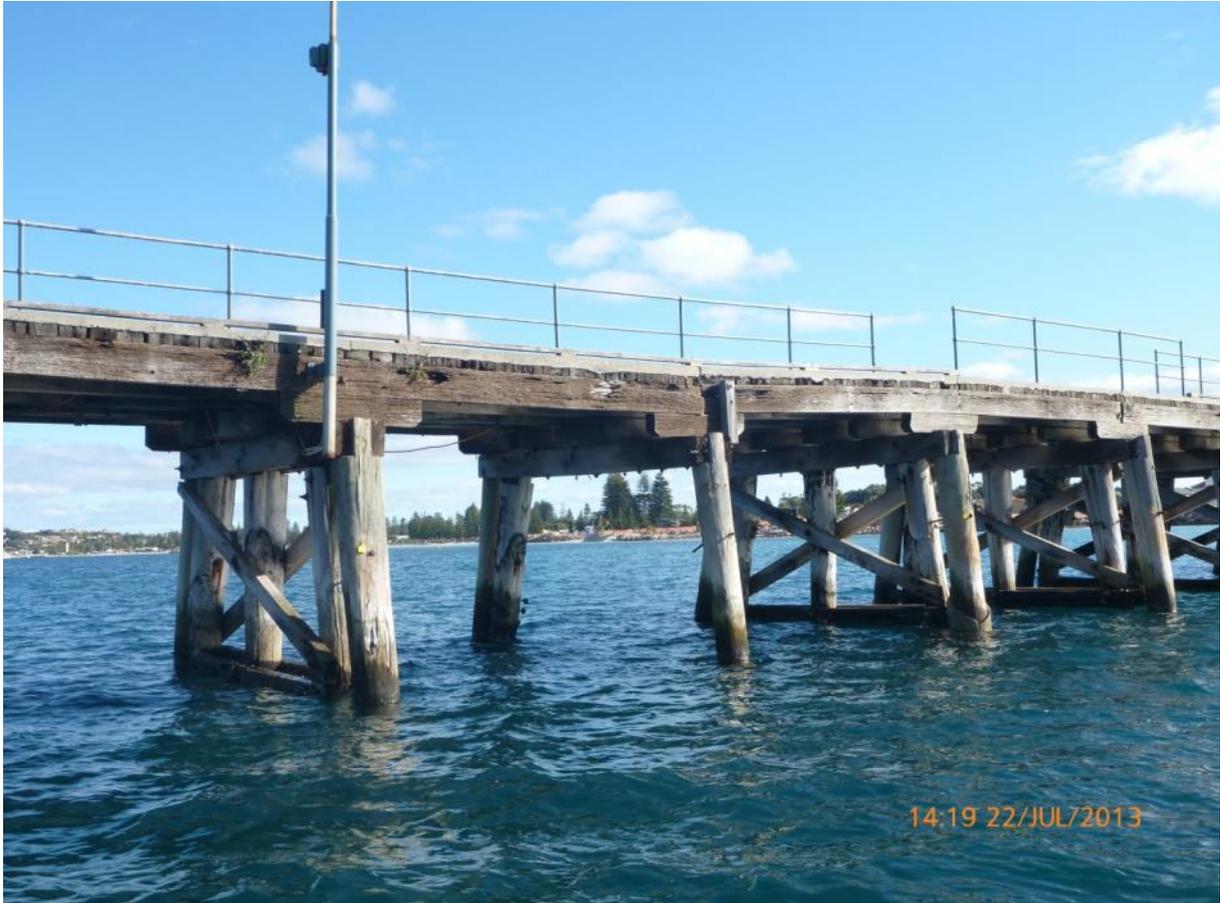
Stringer has weathered and deteriorated beyond repair. The remedial should be in order of preference where possible;

- Replace stringer.
- Reinforce stringer with new member on inside.

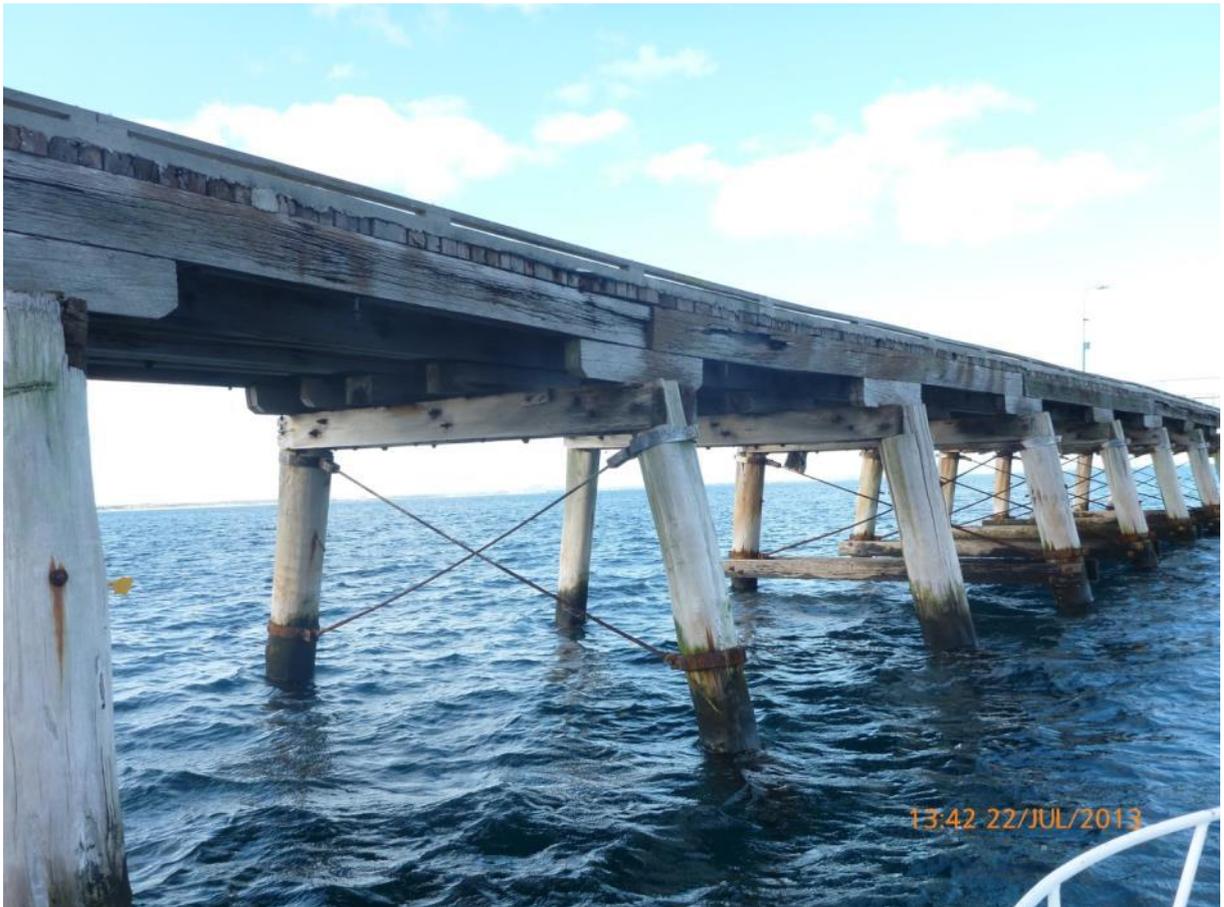
Stringer has weathered and deteriorated beyond repair. The remedial should be in order of preference where possible;

- Replace stringer.
- Reinforce stringer with new member on inside.

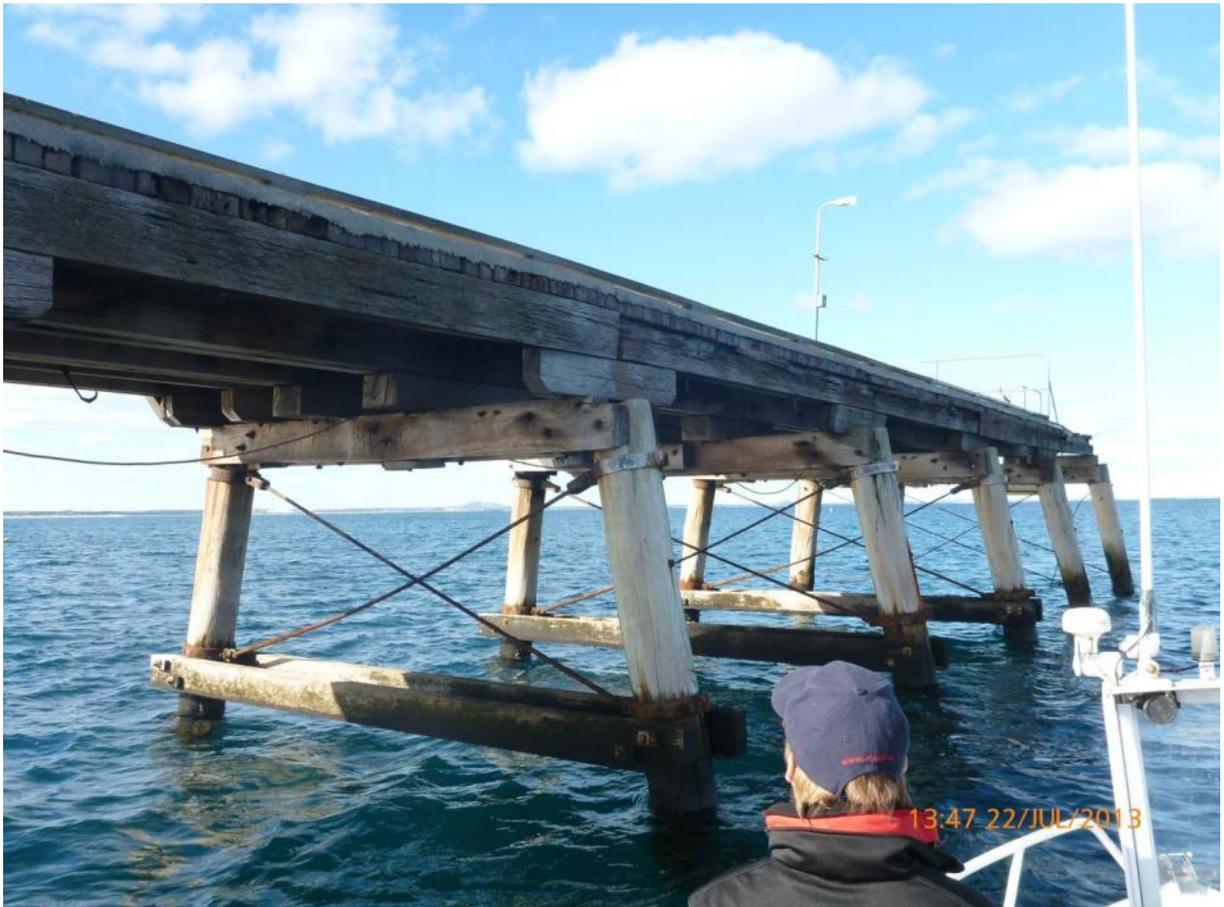
Stringer has weathered and deteriorated beyond repair. The remedial should be in order of preference where possible;

- Replace stringer.
- Reinforce stringer with new member on inside.

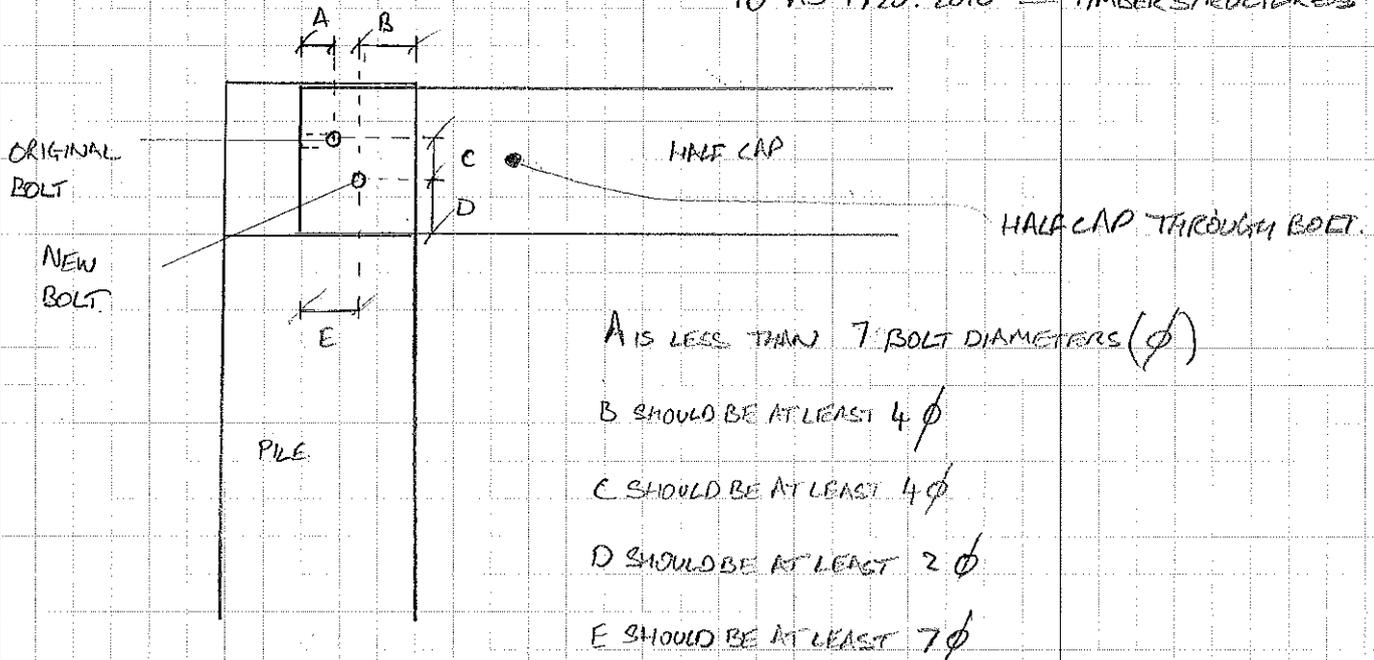
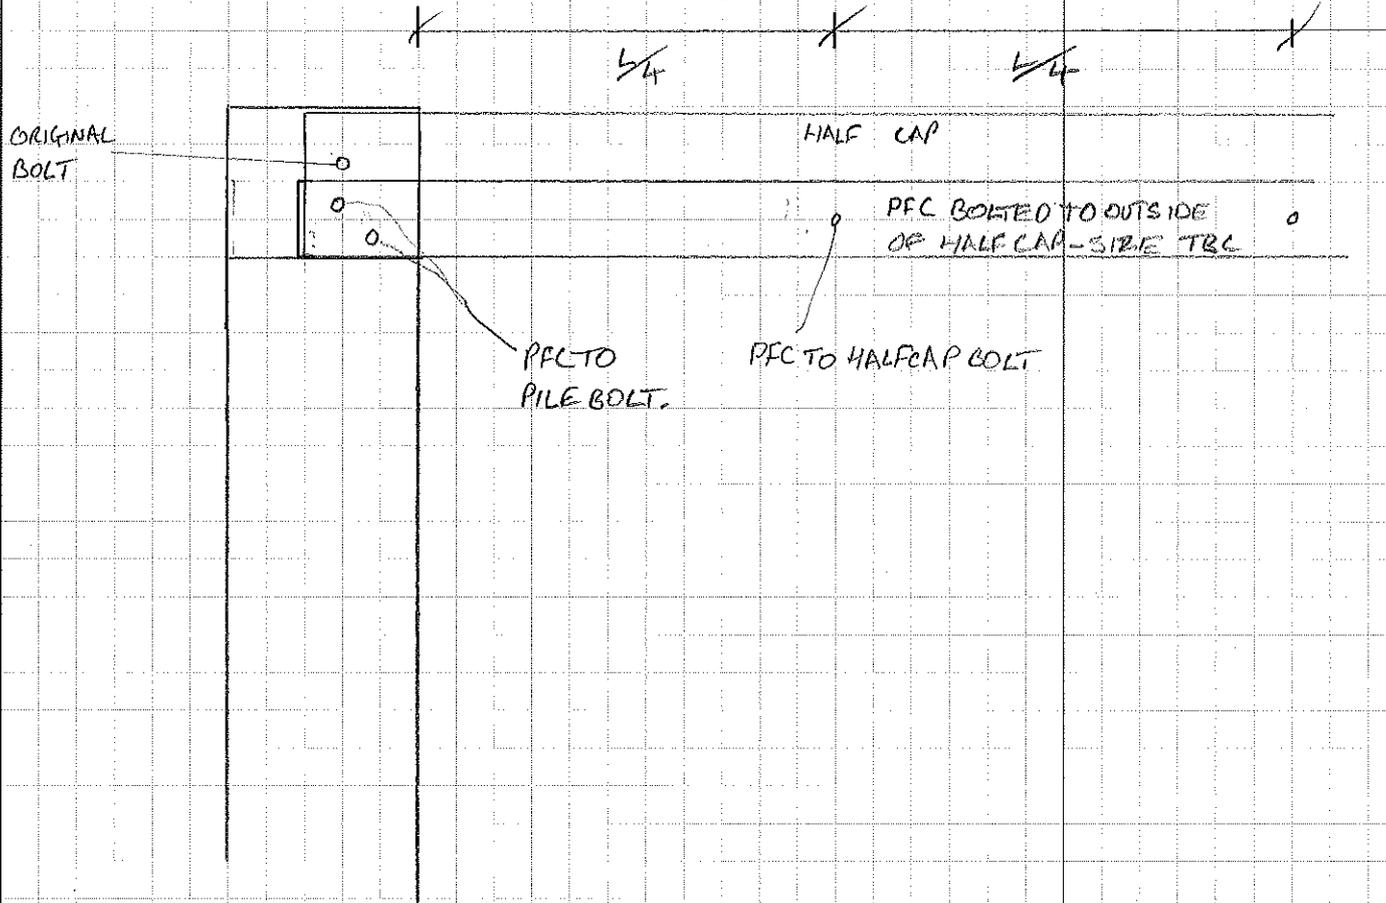
HALF CAP REPAIR - PFC SPLICE

The weakness of the pile to half cap connection is a result of the 1991 refurbishment replacing the outer piles. Using this method to insert piles outward of the original piles and using the original half caps meant that there was a short bearing length and only sufficient room for a single 20mm diameter bolt to be fitted with insufficient (to be in accordance with AS 1720 Timber Structures) end distance. The insufficient end distance in combination with deterioration of the timber due to weathering has caused the shear failures (Example is Fig 3-24) when storm conditions have caused lateral pile movement.

There is no easy fix for this situation as the lack of length of the half caps prevents good end distance on the pile connections. The best repair for this is set out in Drawing 224.06-SK01
