# **ESPERANCE JETTIES CONDITION ASSESSMENTS**

## **Condition Inspection and Maintenance Strategy Report**

Reference: R-J15028-1

Date: December 2015

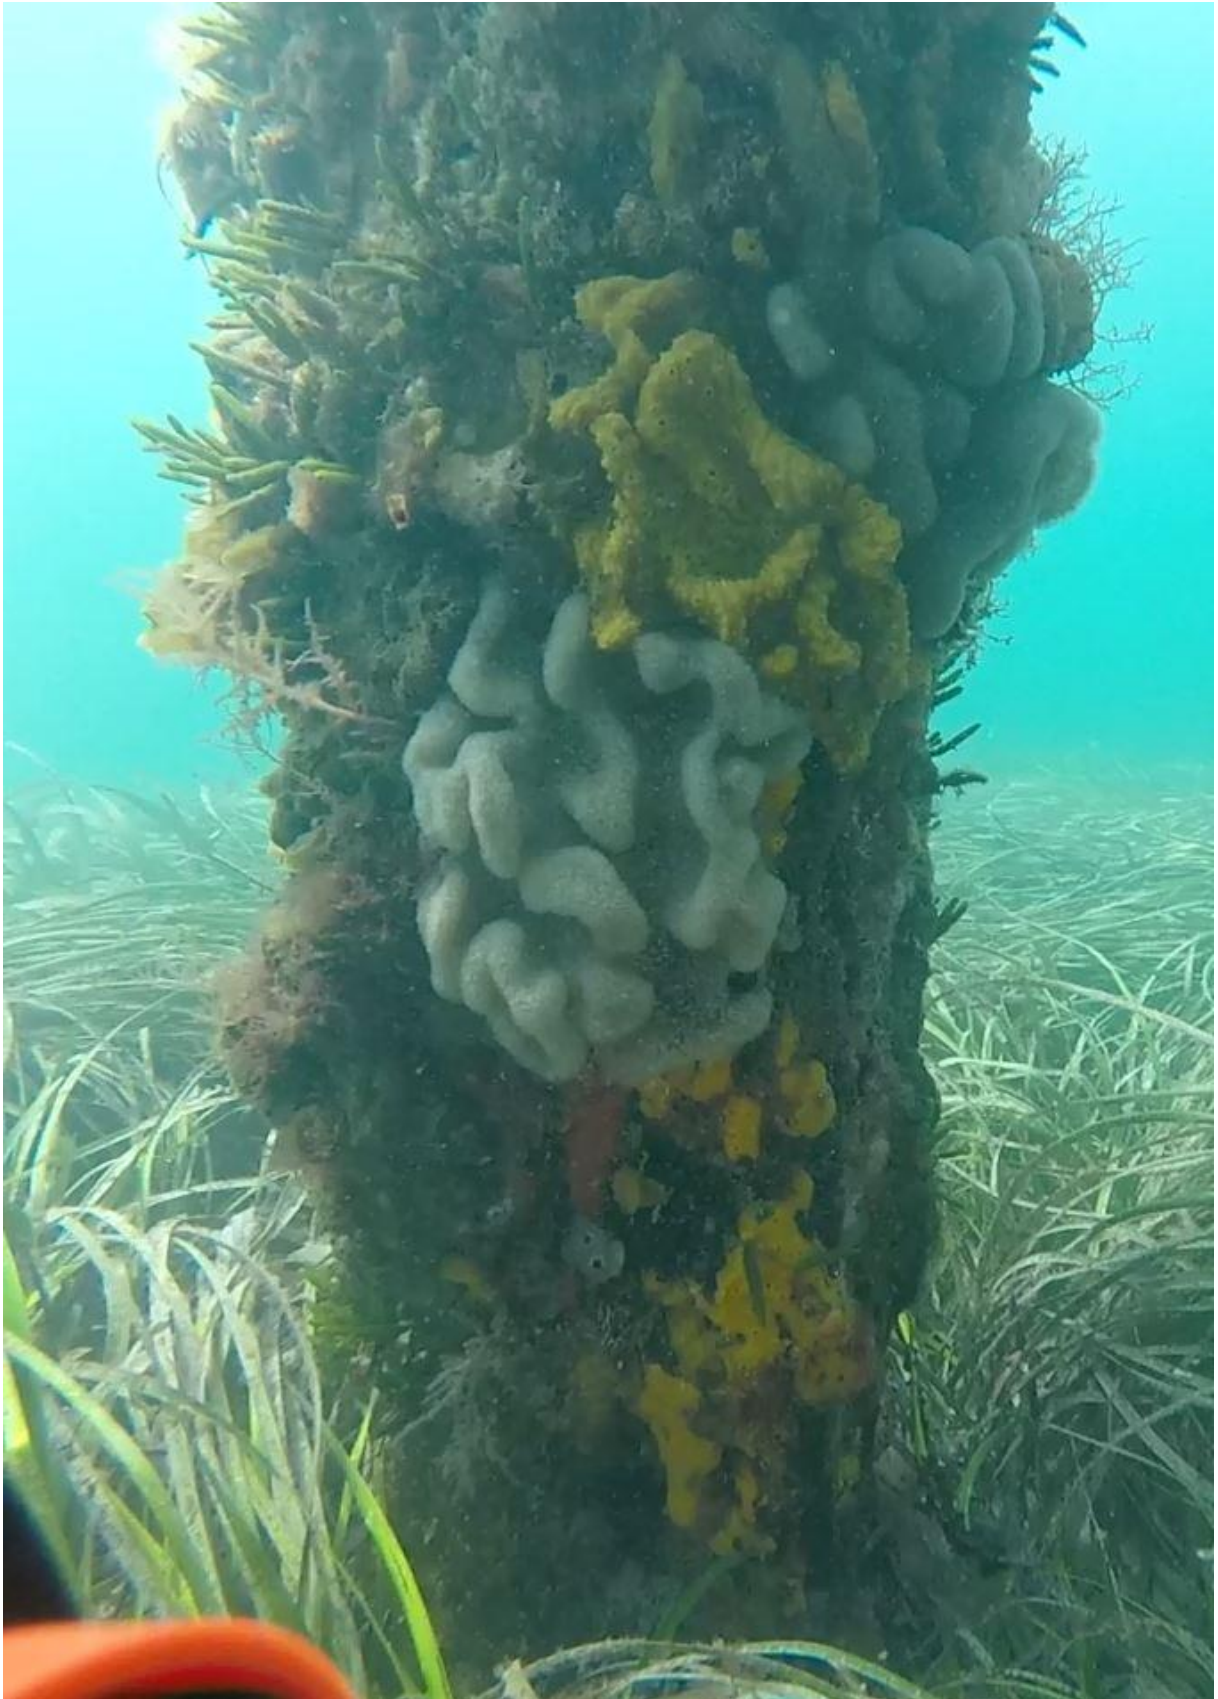
- 54 North – Appears to have failed between surface and sea bed

The most significant defects were; completely failed piles 54 North, 93 North and crushing of both half caps at their northern bearing support adjacent to the bridged section at missing pile 39 North (including 35-38 North, and 40 North).

**Figure 3-1: 54 North 11/11/15 – Severe necking at base (prior to failure identified 17/11/15)**

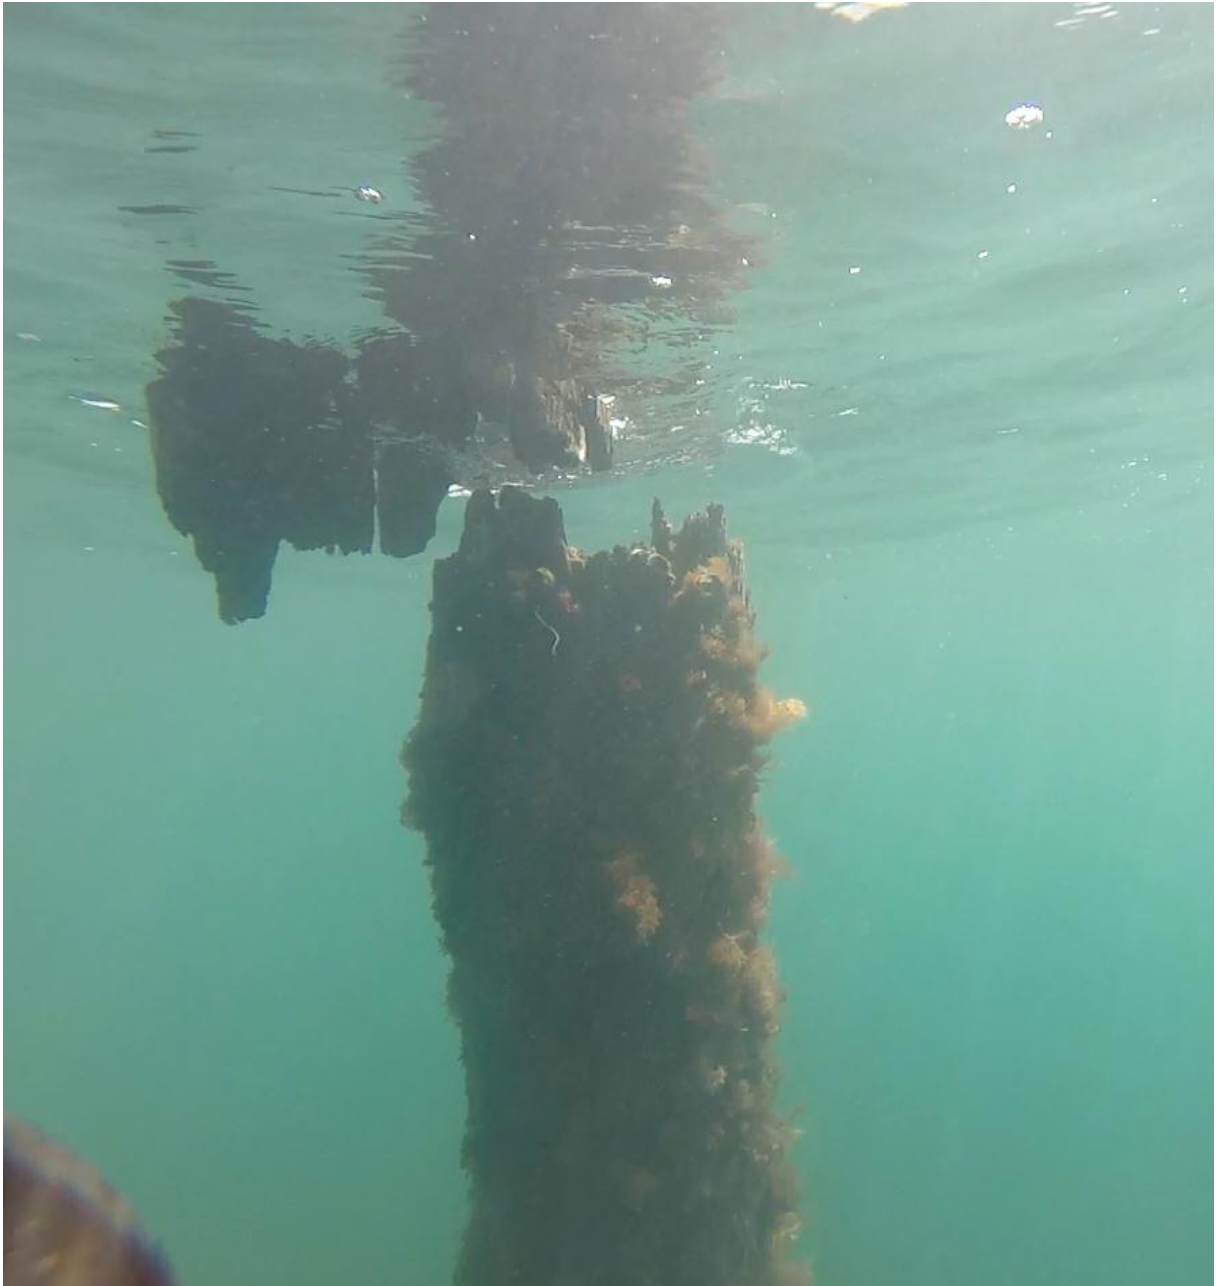
- 93 North - Failed at water surface.

**Figure 3-2: 93 North 11/11/15 – Failure at surface**

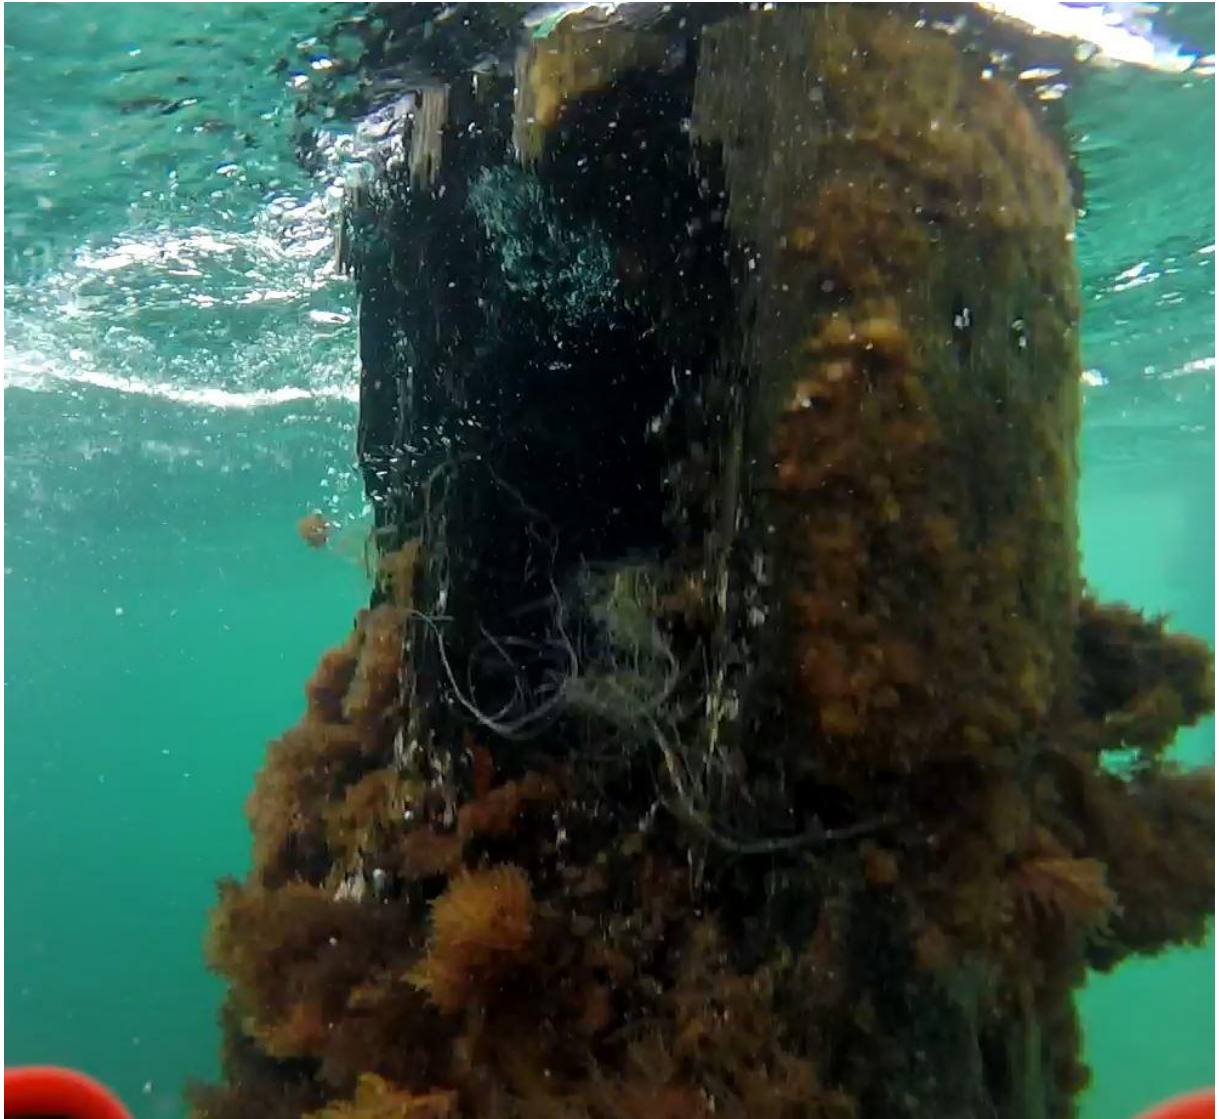
- 53 South

**Figure 3-3: 53 South 11/11/15 – Severe section loss at surface**

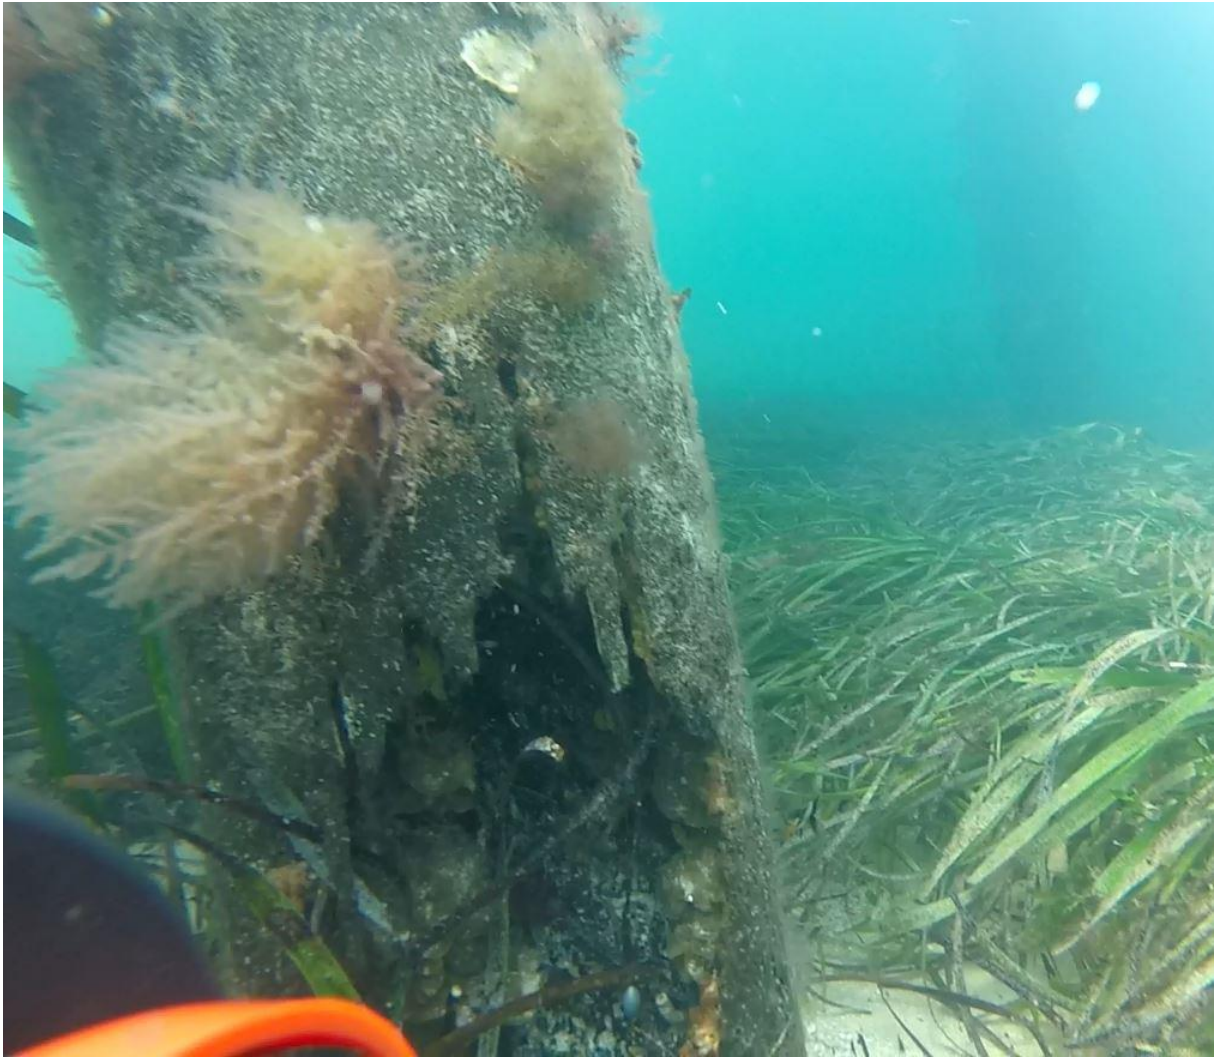
- 58 South

**Figure 3-4: 58 South 11/11/15 – Severe section loss at base**

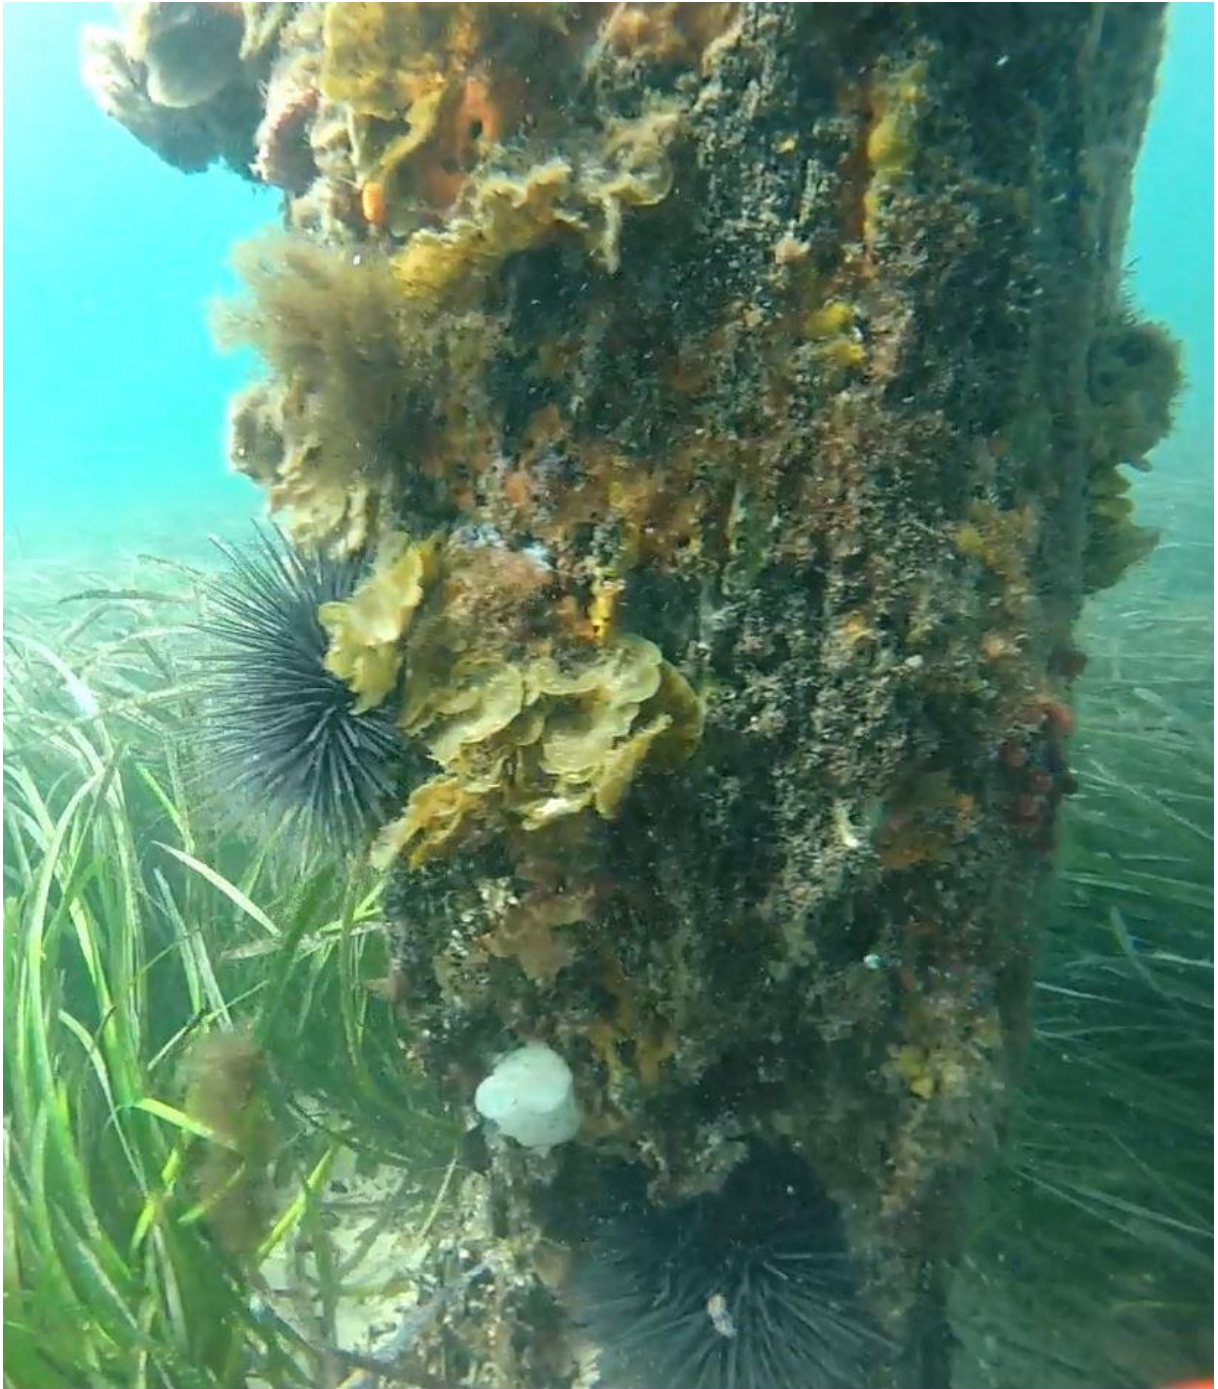
• 66 North

**Figure 3-5: 66 North 11/11/15 – Severe section loss at base**

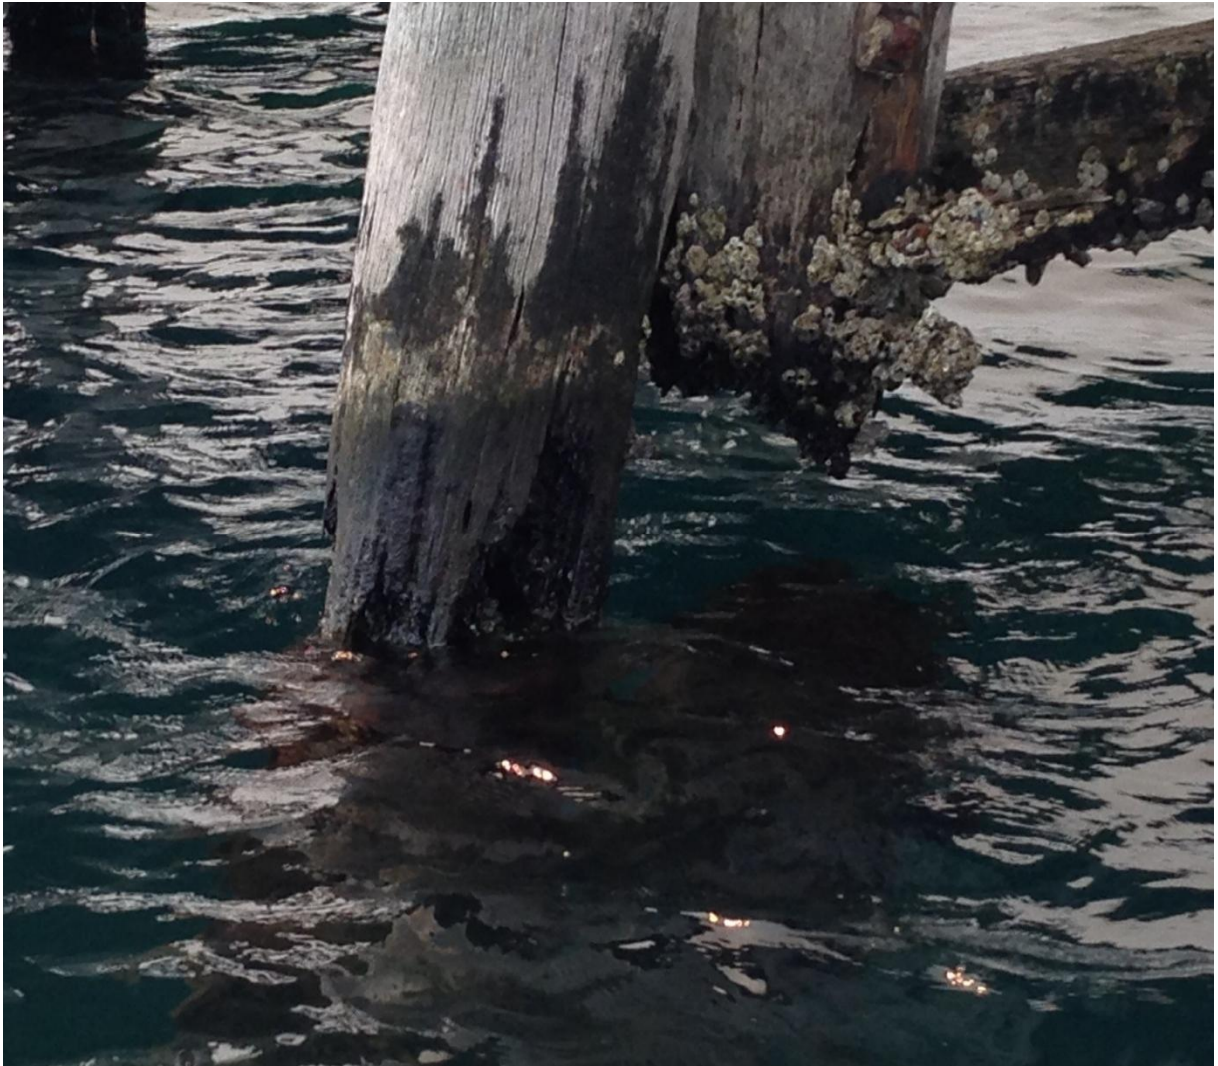
• 70 South

**Figure 3-6: 70 South 17/11/15 – Severe section loss at surface (surface inspected only)**

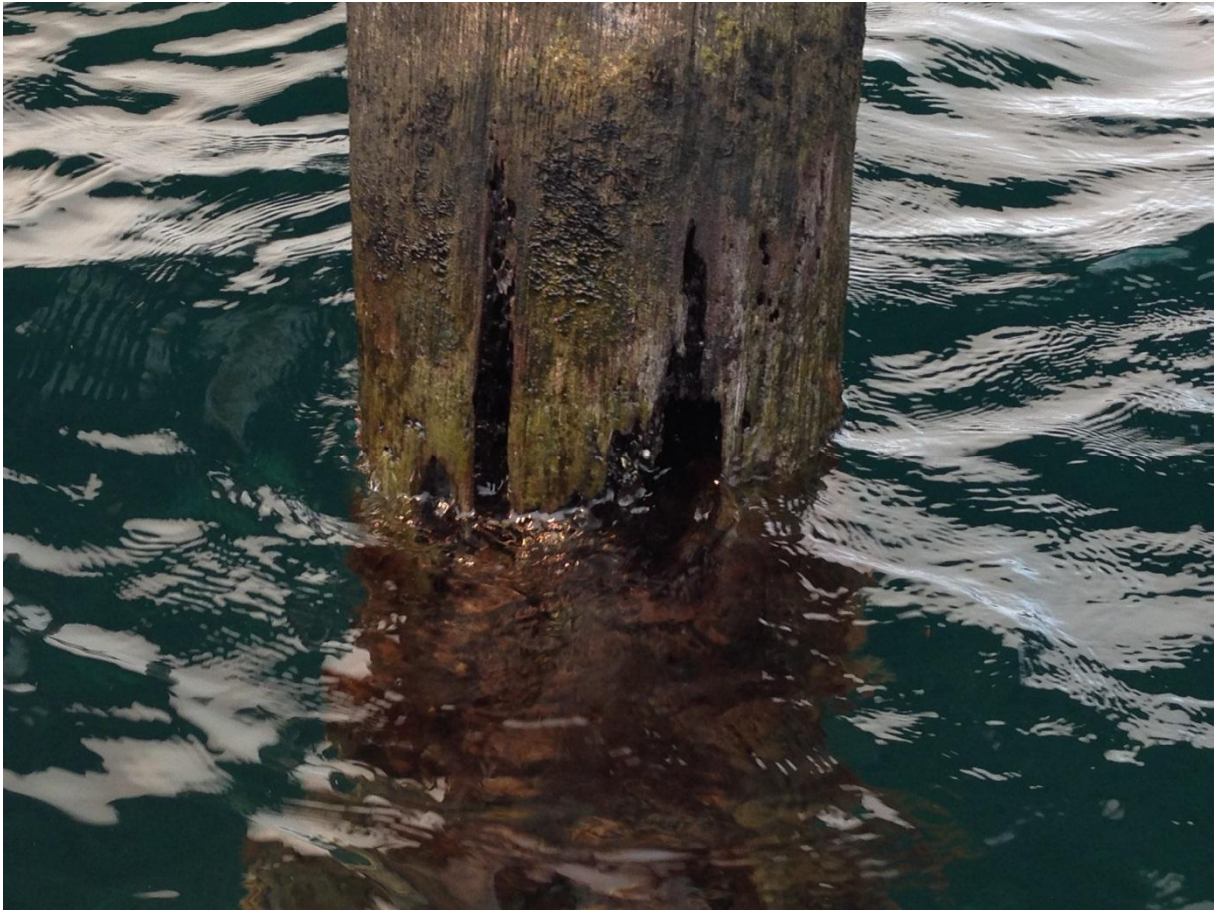
- 71 South.

**Figure 3-7: 71 South 17/11/15 – Severe section loss at surface (surface inspected only)**

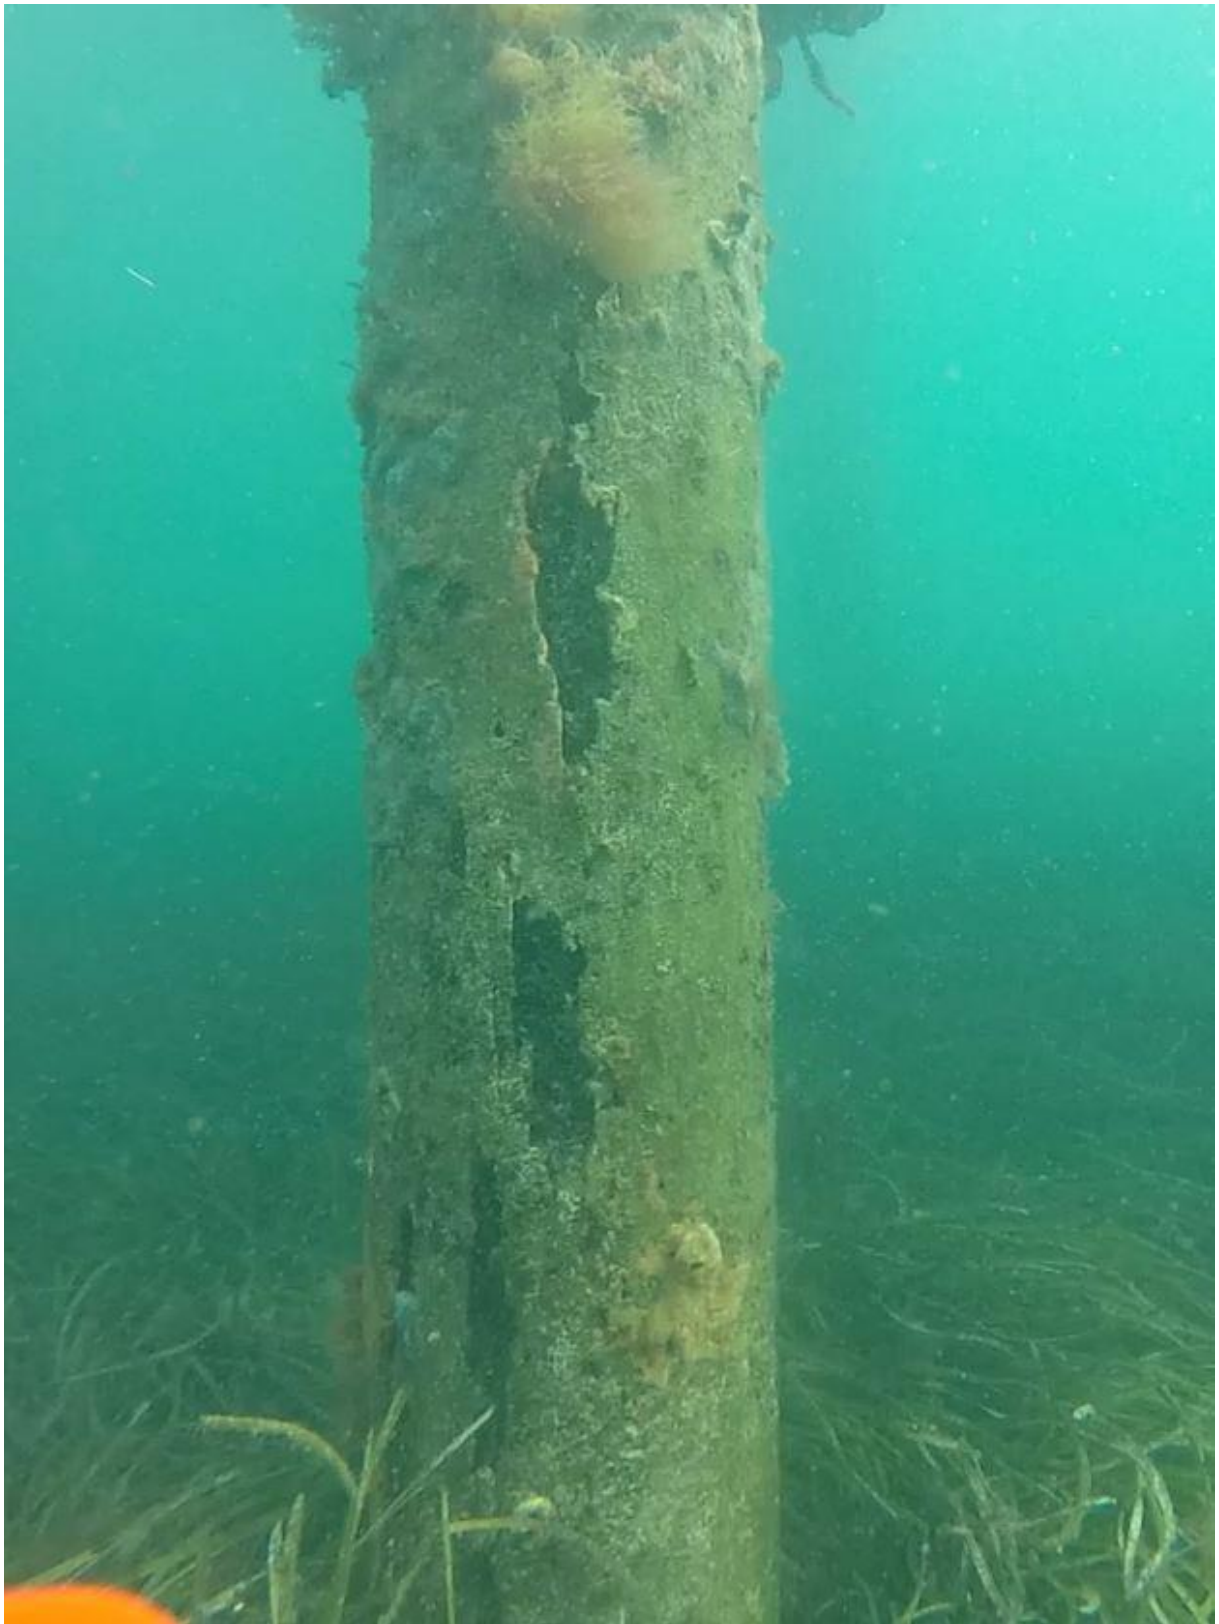
• 74 North

**Figure 3-8: 74 North 11/11/15 – Section loss and splitting at many locations through water column**

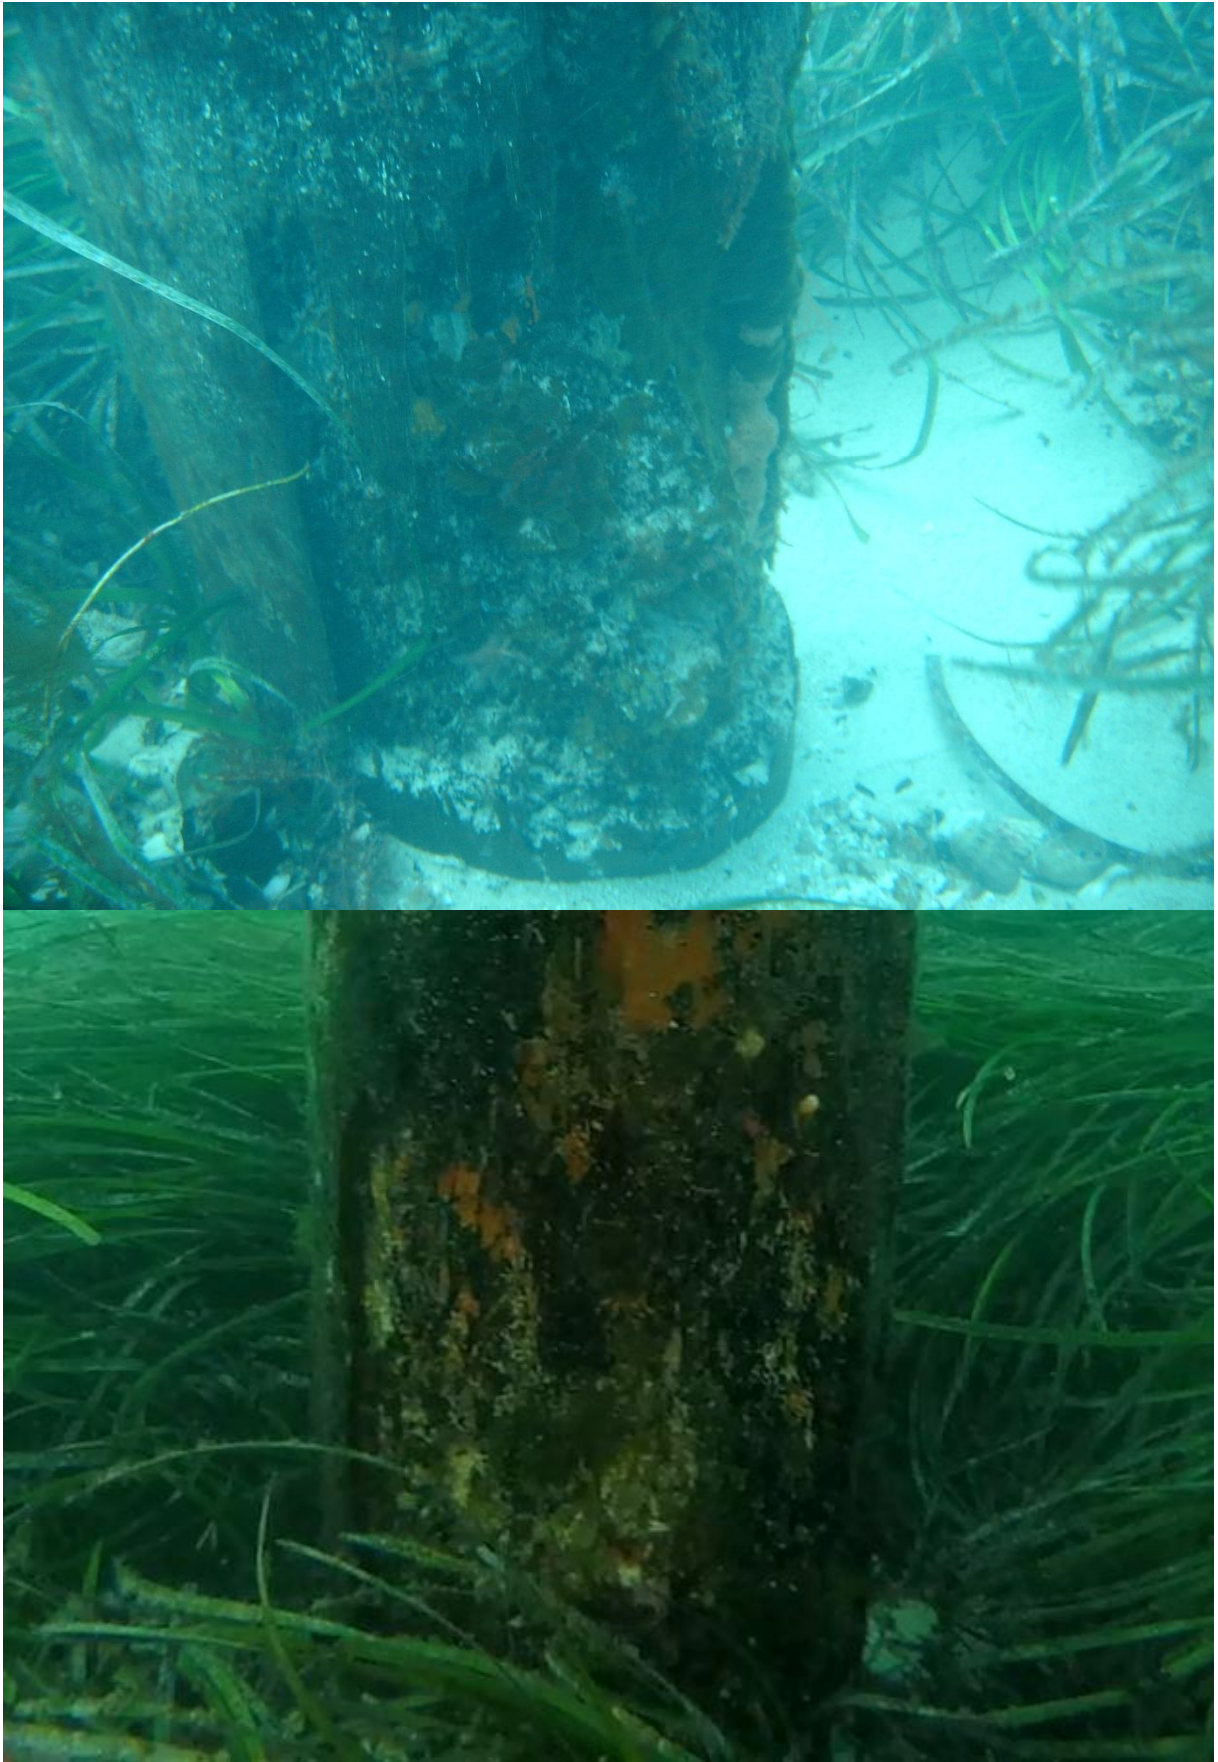
• 91 North

**Figure 3-9: 91 North (Top-3/8/13, Bottom-11/11/15) – Severe section loss at base**

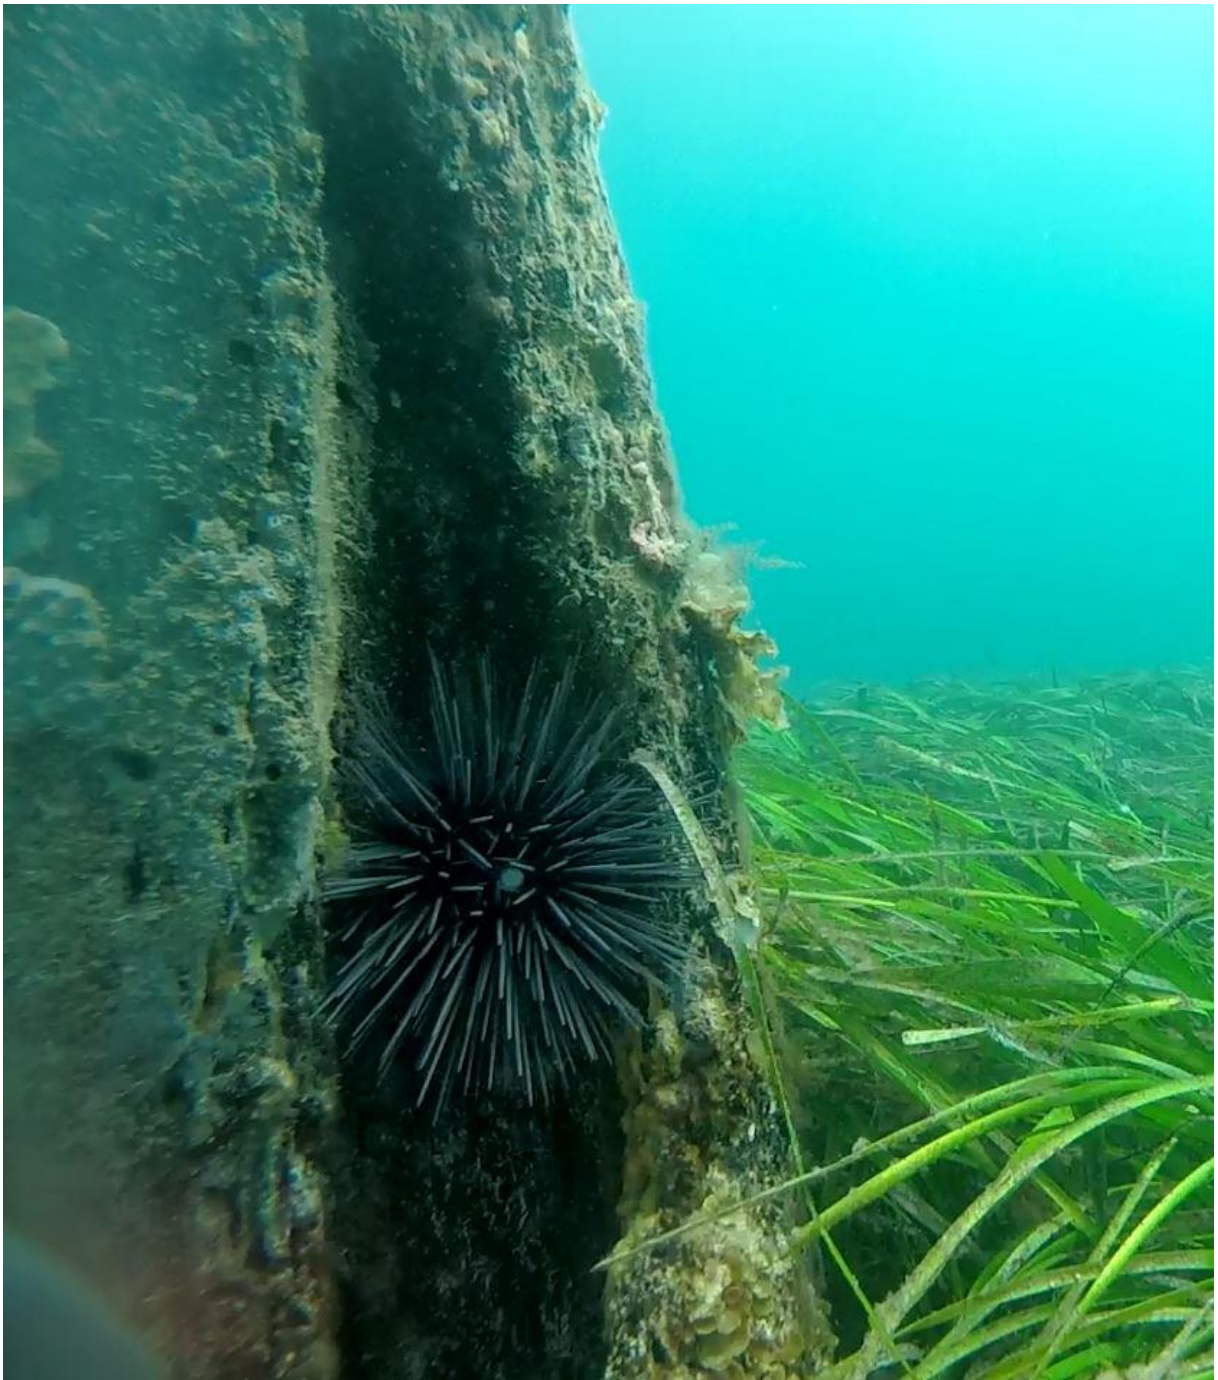
• 101 North

**Figure 3-10: 101 North 11/11/15 – Severe section loss at base**

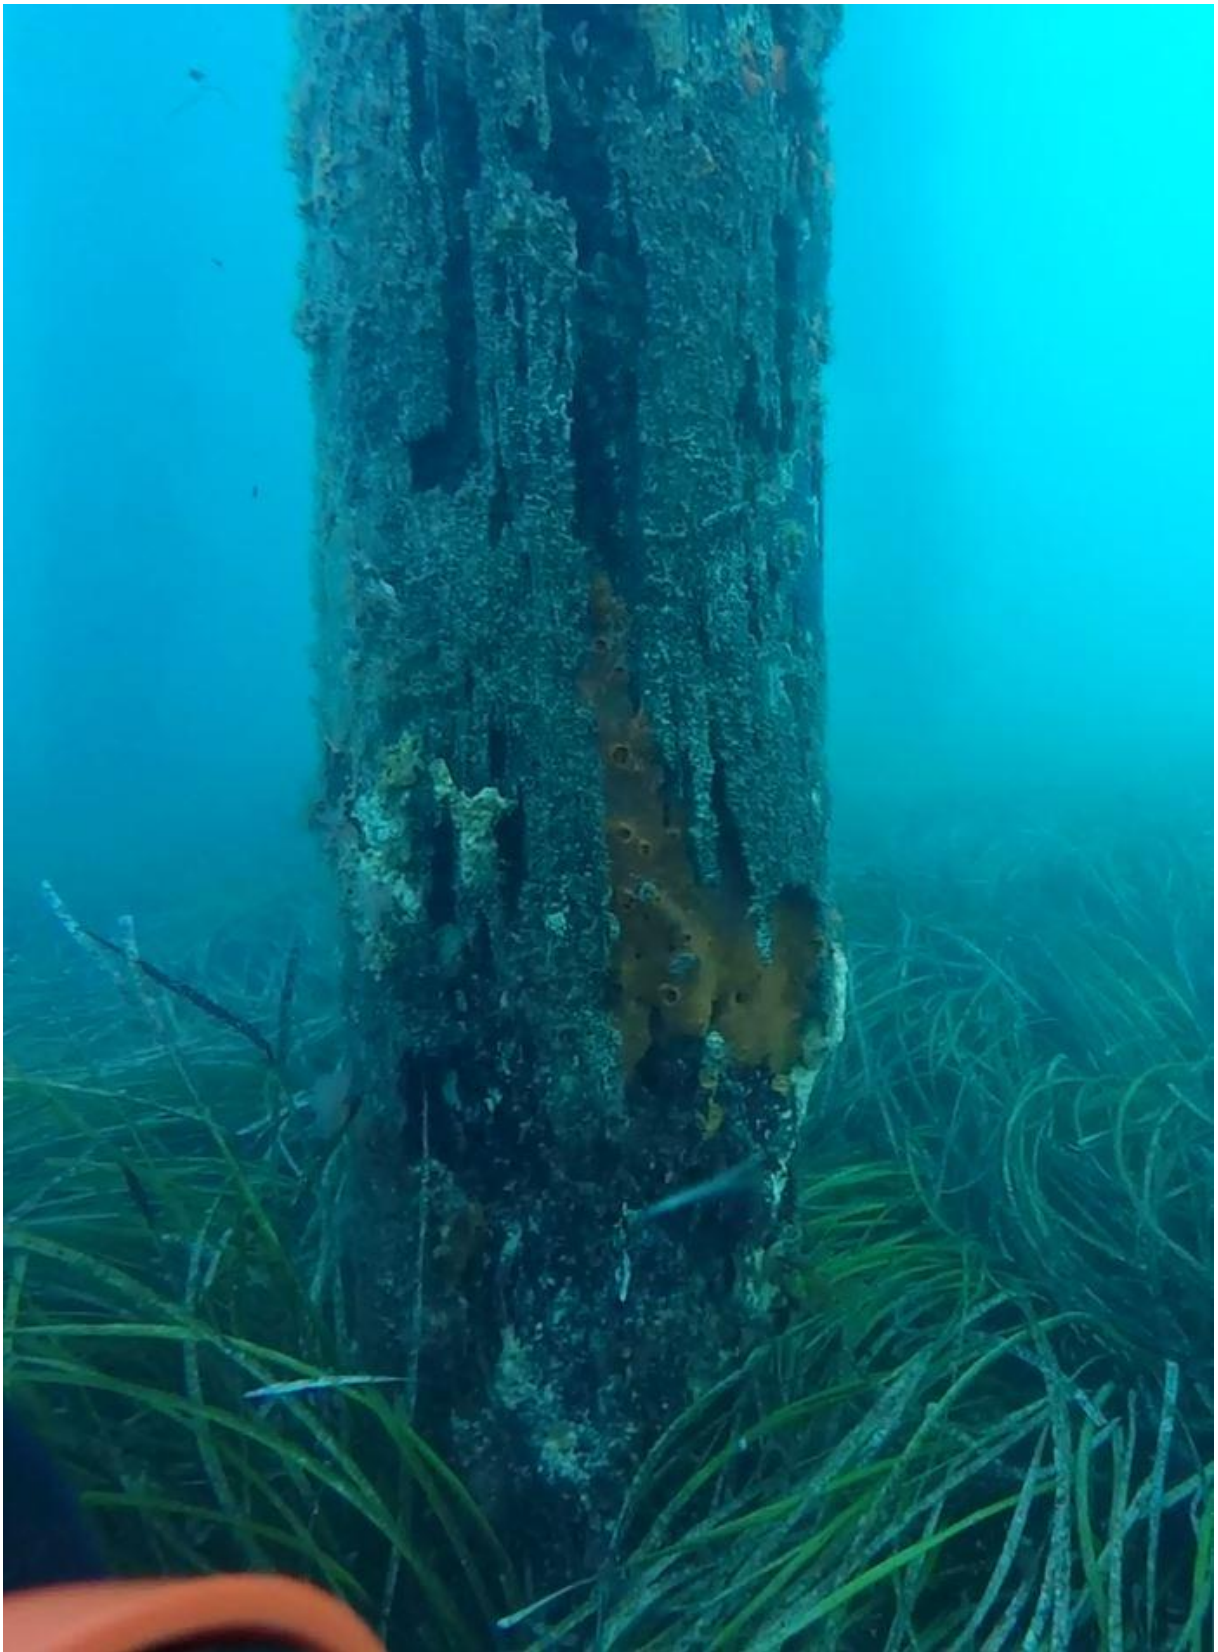
• 112 North

**Figure 3-11: 112 North 11/11/15 – Severe section loss at base**

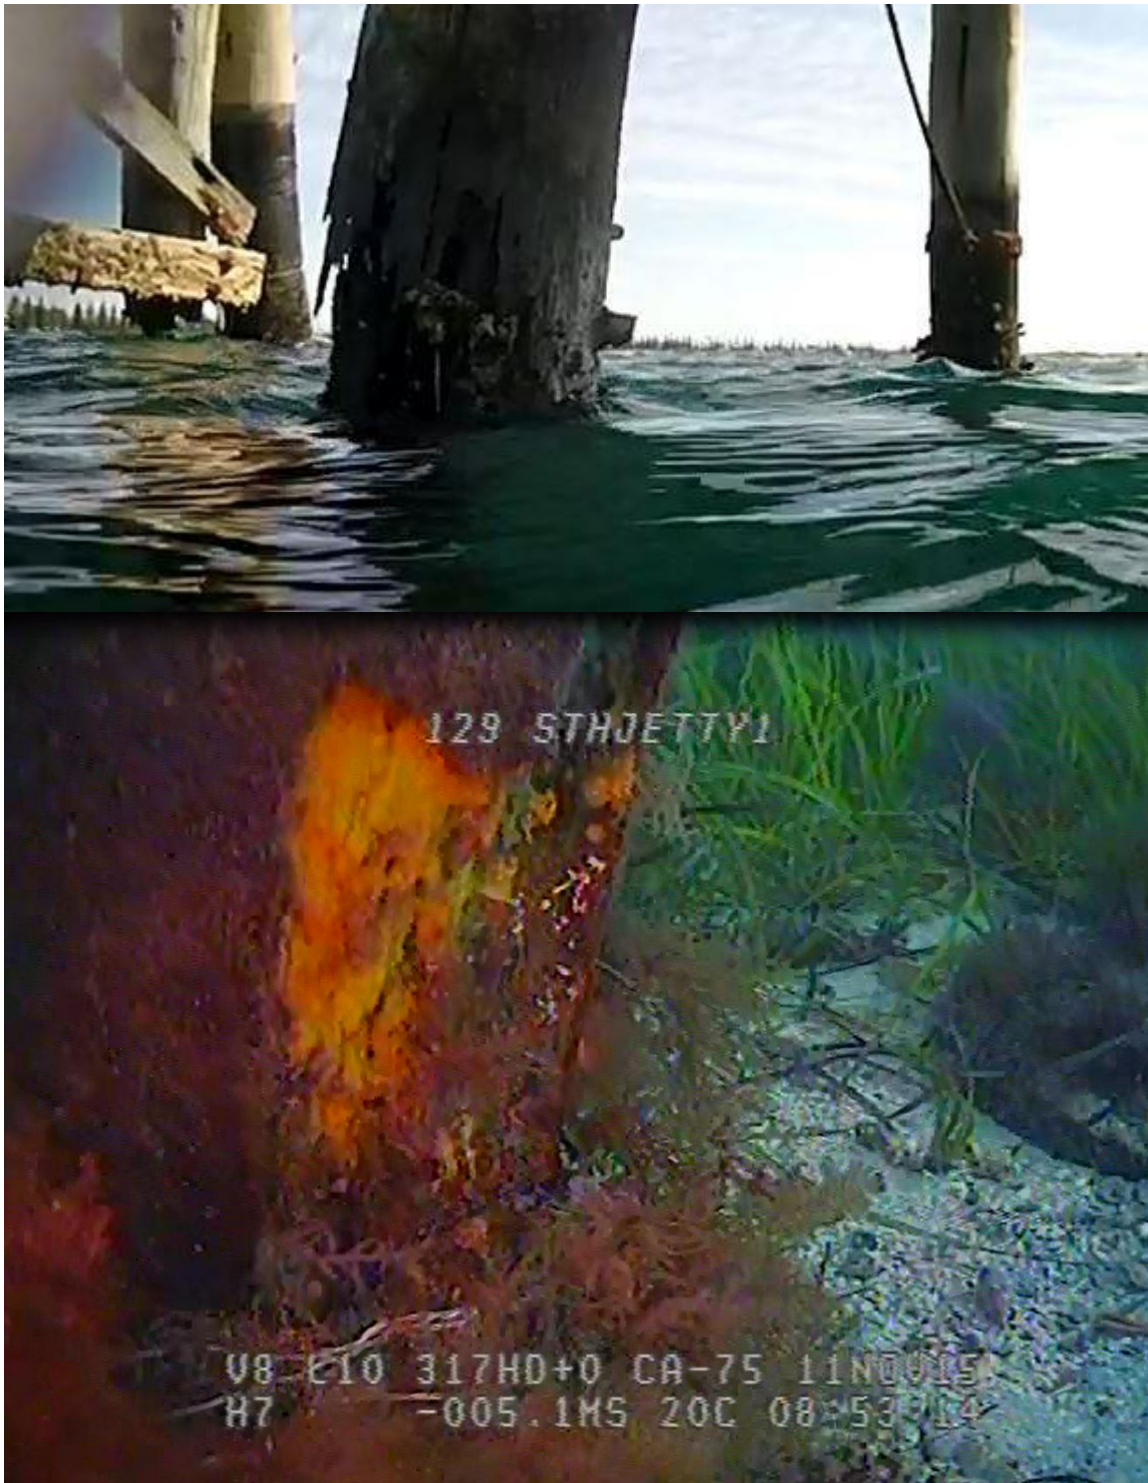
- 129 South

Figure 3-12: 129 South 11/11/15 – Severe section loss at surface (top), section loss at base (bottom)

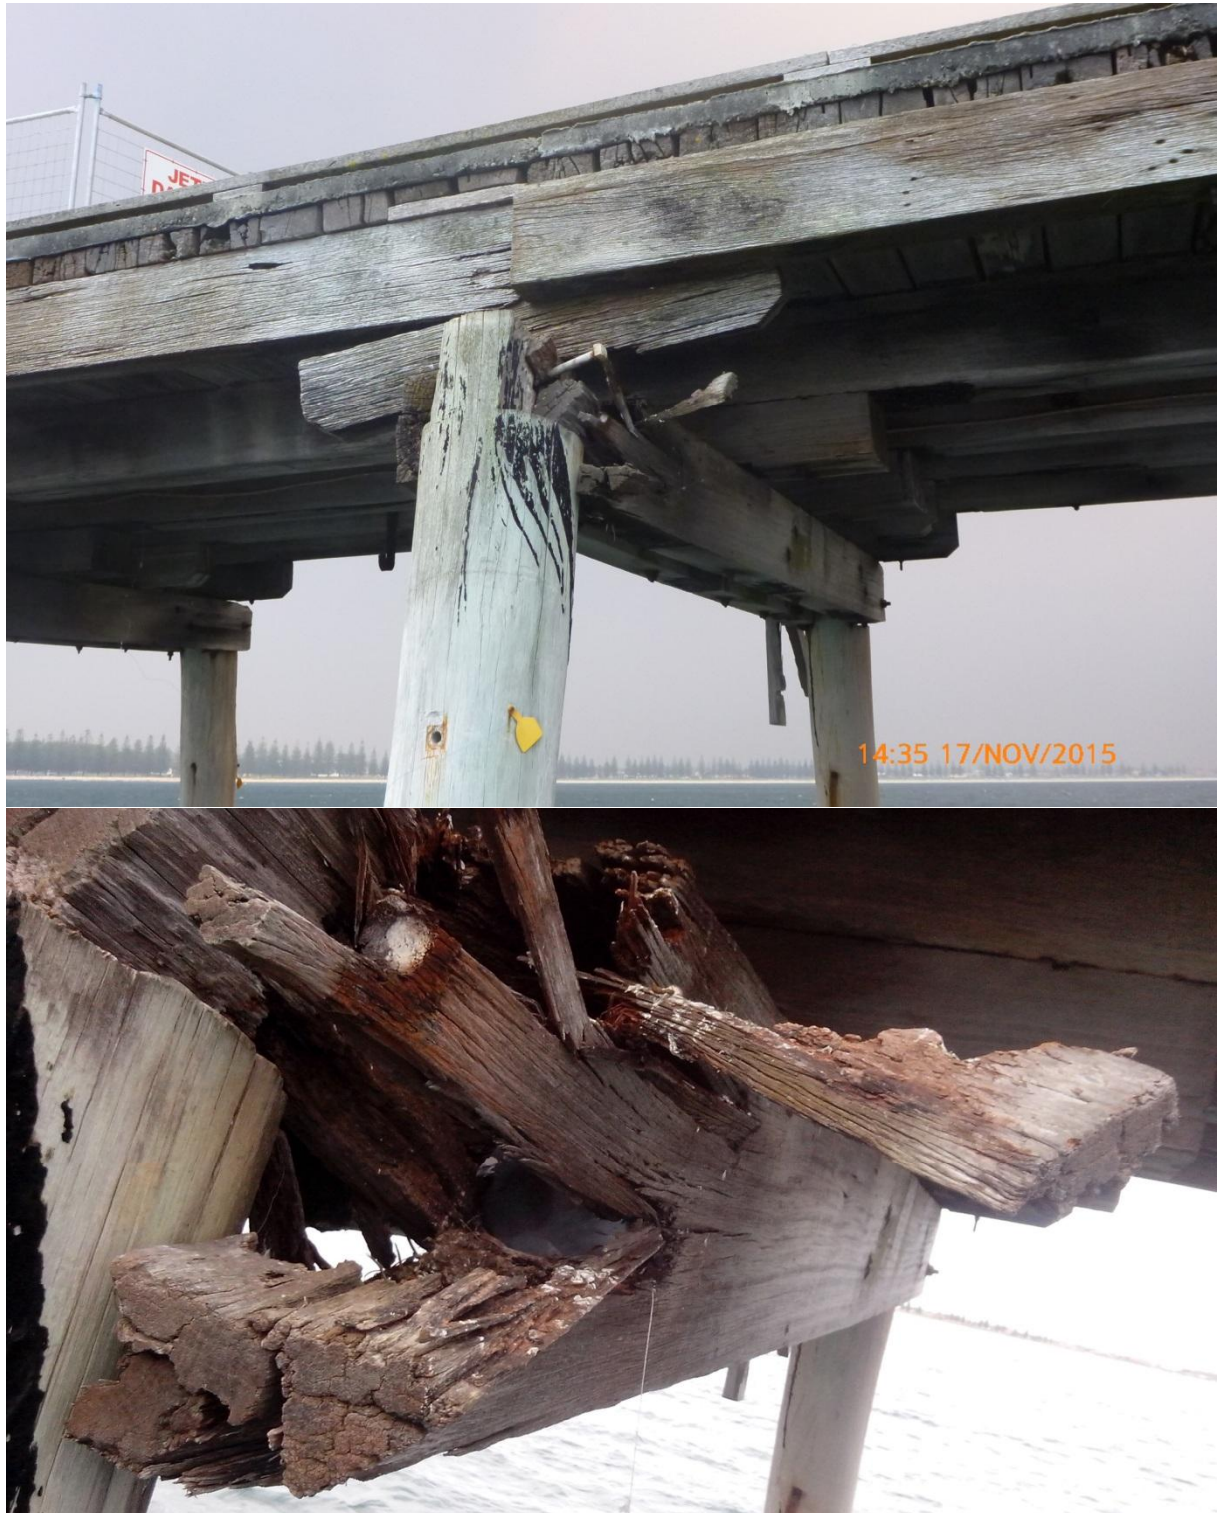
- 95 South.

**Figure 3-13: 95 Southeast (Top-17/11/15, Bottom 30/11/15) – Crushing failure of half caps**

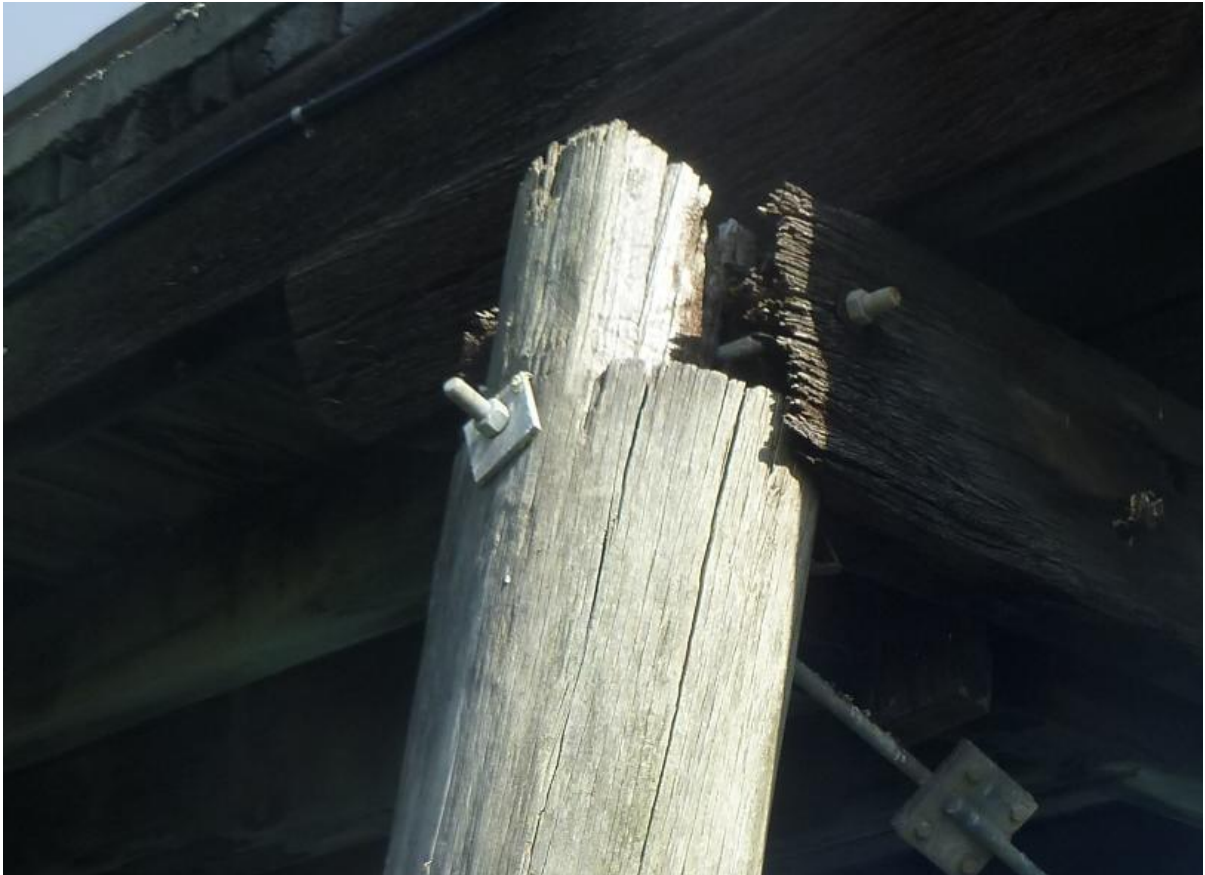
- 35 North

**Figure 3-14: 35 North West 17/11/15 – Crushing of both half caps**
