# **ESPERANCE JETTIES CONDITION ASSESSMENTS**

## **Condition Inspection and Maintenance Strategy Report**

Reference: R-J15028-1

Date: December 2015

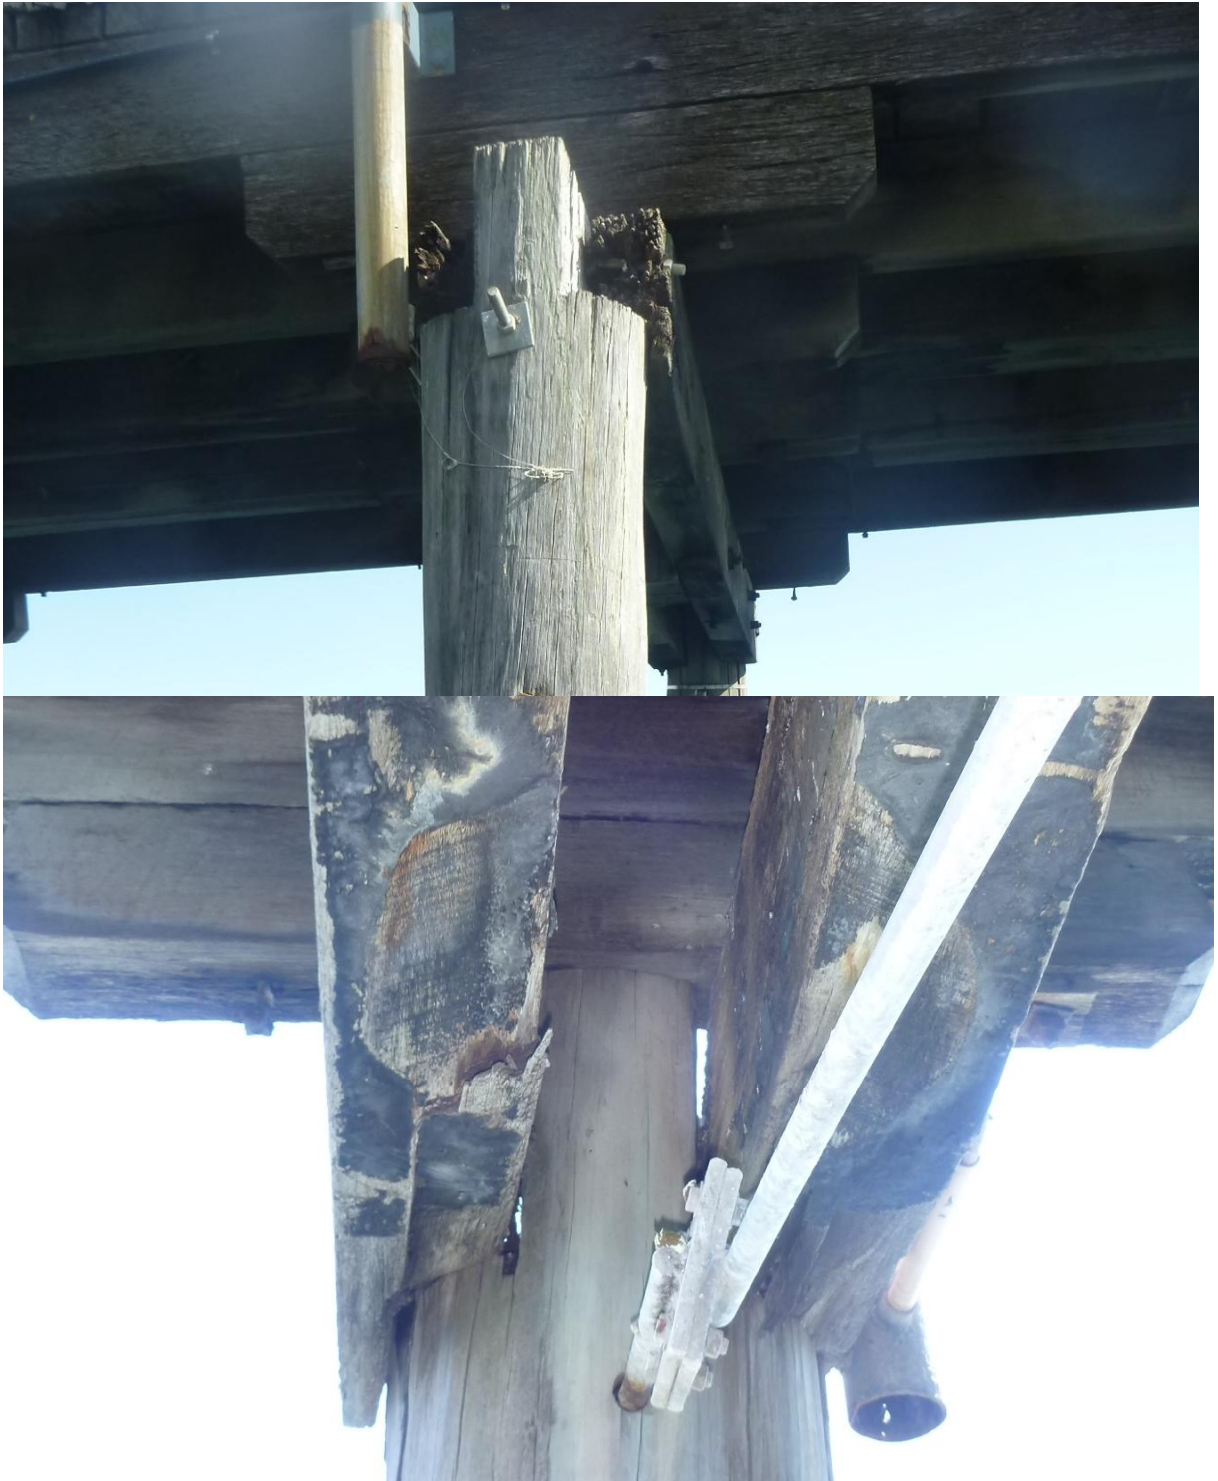
• 36 North

**Figure 3-15: 36 North 17/11/15 – Crushing of both half caps**

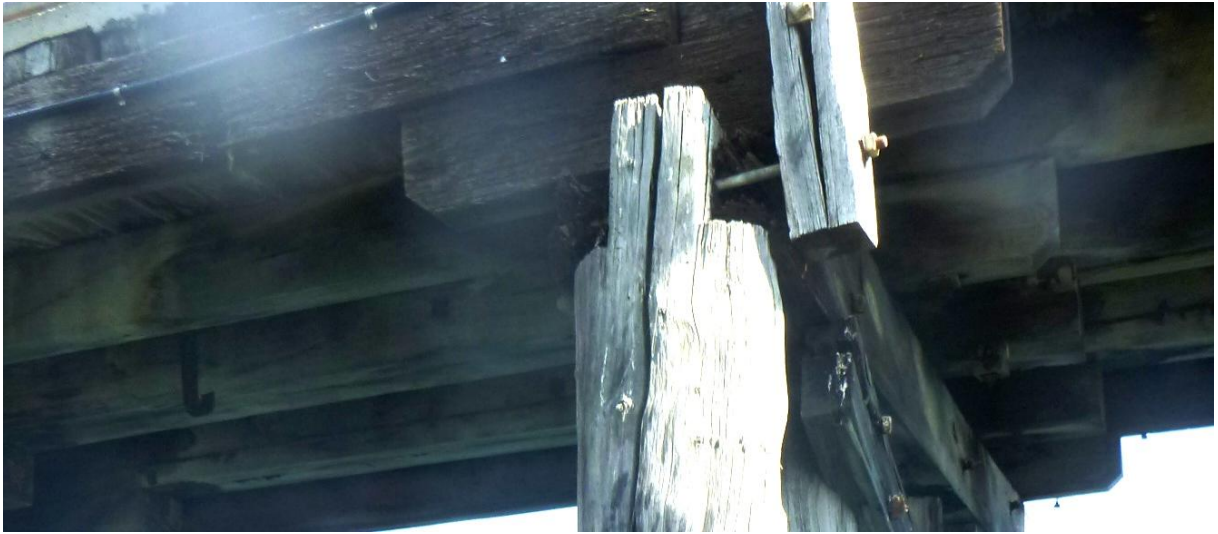
- 37 North

**Figure 3-16: 37 North 17/11/15 – Crushing of both half caps**

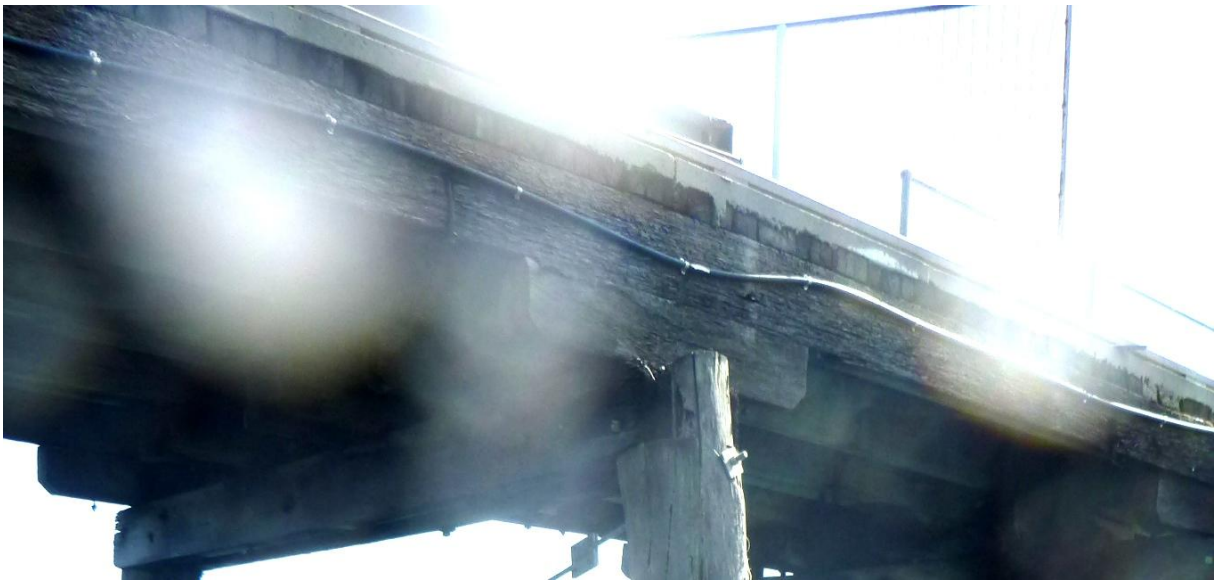
- 38 North

**Figure 3-17: 38 North 17/11/15 – Crushing of both half caps**

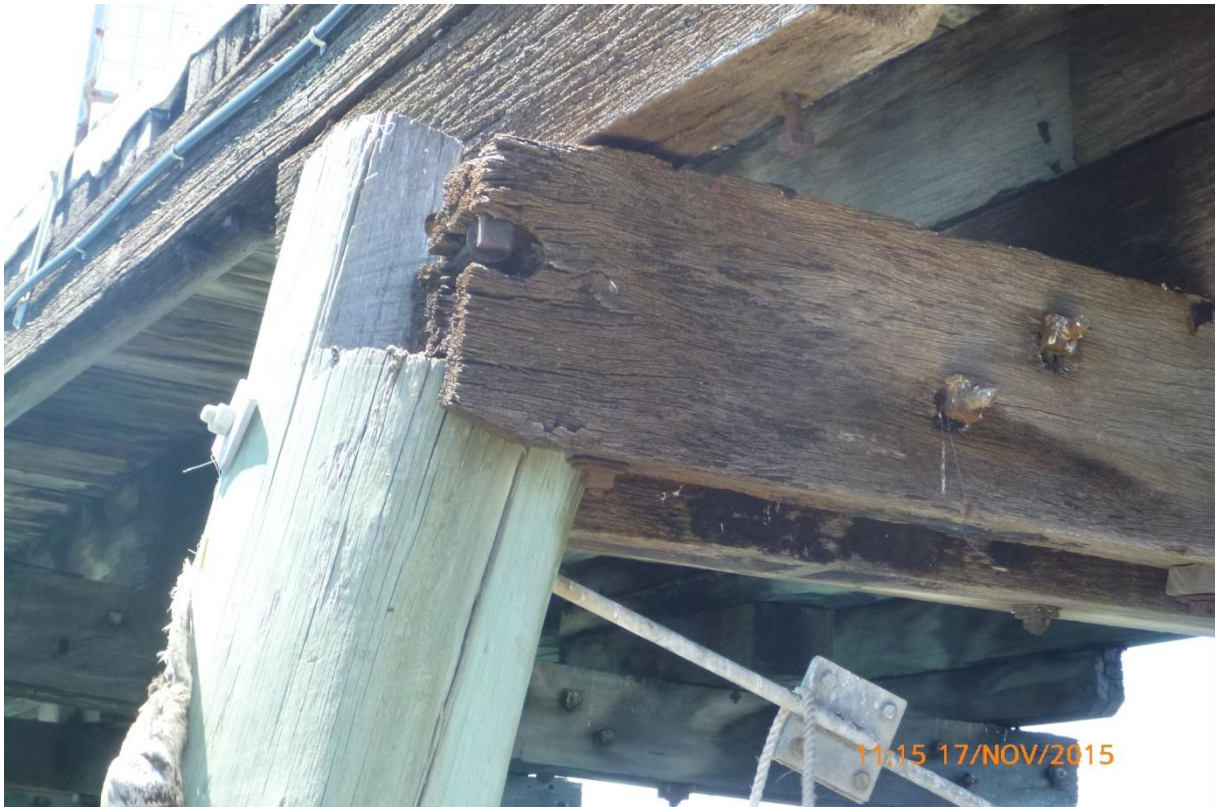
- 40 North

**Figure 3-18: 40 North 17/11/15 – Crushing of both half caps**

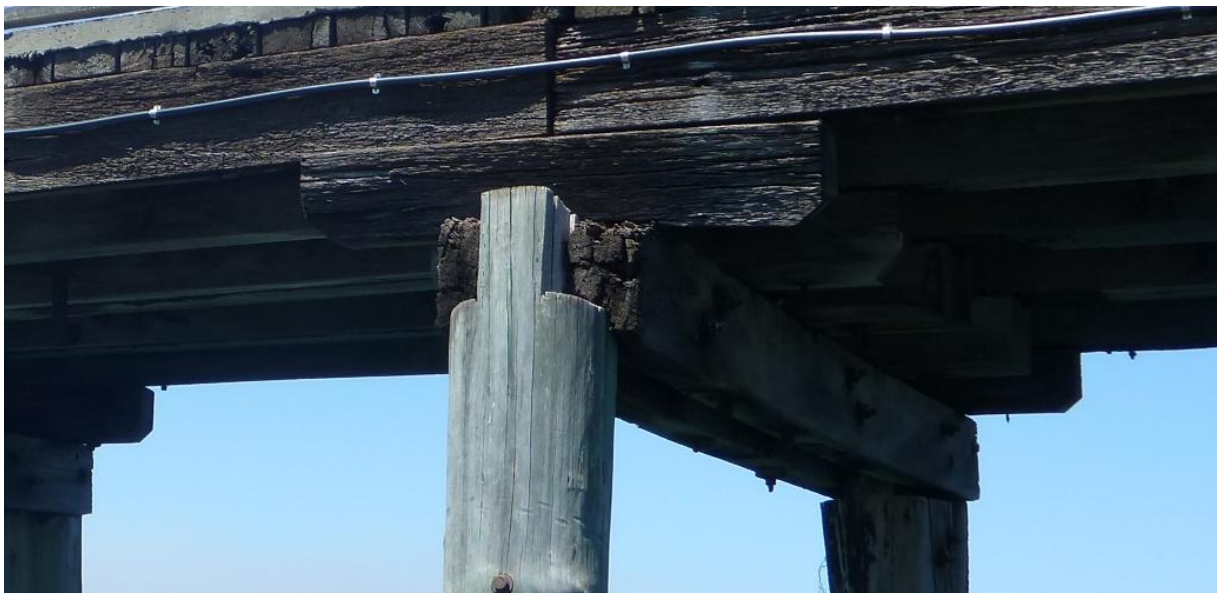
- 43 North

**Figure 3-19: 43 North 17/11/15 – Crushing of both half caps**

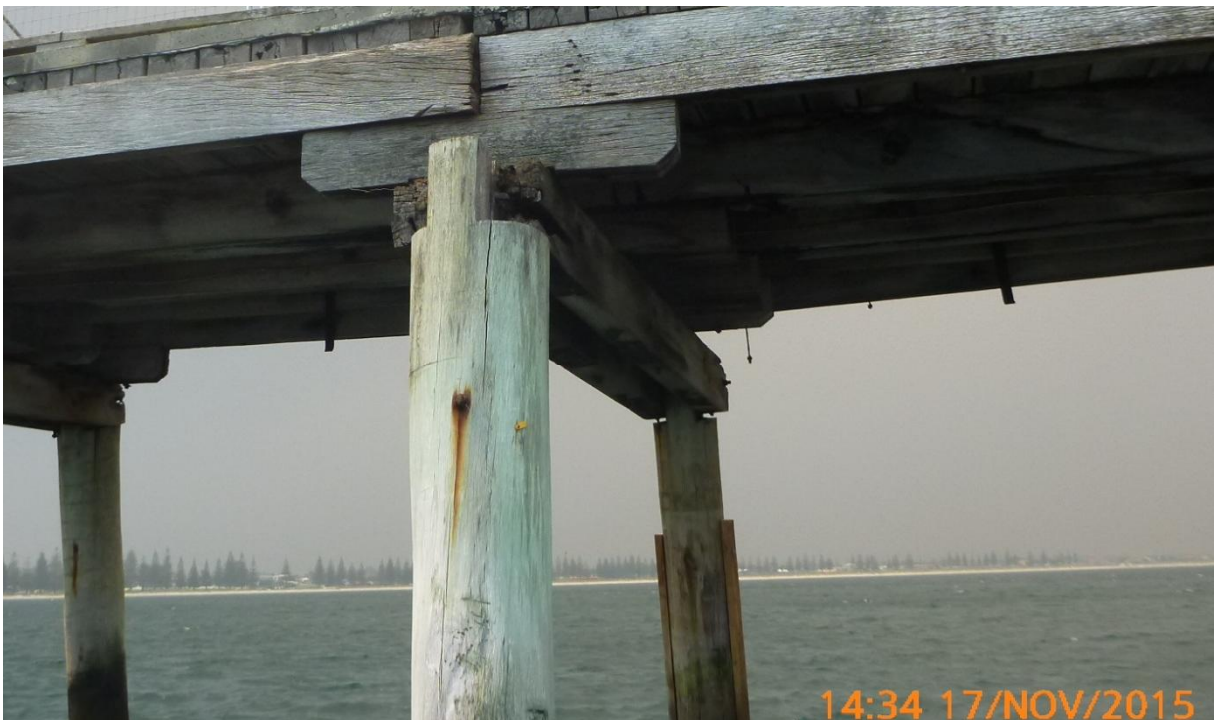
- 93 South

**Figure 3-21: 93 South 17/11/15 – Crushing of both half caps**

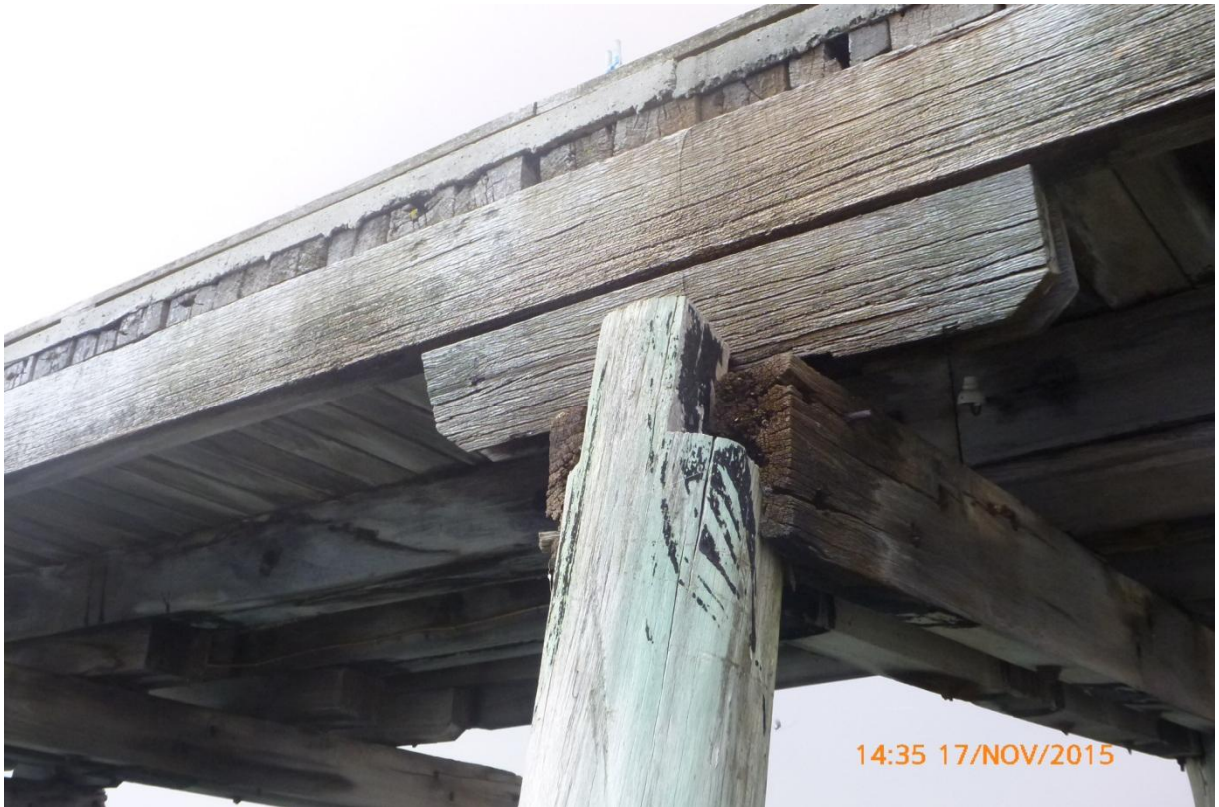
- 94 South

**Figure 3-22: 94 South 17/11/15 – Crushing of both half caps**

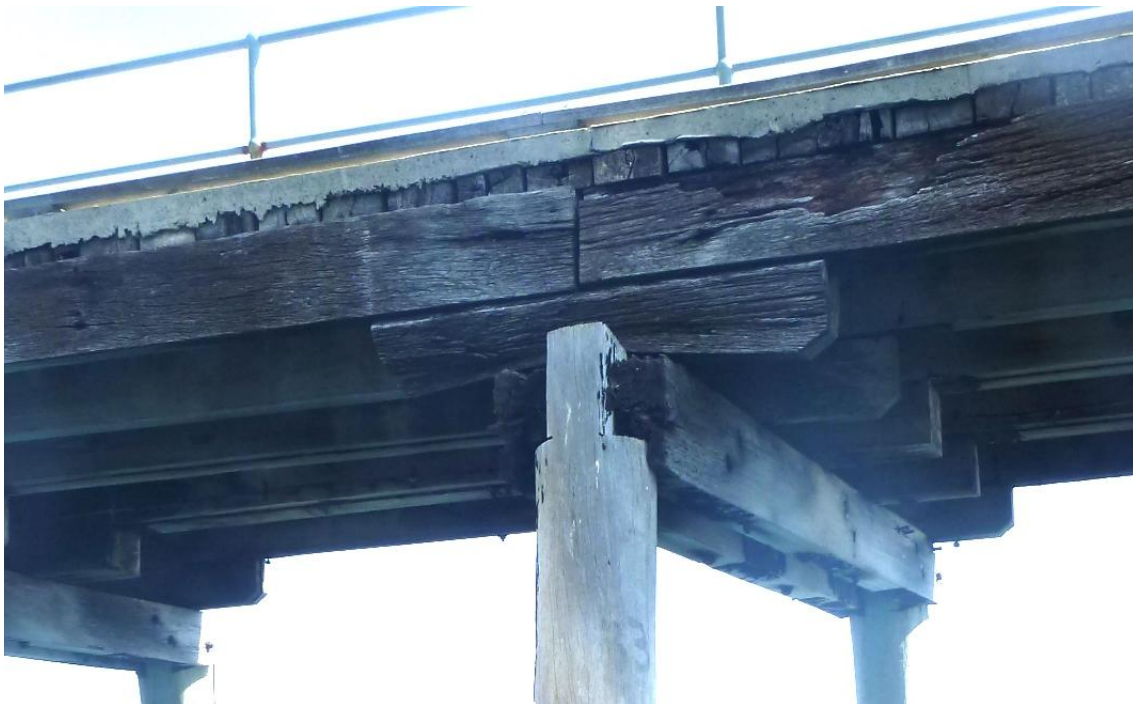
- 133 North

**Figure 3-23: 133 North 17/11/15 – Crushing of both half caps**
