# **ESPERANCE JETTIES CONDITION ASSESSMENTS**

## **Condition Inspection and Maintenance Strategy Report**

Reference: R-J15028-1

Date: December 2015

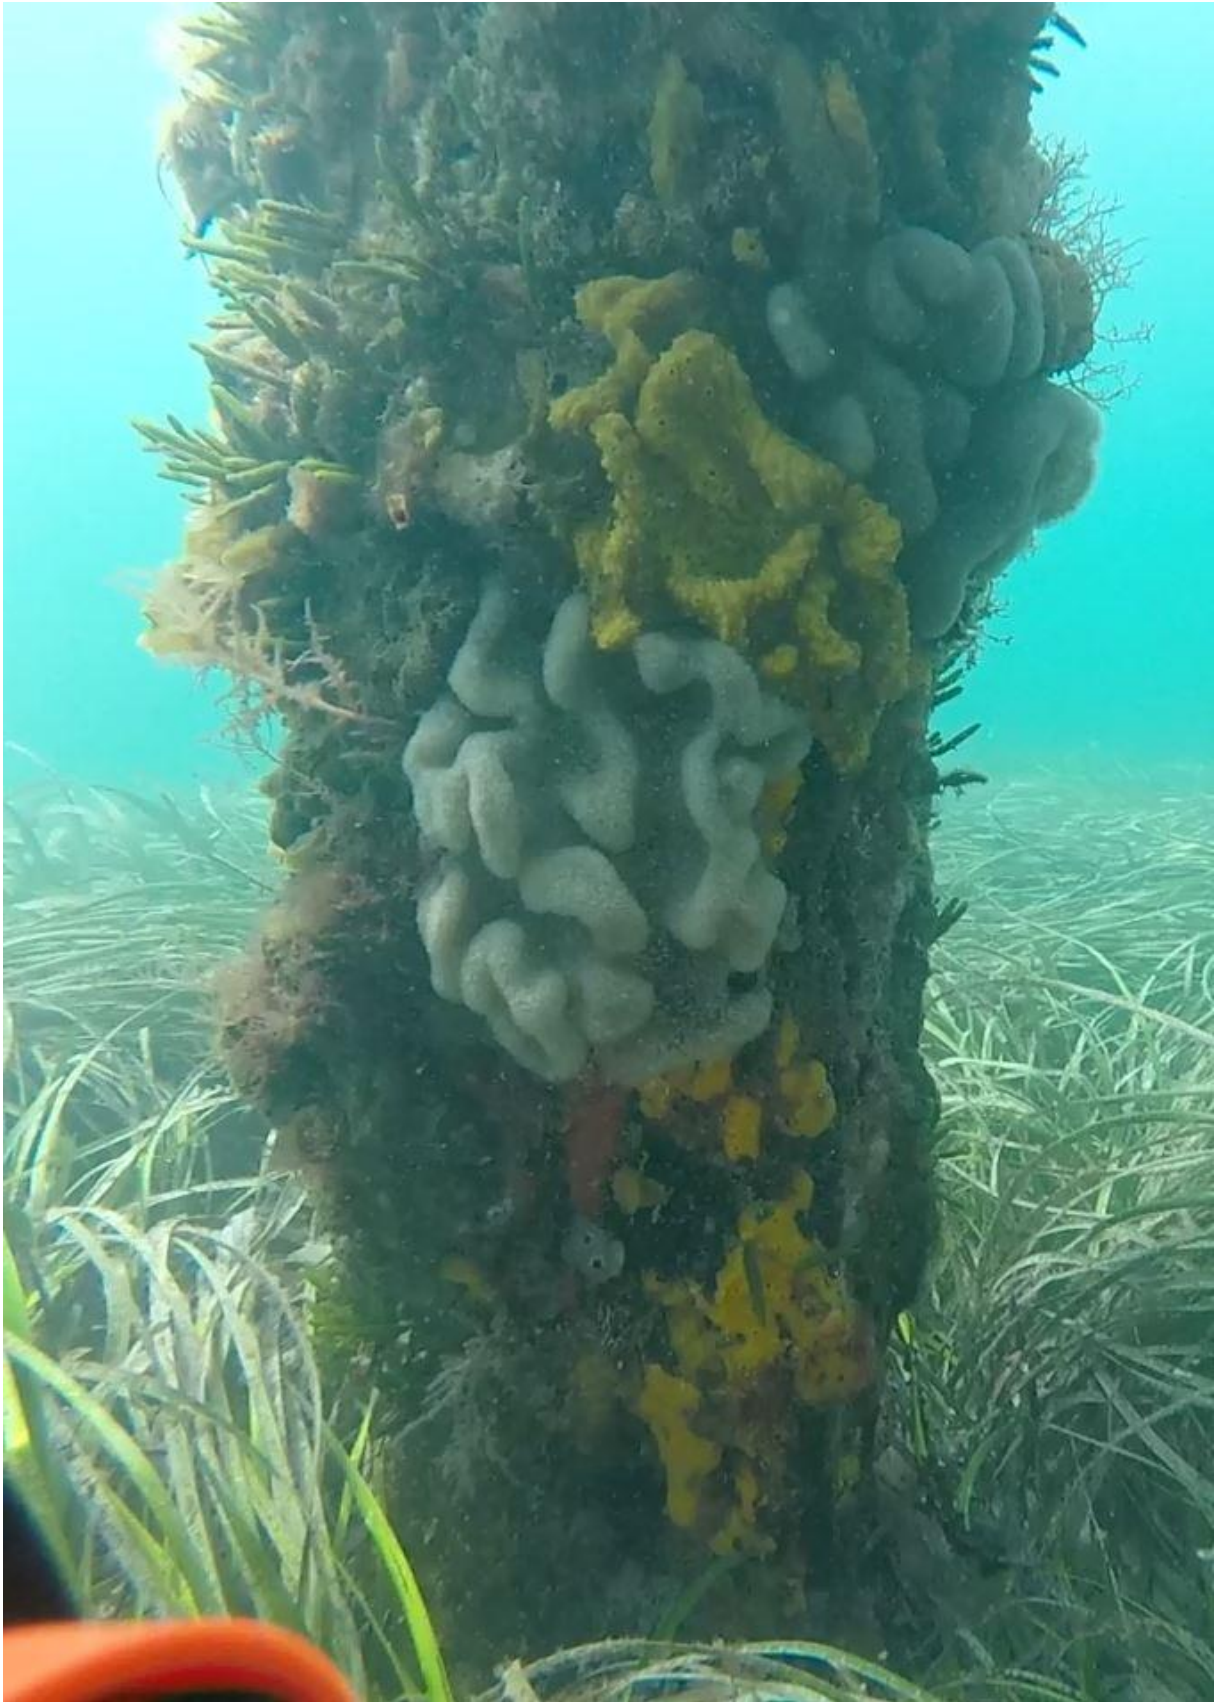
- 54 North – Appears to have failed between surface and sea bed

The most significant defects were; completely failed piles 54 North, 93 North and crushing of both half caps at their northern bearing support adjacent to the bridged section at missing pile 39 North (including 35-38 North, and 40 North).

**Figure 3-1: 54 North 11/11/15 – Severe necking at base (prior to failure identified 17/11/15)**

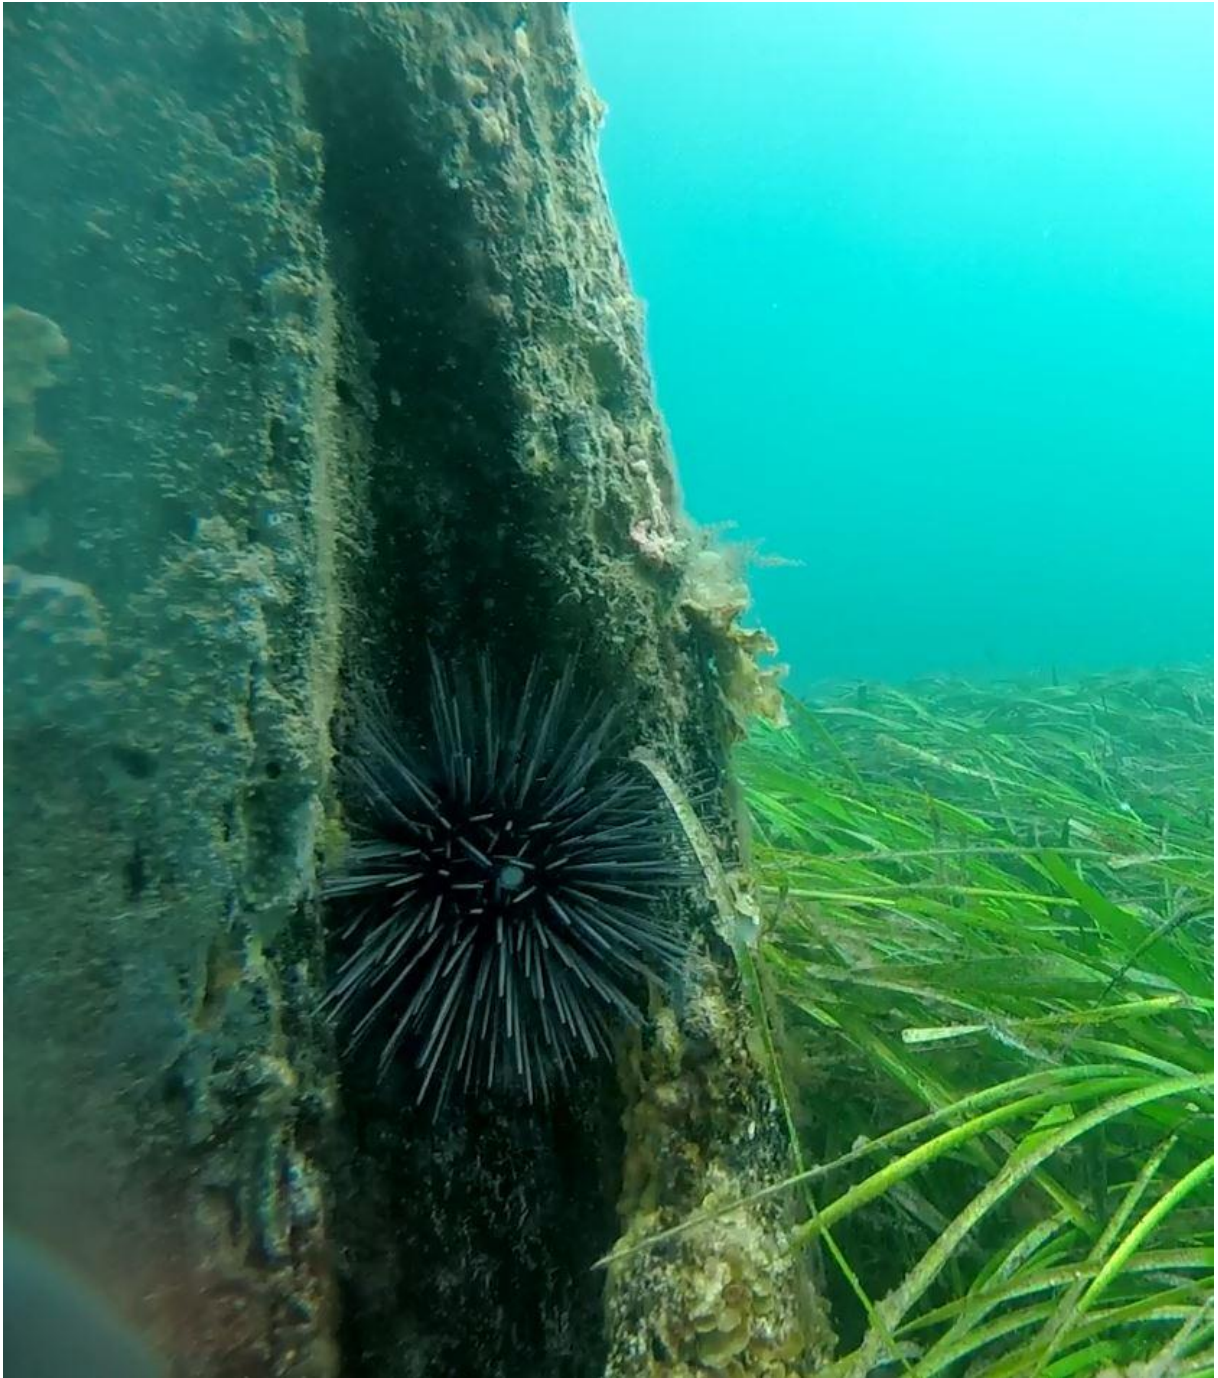
• 101 North

**Figure 3-10: 101 North 11/11/15 – Severe section loss at base**

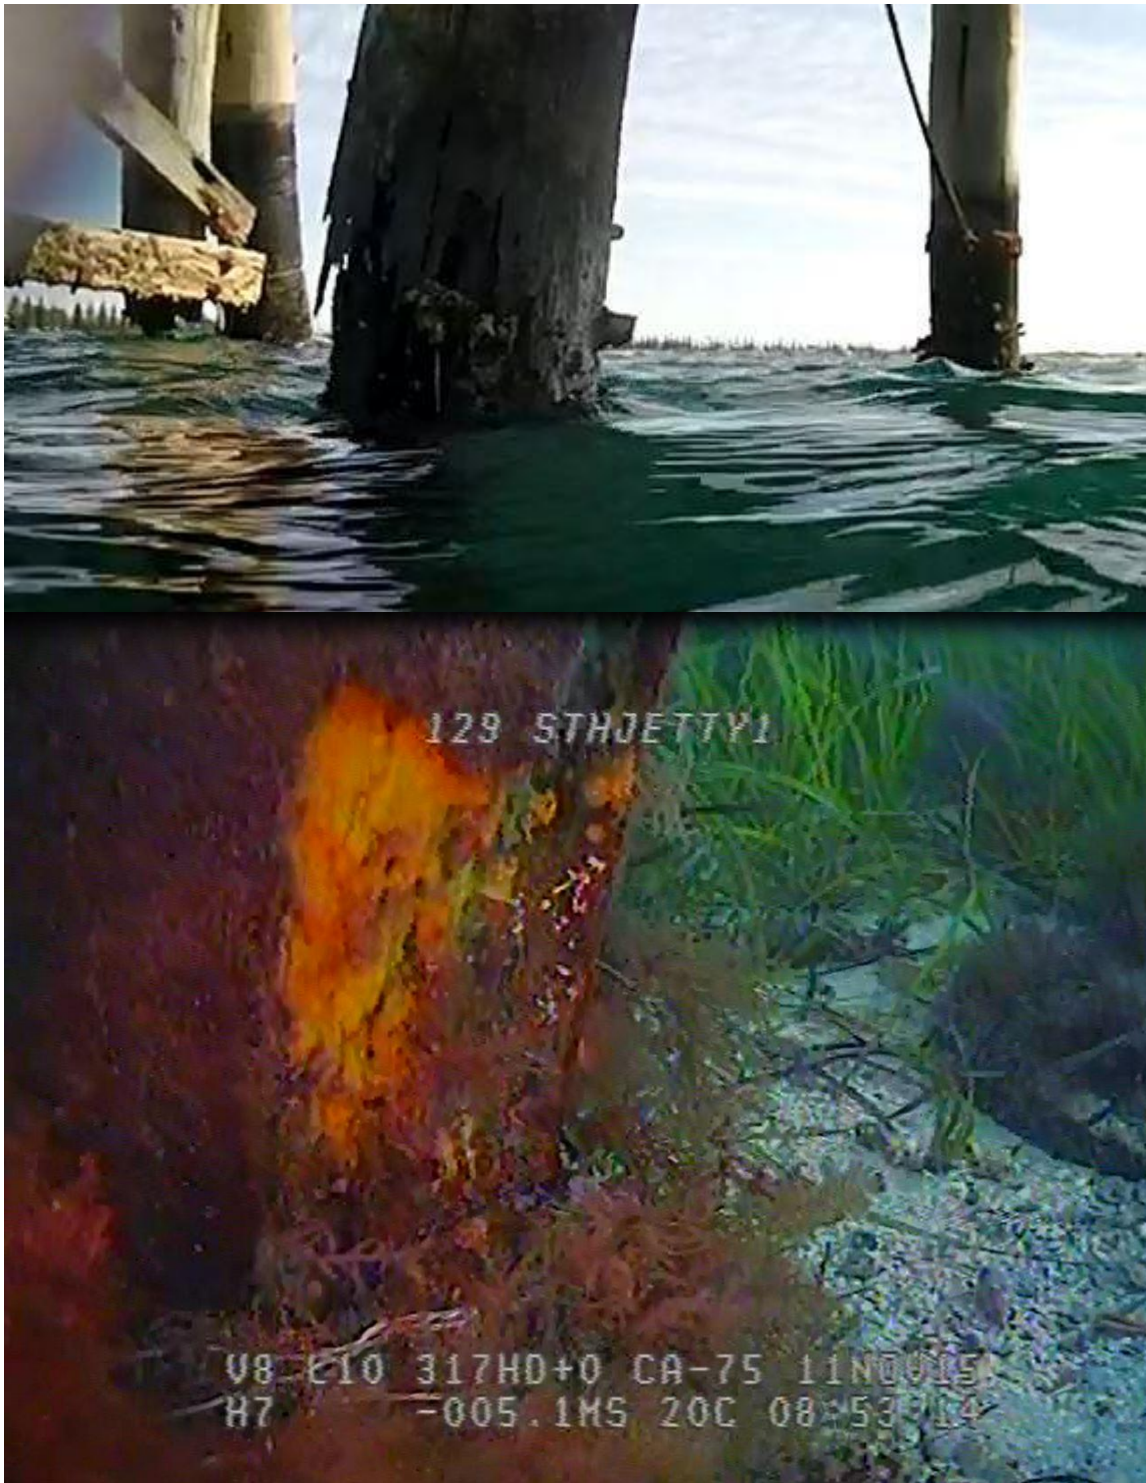
- 129 South

Figure 3-12: 129 South 11/11/15 – Severe section loss at surface (top), section loss at base (bottom)

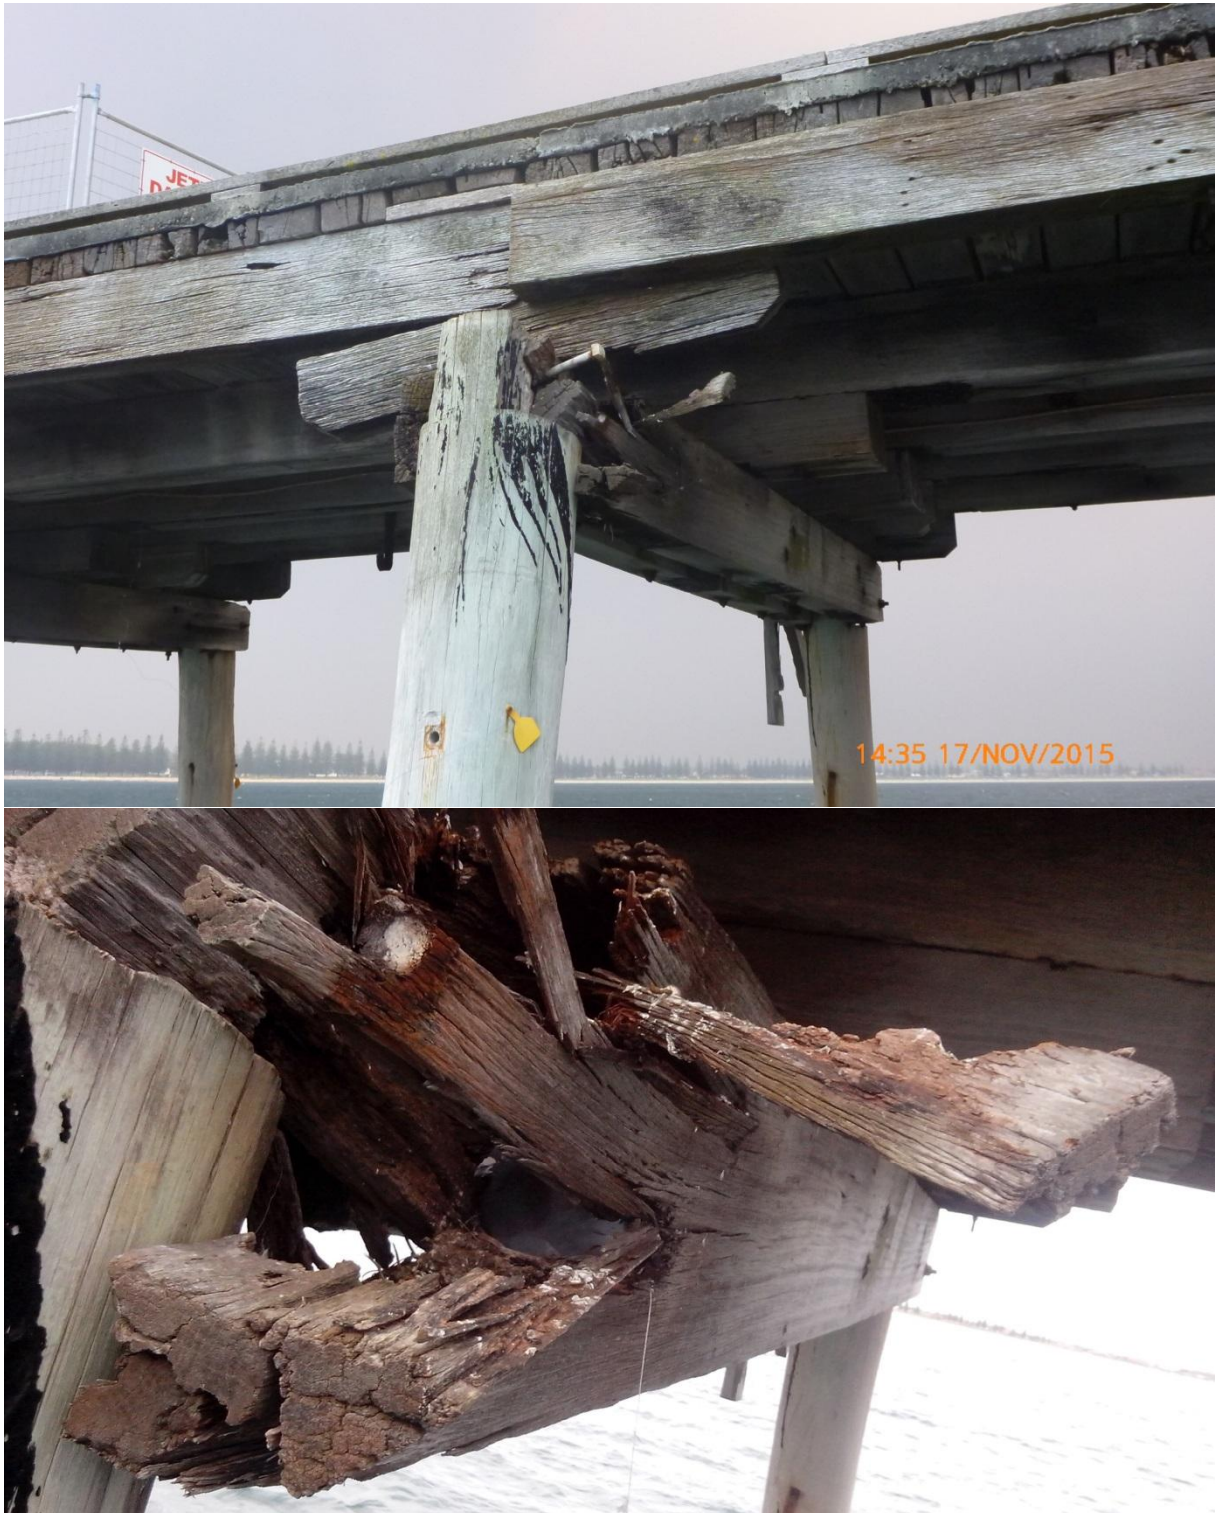
- 95 South

Figure 3-13: 95 Southeast (Top-17/11/15, Bottom 30/11/15) – Crushing failure of half caps

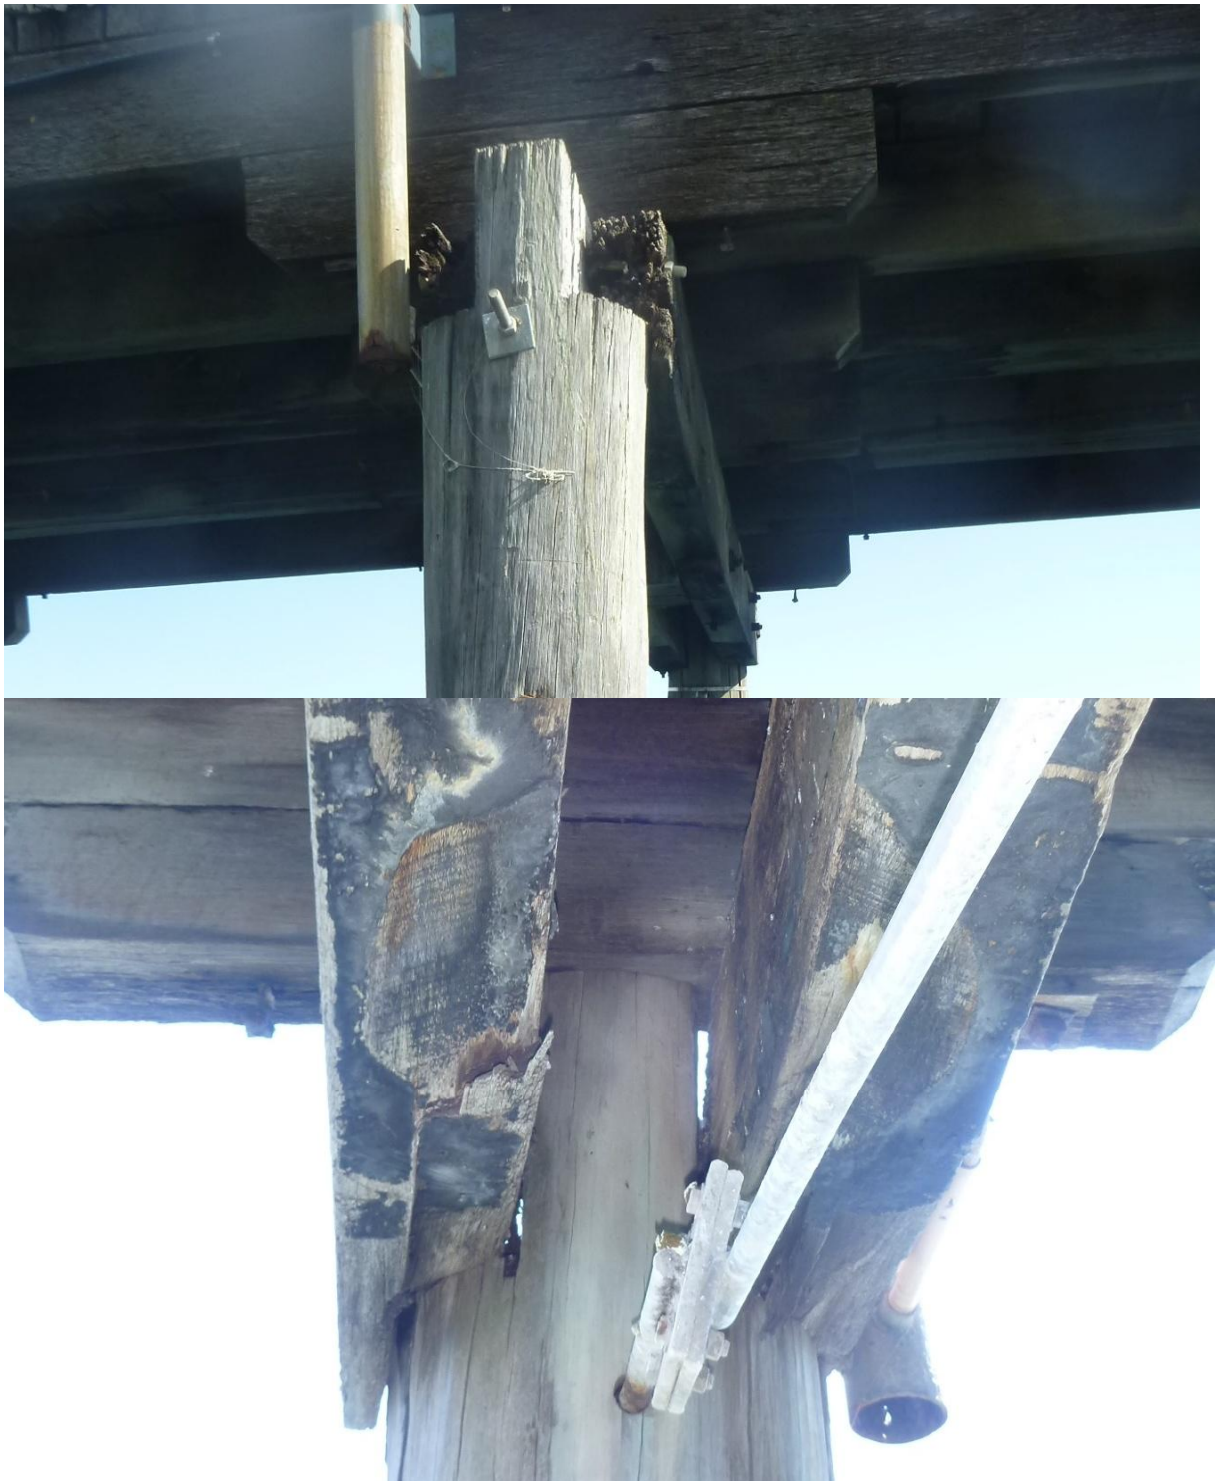
• 36 North

**Figure 3-15: 36 North 17/11/15 – Crushing of both half caps**

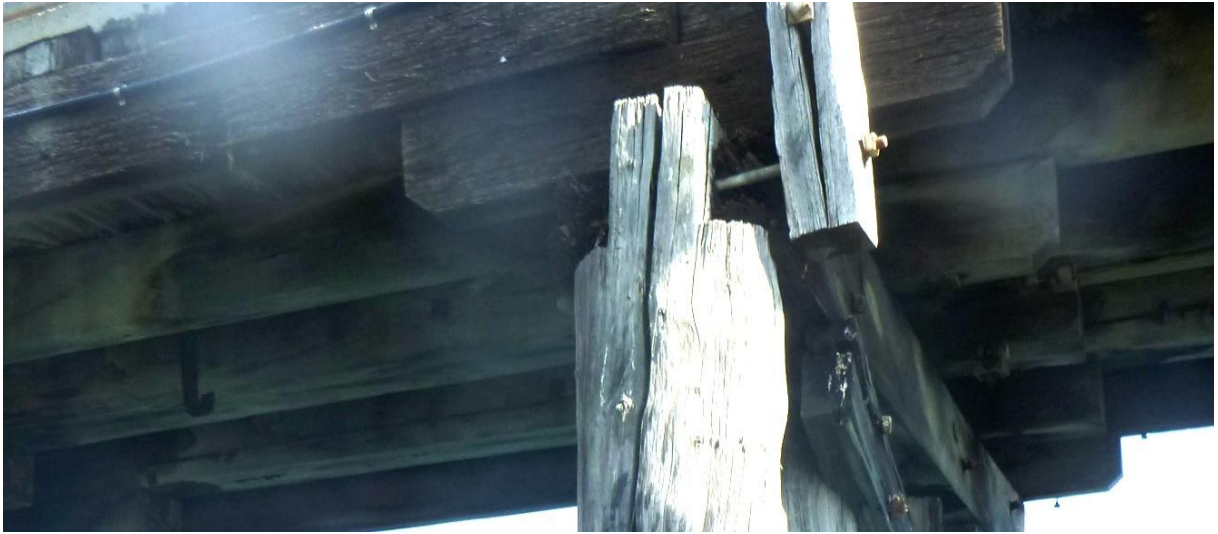
- 37 North

**Figure 3-16: 37 North 17/11/15 – Crushing of both half caps**

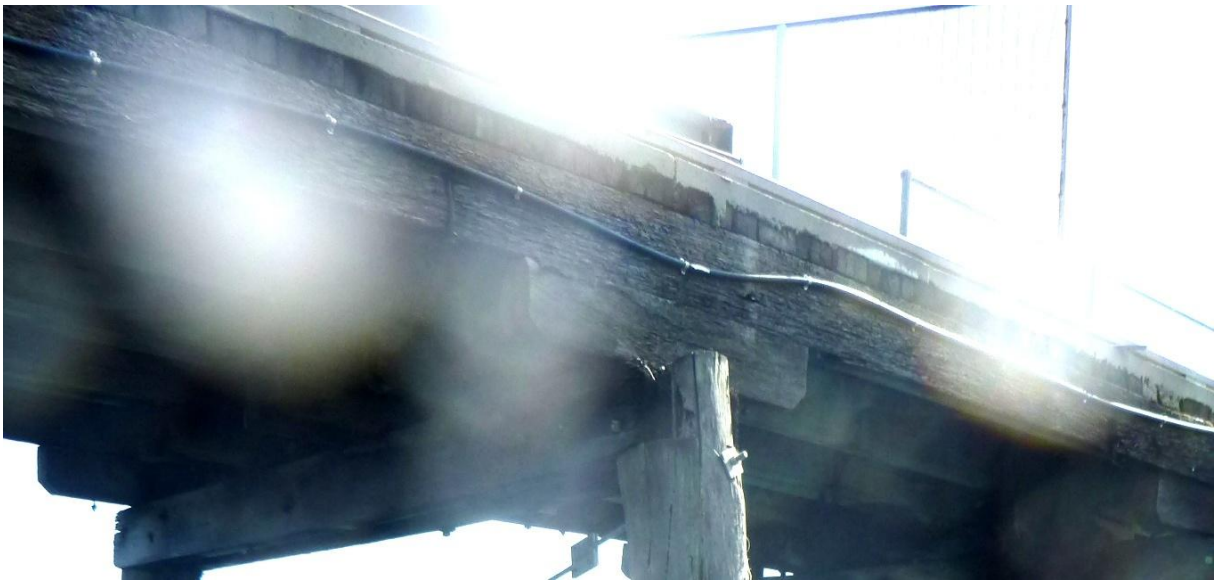
- 38 North

**Figure 3-17: 38 North 17/11/15 – Crushing of both half caps**
