Brief Report Condition of Esperance Tanker Jetty Timbers

Brief Report on the condition of jetty timbers arising from the partial uncontrolled collapse on the 9th September 2017.

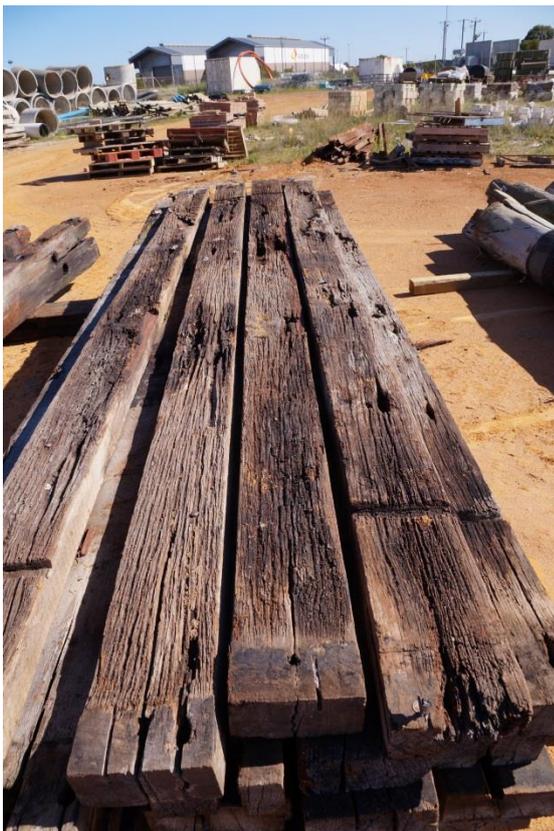
Image 1 - Deck Plank 1

Deck planks that were previously covered in concrete topping were found to be generally in worse condition than the planks recovered from the partial deconstruction of 2013.

Many of the planks broke into pieces, which cannot be fully attributed to the collapse event, since they were in a very rotted and distressed condition on their upper surfaces. This was in keeping with the advice Shire was given by a number of jetty restoration contractors and Engineers in 2014 and 2015. The reuse of jetty deck planks in any future decking application, even if turned upside down, seems unlikely to result in a compliant structure.

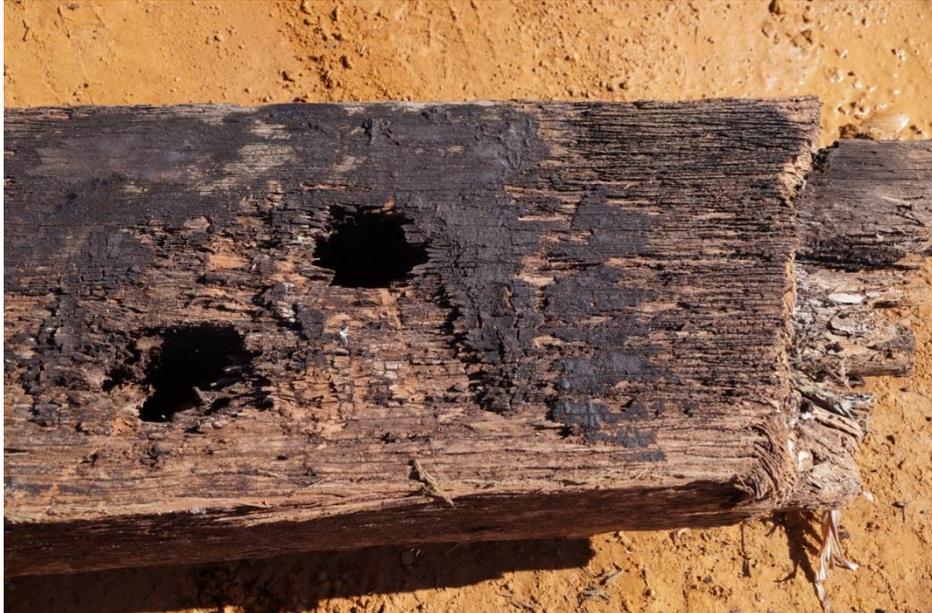
Image 4 - Outer Stringer 1

Outer stringers were found to be severely rotted through the various fixing points such that significant cavities running vertically through the timbers were observed. Many of the outer stringers broke in the collapse event, partly due to the unusual loads applied during the collapse, but mainly due to their rotted, decayed condition.

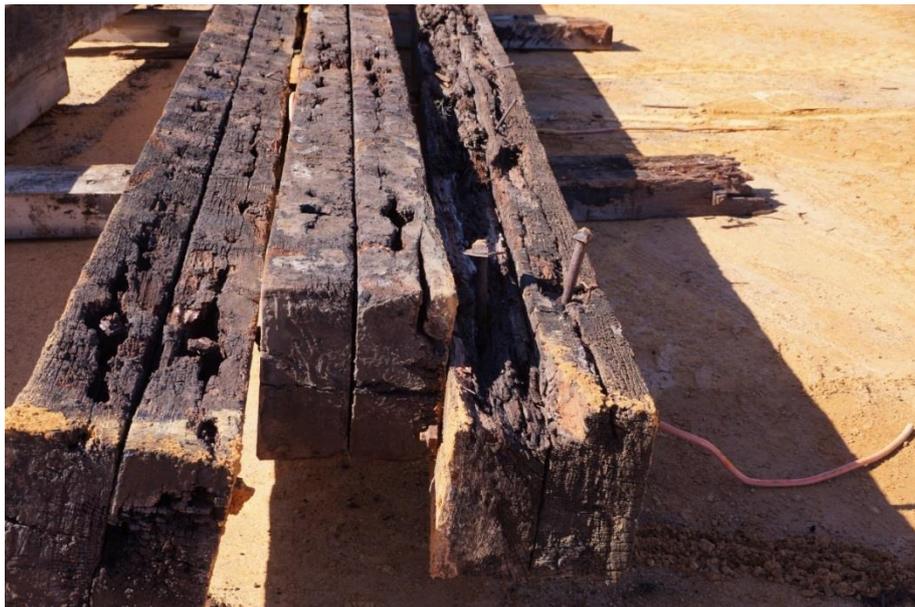
Image 6 – Inner Stringer 1

Inner Stringers were generally in fair condition on first examination. Closer inspection revealed rotted pockets or cavities running vertically through the timbers, in particular at the locations where corbels had been bolted. It may be that lengths of double stringer of lengths up to 3.5 metres would be salvageable, possibly longer if a heritage timber Engineer was willing to certify them. Most of the inner stringers, in particular the railway line double stringers, were recovered whole.

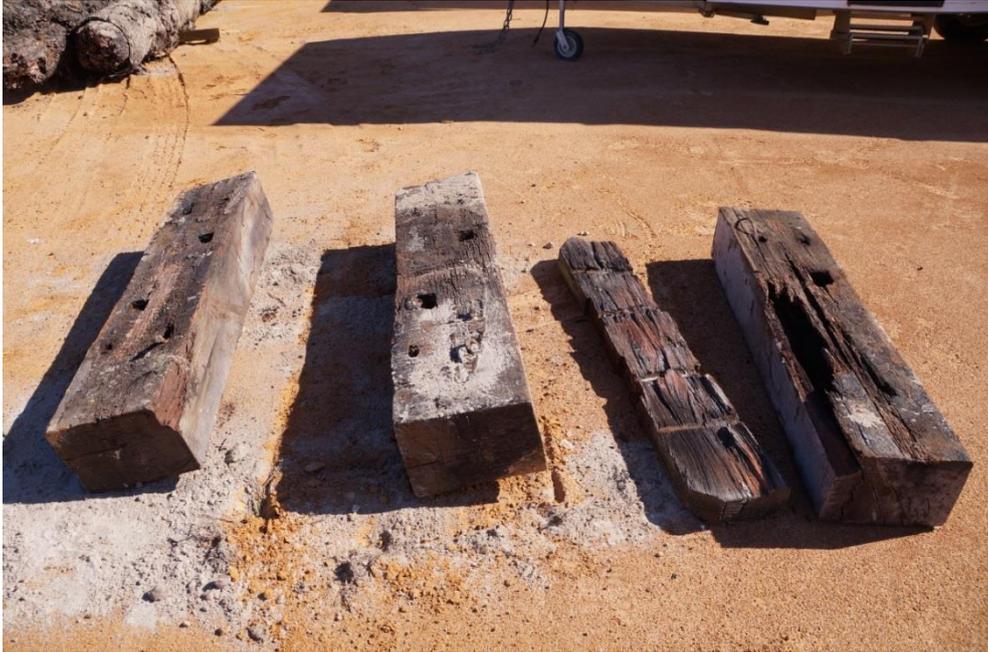
Image 9 - Single Corbel 1

Single corbels were generally split vertically and longitudinally where fixing bolts appear to have corroded and expanded.

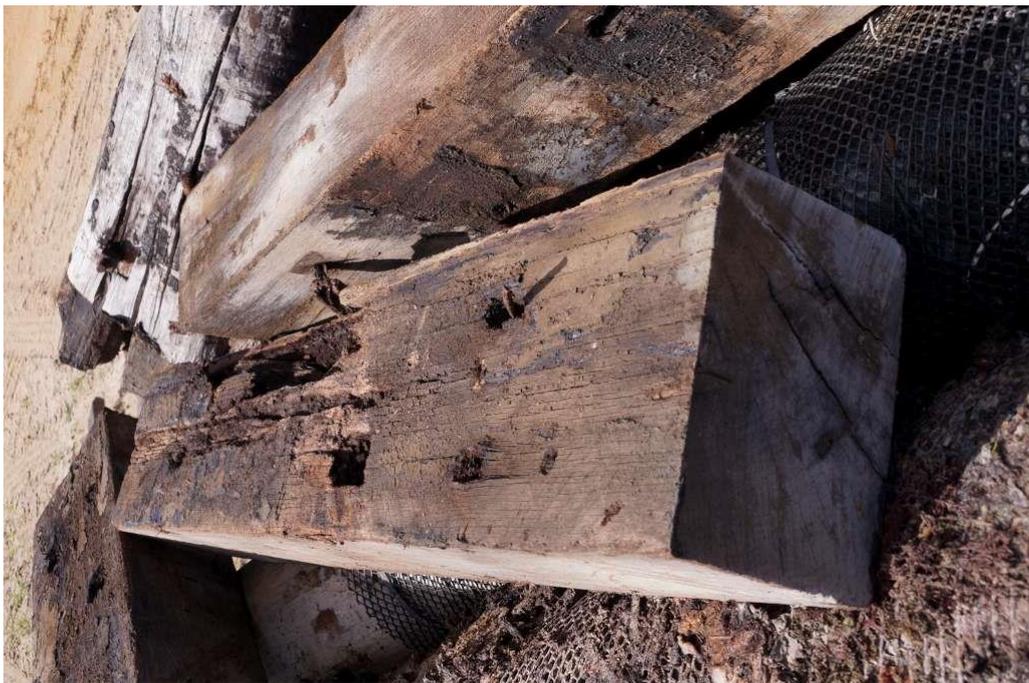
Image 12 - Double Corbel 1

Double corbels (railway line corbels) were found to be in generally better condition; however pockets of rot around fixings were present.

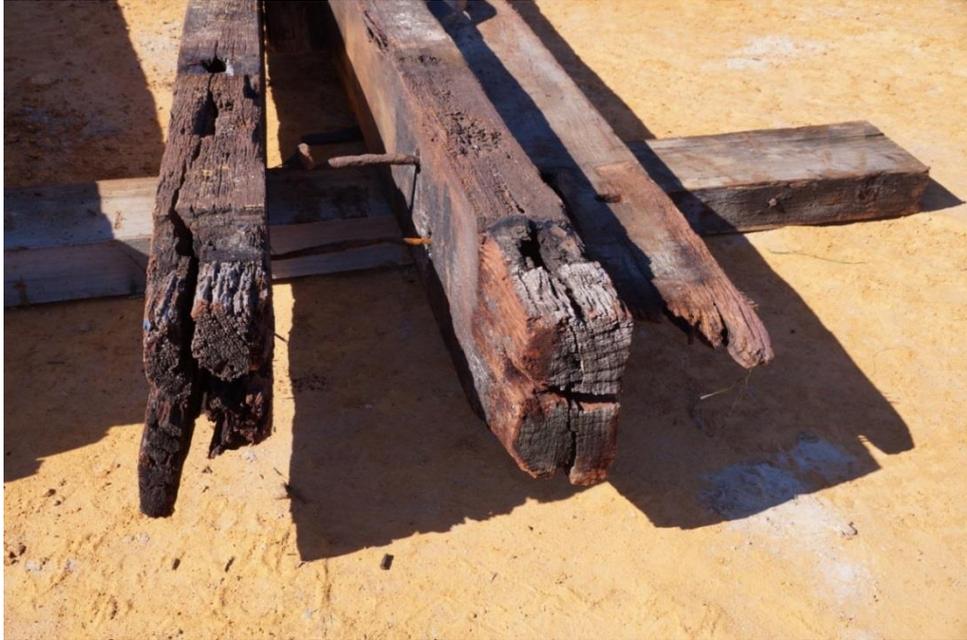
Image 13 - Halfcap 1

Half caps were found to be almost entirely rotted in parts and may not be fit for any reuse.

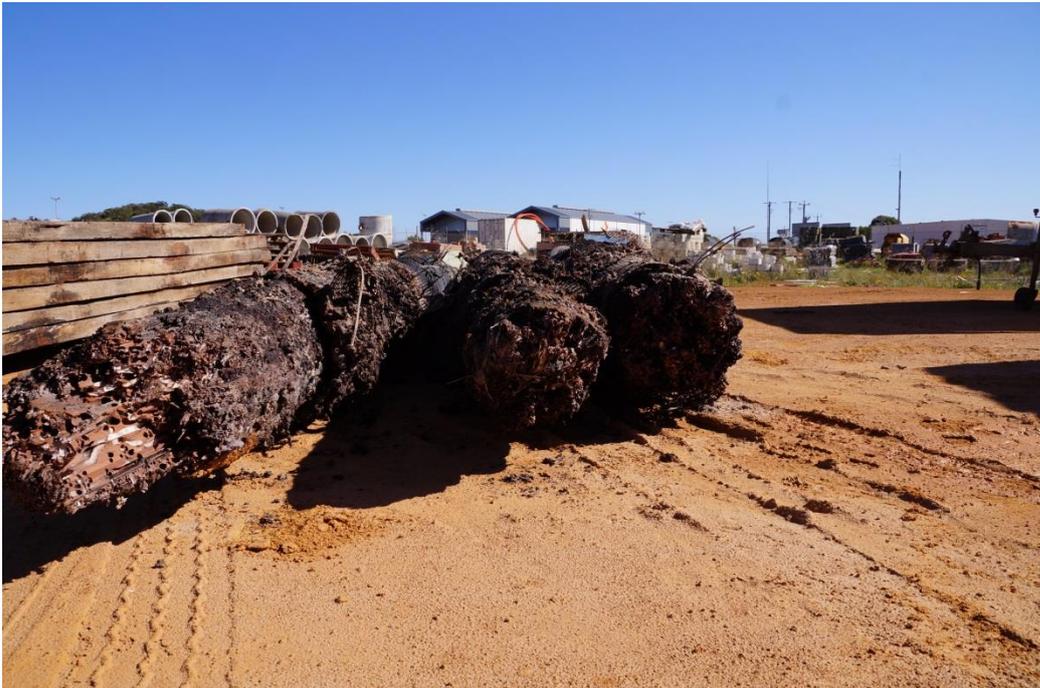
Image 16 - Pile 1

Piles were noted to be very severely degraded at sea bed level, Teredo worm attack having left very little of the pile cross section intact. It should be noted that many of the piles found to be compromised in this manner had been visually assessed in previous underwater inspections as being in good to fair condition, whereas they were all in condition 7 – 'Failed / Greater than 50% loss of section' on the WSCAM scoring scale of 1-7.
