**Shire of Esperance**

## **Library Building Future**

# Esperance Public Library Building Condition

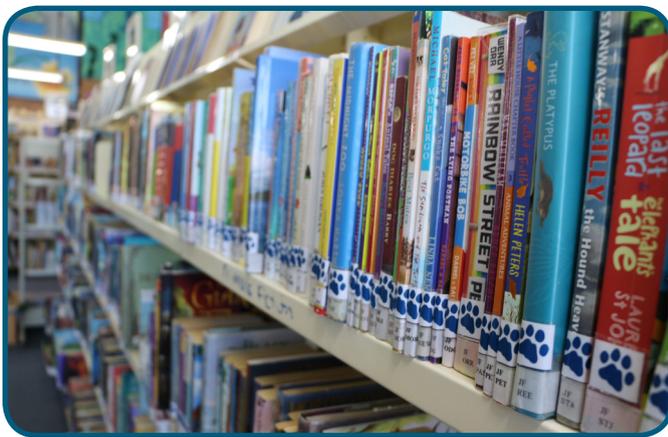
The two major defects that will affect the library building are water proofing of the roof and the continuing rotation of the eastern external wall. If the major defects are not resolved, a replacement is expected to be required in approximately 10 years.

The most likely cause of the structural issues encountered is the presence of loose/uncompacted soils beneath the building, likely formed by coastal processes.

- Water proofing of its roof: Replacing the roof, ceiling, gutters, pipes and install soak wells, approximately \$475,000 with a 12 week closure required
- Continuing rotation of its eastern external wall: Underpinning the foundation, approximately \$554,000 with 14 weeks closure time required to grout inject around all footings and reinstate the access points
