Technical Note

Project Number: J15028.00 Project Name: Esperance Jetties Condition Assessments

Date: 22/09/2017 Doc Ref: Tn-J15028-5

Subject: Esperance Tanker Jetty - Feasibility of preventing potential collapse of the Tanker Jetty superstructure

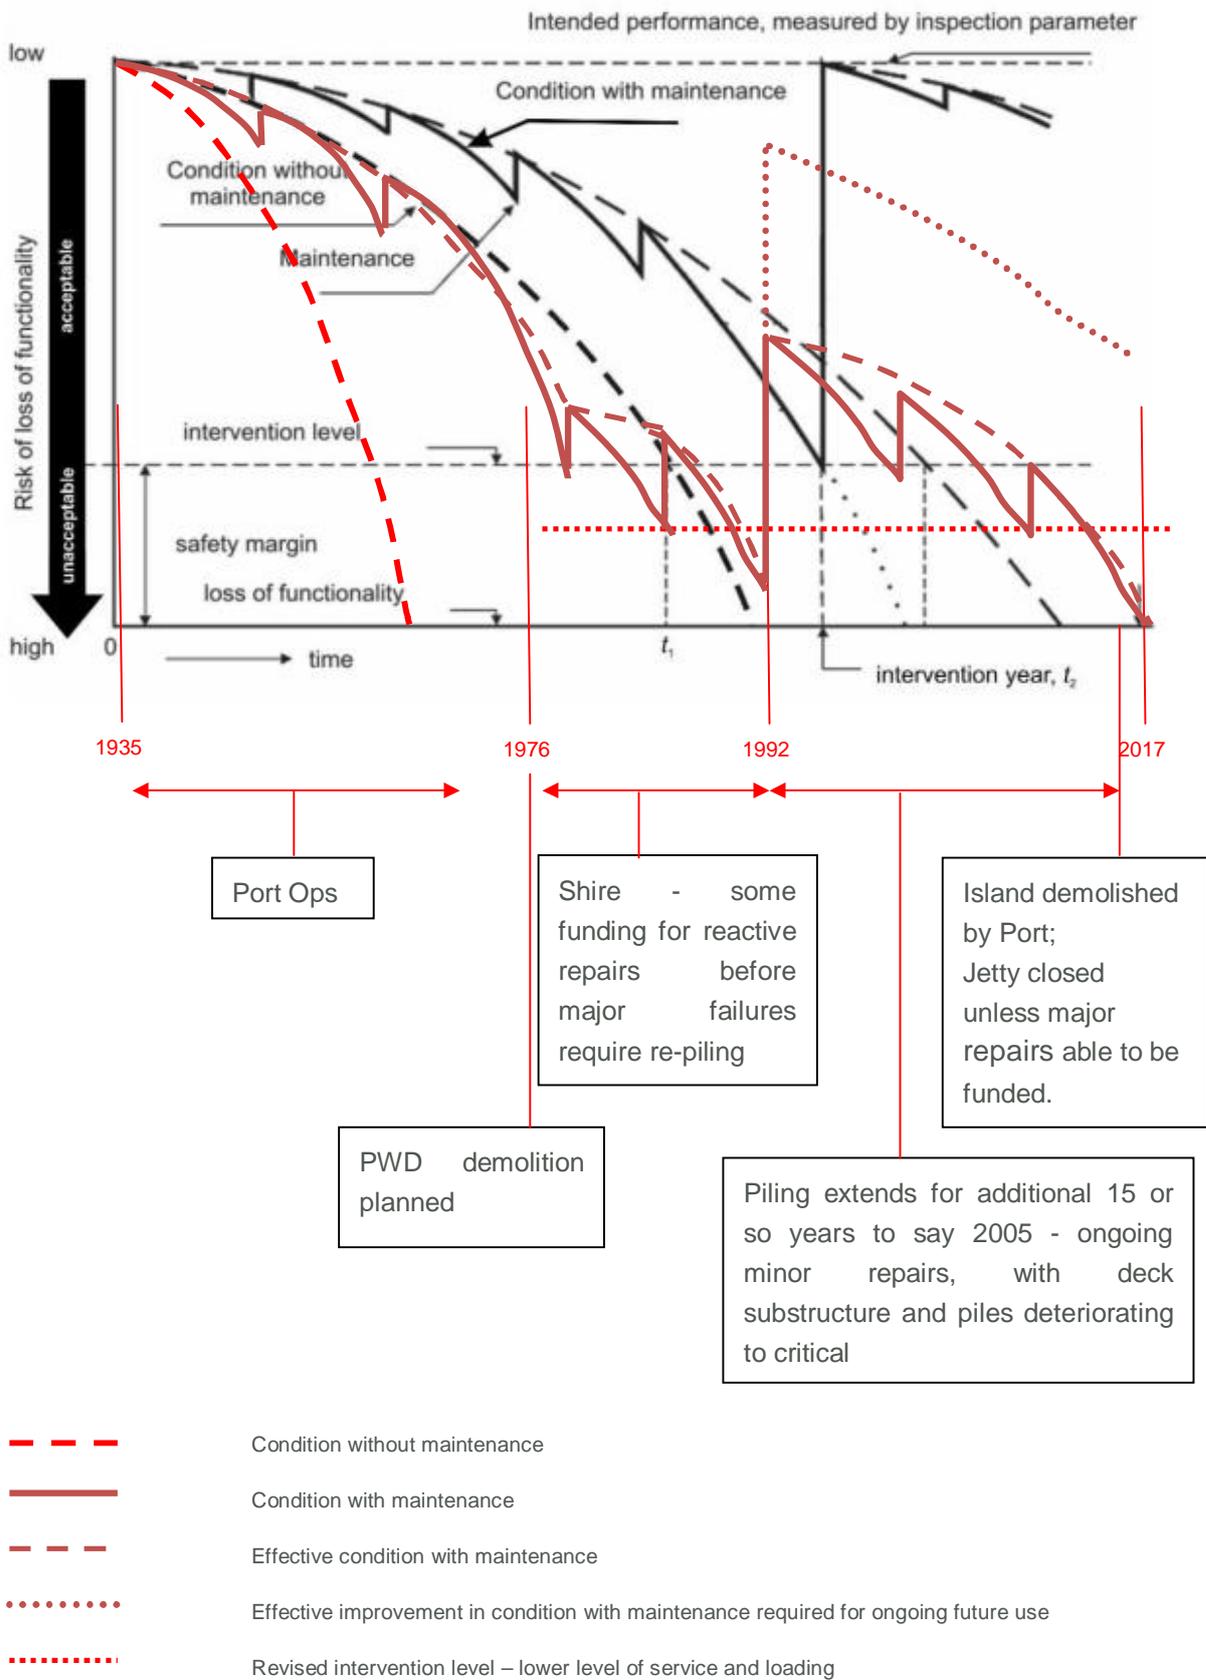
Figure 1 How we got here - Tanker Jetty Condition (Ageing of a structure – (sources CIRIA C674 & The Rock Manual⁸))

The chart shows the concepts of a variation in loss of functionality with time with a range of strategies and highlights the impact of various interventions. Even with good durability design and construction, a structure may be assumed to approach some limiting criteria based on functionality, capacity, failure mode and often safety. The strategy employed must ensure that management actions are optimised over its defined life and economic decisions can be framed around its later performance with regard to rehabilitation or replacement⁸.
