Technical Note

Project Number: J15028.00 Project Name: Esperance Jetties Condition Assessments

Date: 02/05/2018 Doc Ref: Tn-J15028-5

Subject: Esperance Tanker Jetty - Feasibility of preventing potential collapse of the Tanker Jetty superstructure

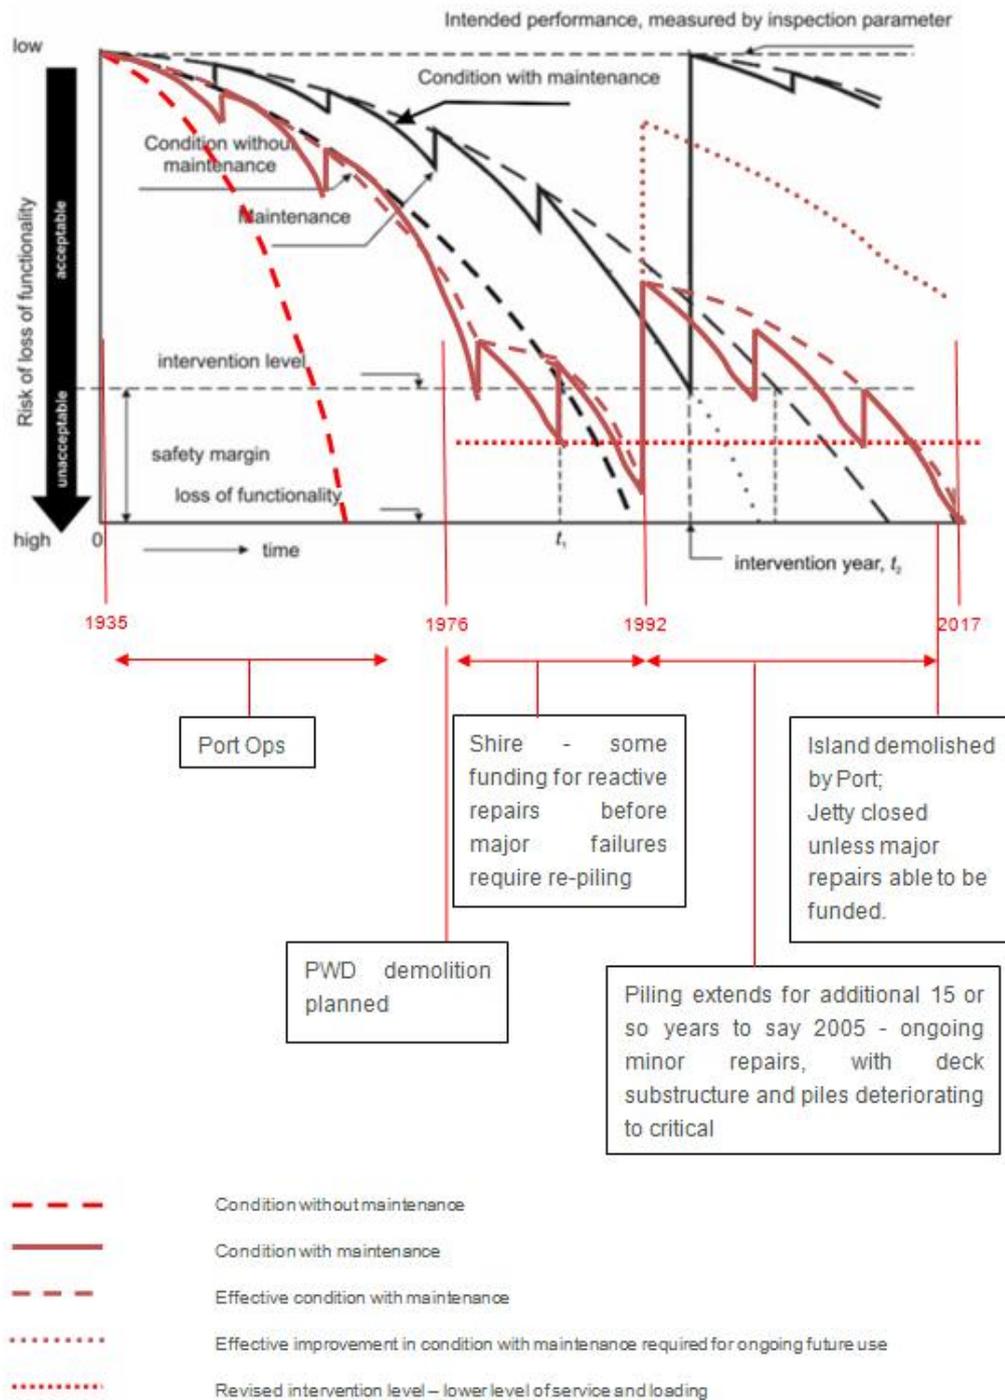
Figure 1 How we got here - Tanker Jetty Condition (Ageing of a structure – (sources CIRIA C674 & The Rock Manual ⁸))

The chart shows the concepts of a variation in loss of functionality with time with a range of strategies and highlights the impact of various interventions. Even with good durability design and construction, a structure may be assumed to approach some limiting criteria based on functionality, capacity, failure mode and often safety. The strategy employed must ensure that management actions are optimised over its defined life and economic decisions can be framed around its later performance with regard to rehabilitation or replacement ⁸.

The condition axis can also be thought of in terms of cost, the lower the structure is over time on this axis the larger portion of its replacement value will be required to bring it back up to the deterioration curve one expects with ongoing maintenance. The following element condition issues exist for the structure:
