Technical Note

Project Number: J15028.00 Project Name: Esperance Jetties Condition Assessments

Date: 24/04/2018 Doc Ref: Tn-J15028-6

Subject: Esperance Tanker Jetty – Stabilisation Proposal Bent 67

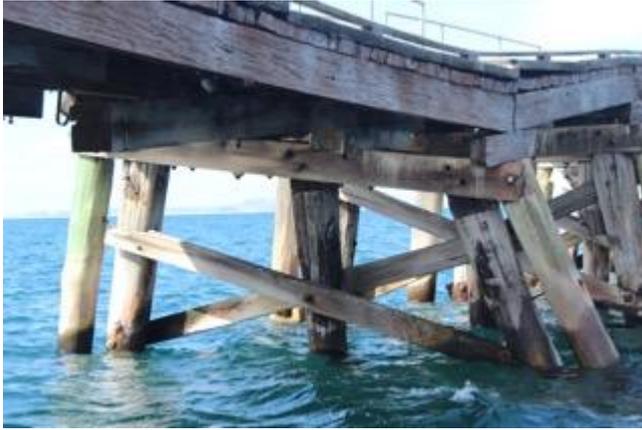
Figure 1 Pile Group 66 (missing) & 67 07/04/18

- the stringers are separating as the deck drapes between adjacent pile bents to Group 66 as a result of complete loss of bolt section to all connections on the structure

The conditions leading to the current state of the stringer is widespread in the structure deck. The condition of the piles that led to the failure of Pile Group 66 and 67 is also widespread within the structure. It is likely that additional loading of adjacent bents will continue to fail them resulting in a progressive collapse in time as was predicted previously. This could occur at any time and particularly the risk increases with winter storm wave events.

Mitigating actions to preserve the fabric remaining would be to remove sections of deck when they show this level of distress. This would decrease loading of adjacent bents until such time as either of the piles failed, but would not prevent failure over time.
