Timber Sorting Matrix*

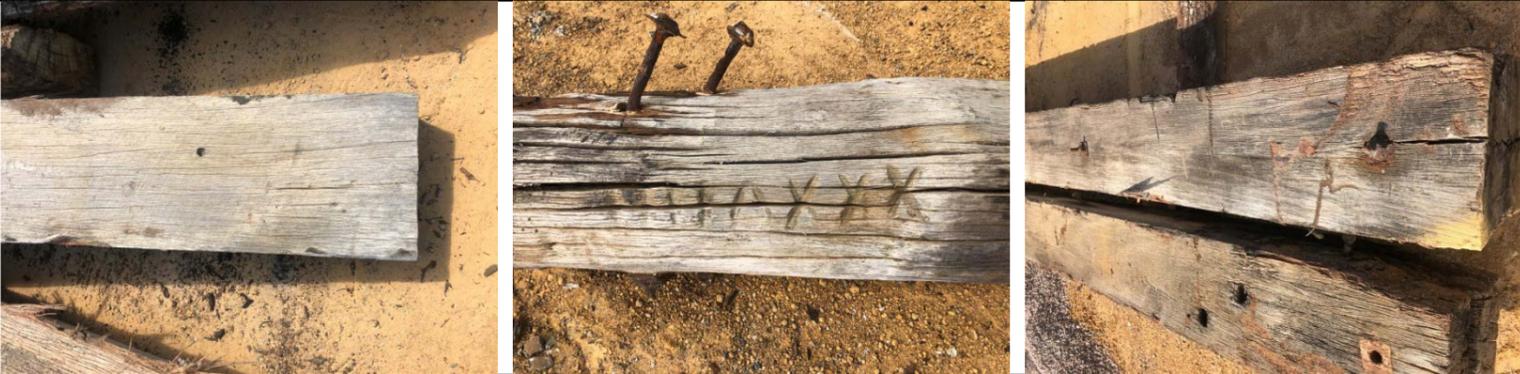
Grade	Extent of Visual Defects	Nature of Defects	Integrity & Authenticity	Future applications	Value	Example Photographs
1	≤10%	Weathering consistent with age. Localised deterioration around fixings and cut ends only. Timber in good, sound condition	Original 1933 fabric in intact lengths; original intact assemblies; fabric with desirable historic markings;	Re-use in Replacement Jetty design elements; Other Shire projects	Commercial

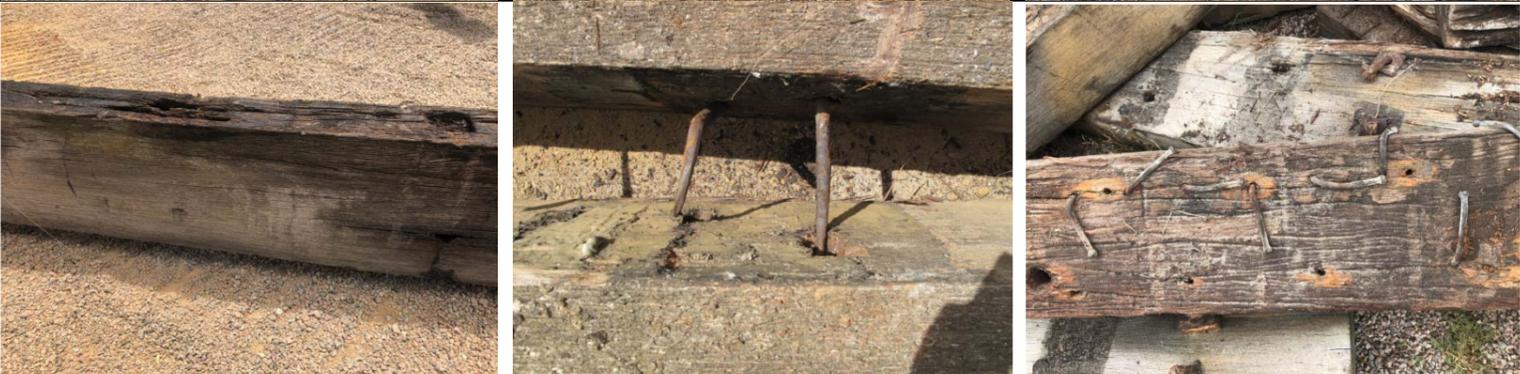
2	≤25%	Weathering consistent with age. Localised deterioration around fixings and cut ends, as well as other wear and tear/ general surface damage; timber generally in good to fair condition	Original or early fabric in intact or slightly modified lengths; timber in sound condition	Other construction projects; timber trader market	Commercial

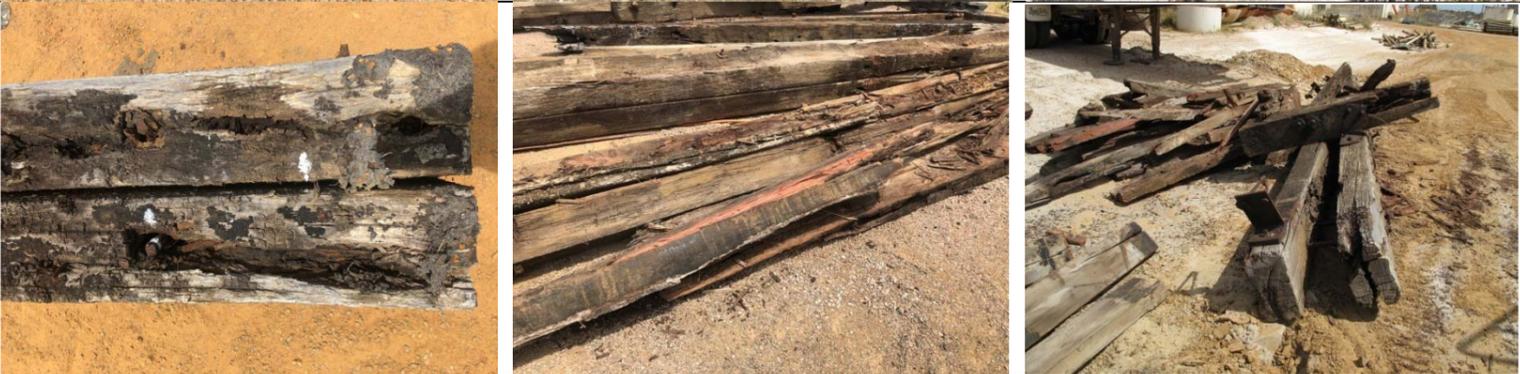
3	>25%	Considerable weathering; enlarged recesses and deterioration to exposed surfaces and around fixings and cut ends; timber generally in fair to poor condition	Cut-down or damaged lengths of 1933 fabric; non-original replacement fabric	Small scale domestic and community use; opportunistic salvage	Community

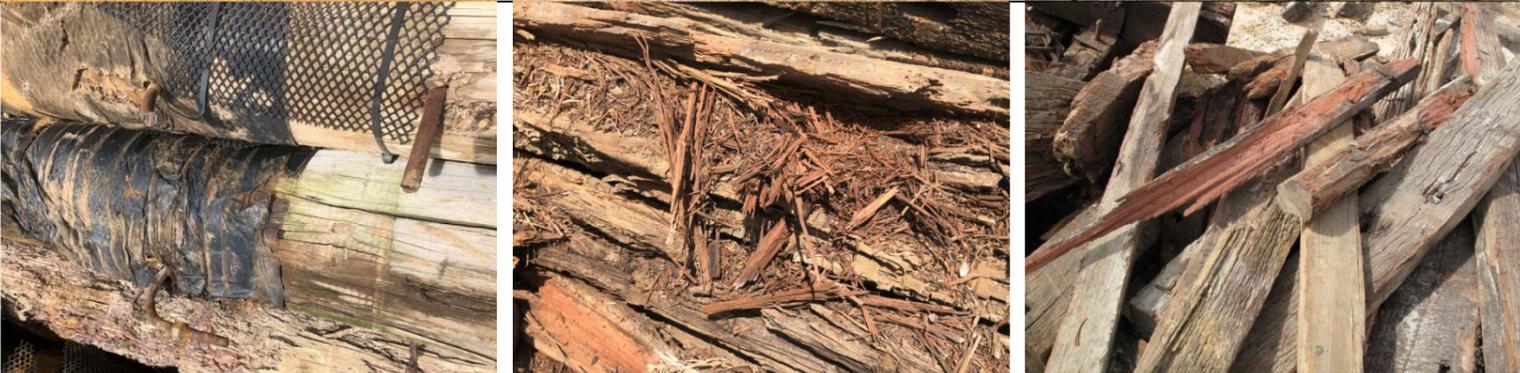
4	Defective	Excessive weathering and deterioration. Broken, rotted, splintered timber with structural failure; timber with contamination; timber generally in poor condition	Broken lengths; non-original replacement fabric; contaminated material	Opportunistic salvage; landfill	Minimal
