# Shire Of Esperance

## Esperance Tanker Jetty Remediation Options Review

### Independent Peer Review

November 2016

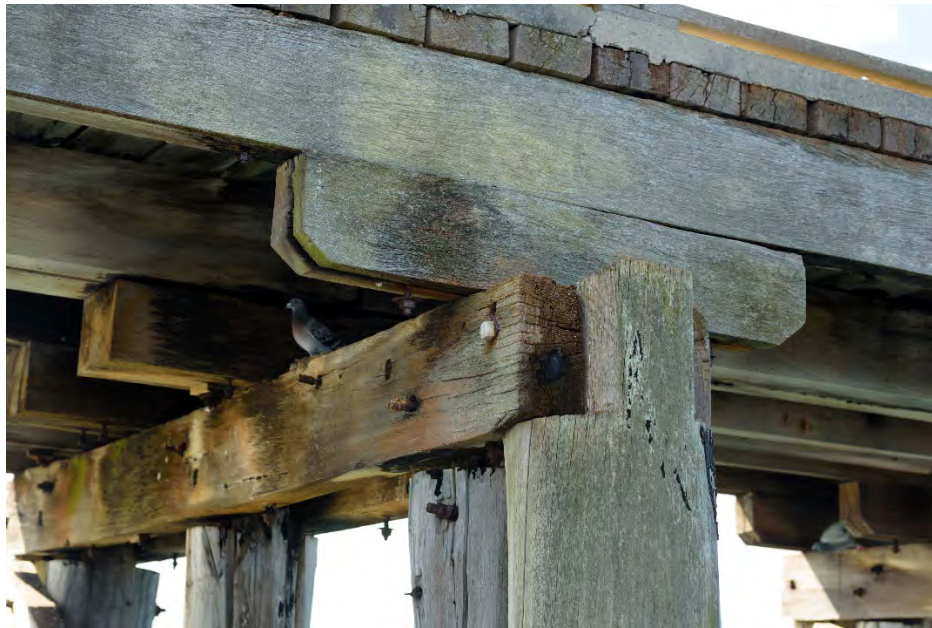
Below is an image of a typical bent, showing the piles, headstock beam (connected to the pile via the halfcap joint), the timber corbel on the headstock and the stringers above the corbel. This particular images also shows one of the very few bents that still have the original (1935) timber piles still attached.

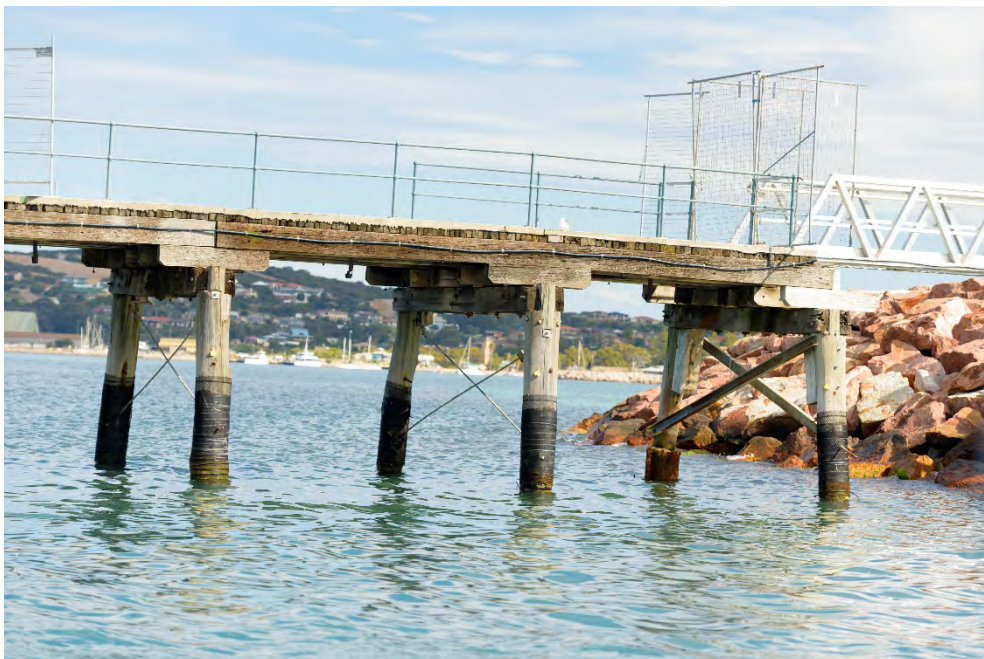
**Current aluminium gangway span onto the Jetty**

The current abutment span is a 20m long aluminium gangway onto the existing Jetty. The gangway is approximately 1.9m wide (clear), whereas the Jetty is 4.6m wide. A photo of the gangway-jetty connection is shown below. It has been assumed that this existing arrangement will remain for the baseline case, to minimise costs. However, the opportunity exists to improve upon this somewhat unattractive and relatively narrow entrance onto the Jetty. In particular, I suggest consideration be given to the design of a special feature “Entry span” constructed from or featuring original and salvaged Jetty timber. We suggest the cost of such an entry span (4.6m wide x 20m long) would be in the order of \$200,000.

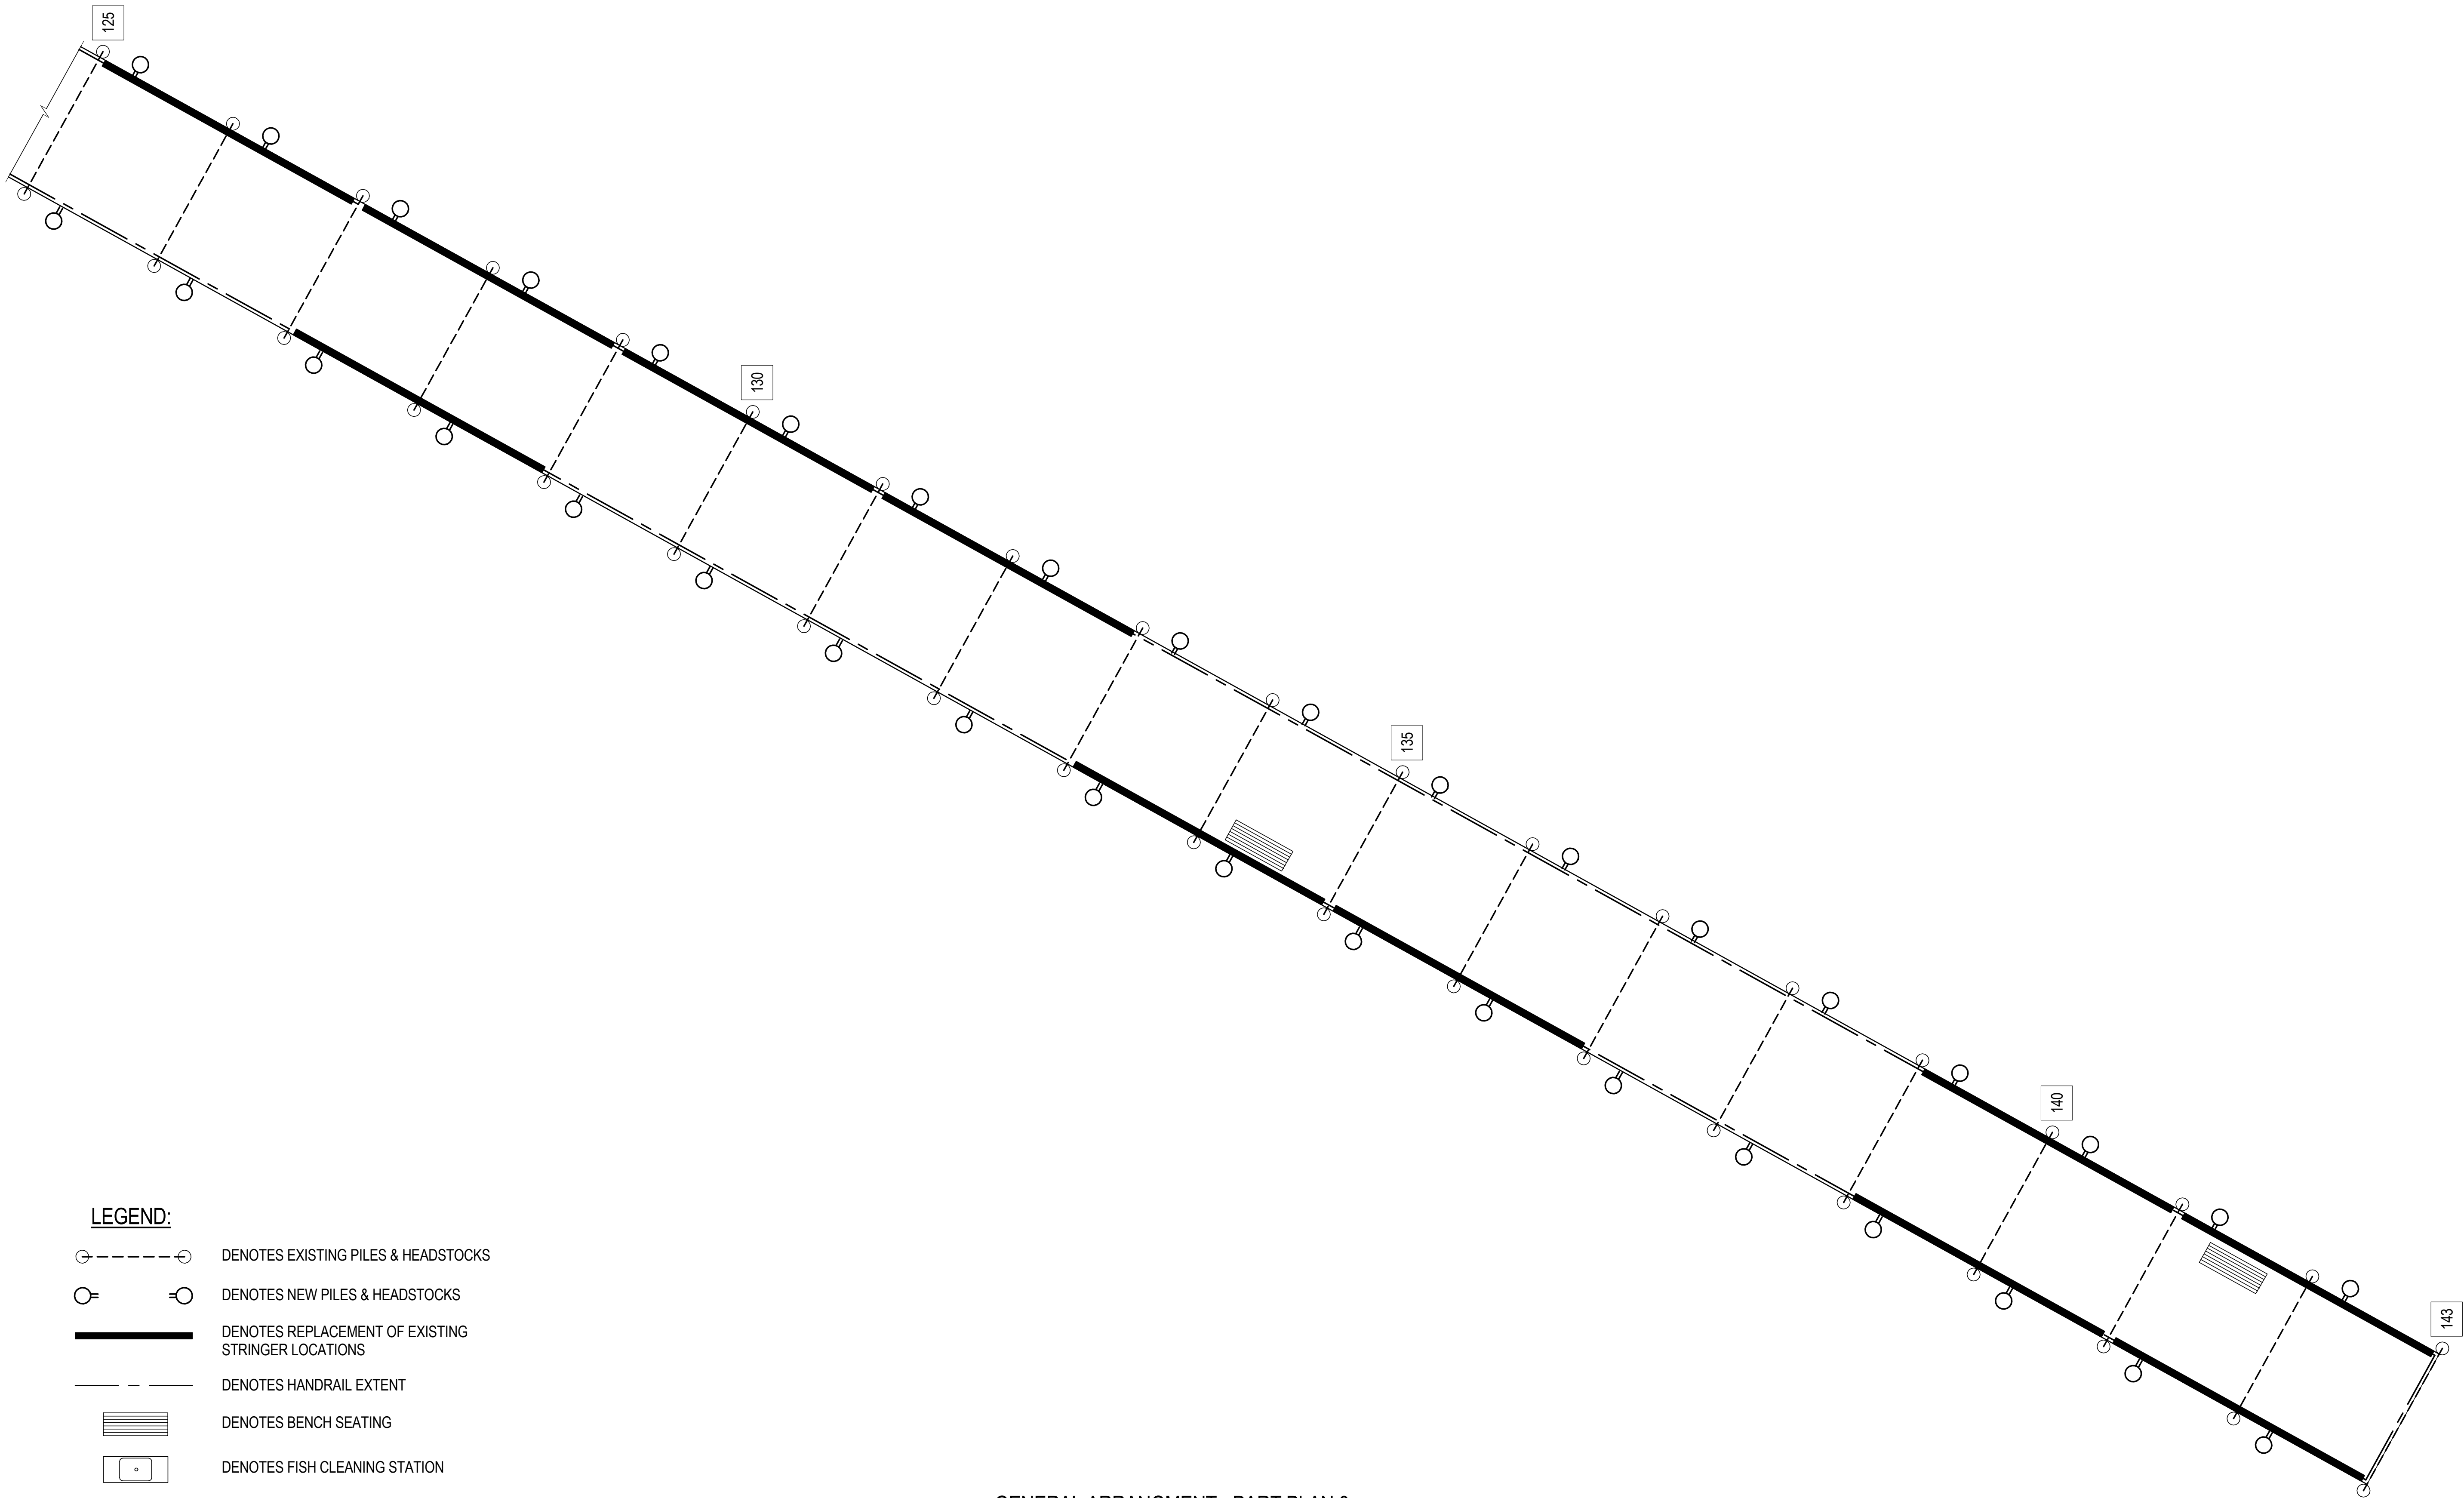
In total there are 48 external stringers that have been identified by myself as requiring replacement or structural augmentation. In section 9 below, I discuss the proposed stringer replacement or strengthening options.

- DENOTES EXISTING PILES & HEADSTOCKS
- DENOTES NEW PILES & HEADSTOCKS
- DENOTES REPLACEMENT OF EXISTING STRINGER LOCATIONS
- DENOTES HANDRAIL EXTENT
- DENOTES BENCH SEATING
- DENOTES FISH CLEANING STATION
