ESPERANCE TANKER JETTY STRUCTURAL ASSESSMENT

16 June 2011

Ref: P09171

Structural Analysis Report

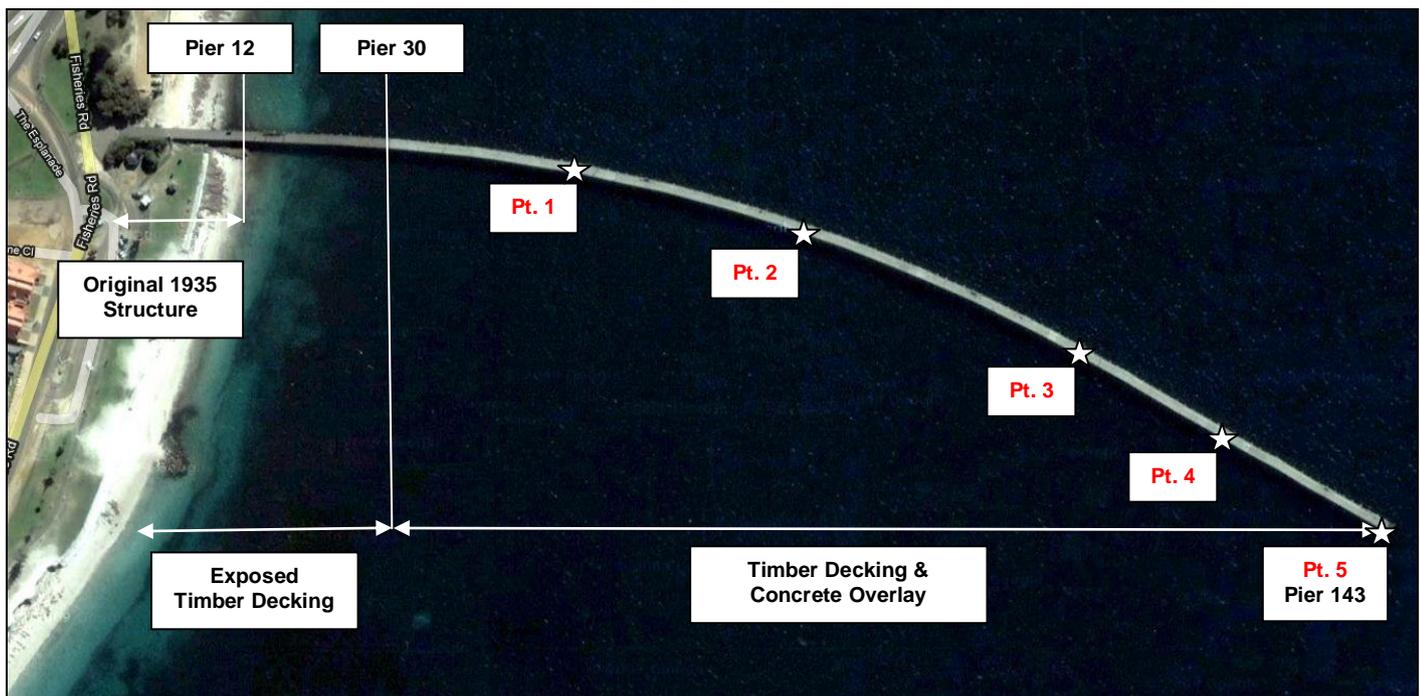
6.3 Jetty Plan View

1. Jetty reference points 'Pt. 1 to Pt. 5' represent specific locations along the jetty where wave conditions and forces were determined by JFA Consultants as part of the Wave Study.

The span number corresponds to the pier number at the eastern span end. The stringers and corbels are identified numerically from left to right when viewed in the direction of increasing chainage.
